Project Number A-00738 (4949)

**Refurbishment and Demolition
Asbestos Survey Report**

**The Mill
Gurney Slade
Radstock
BA3 4TE**

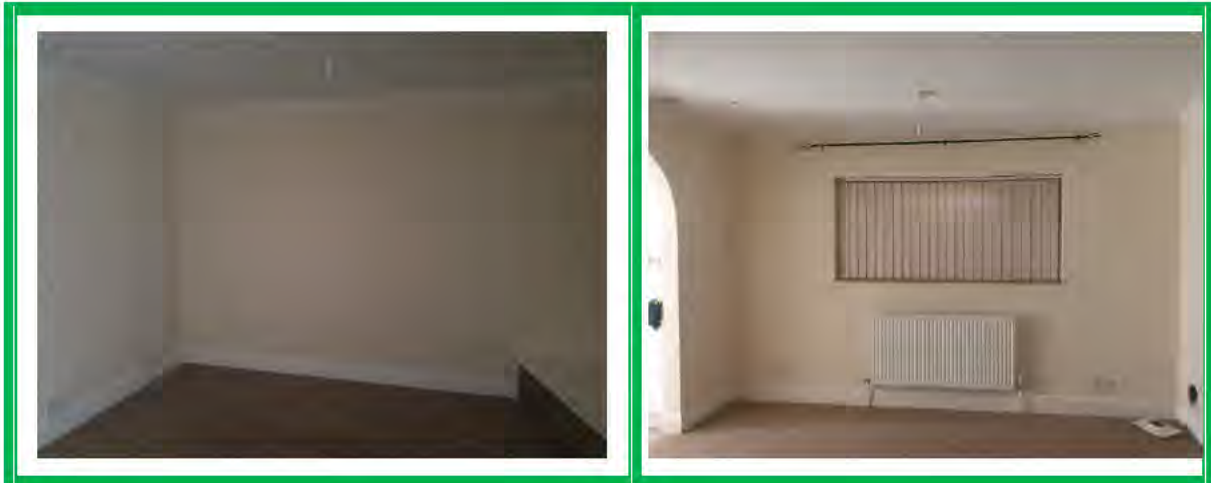
| Item No: | 4 | Sample No: | N/A |

| Location: | Ground Floor - Bungalow 1 – Living Room 004 | | |

| Material Description: | No Suspect Materials Found | |

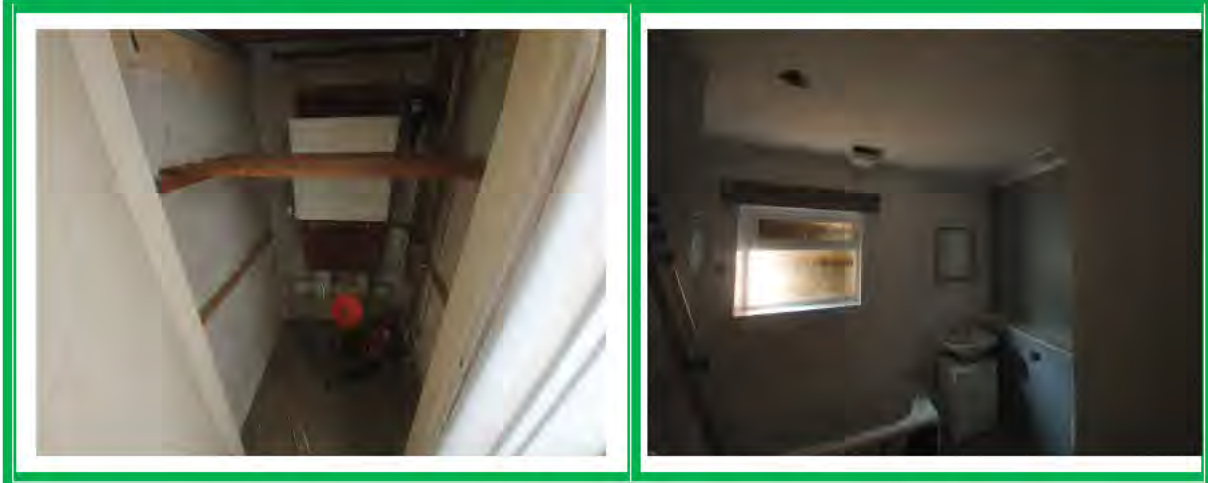
| Item No: | 5 | Sample No: | N/A |

| Location: | Ground Floor - Bungalow 1 - Cupboard and Bathroom 005 | | |

| Material Description: | No Suspect Materials Found | |

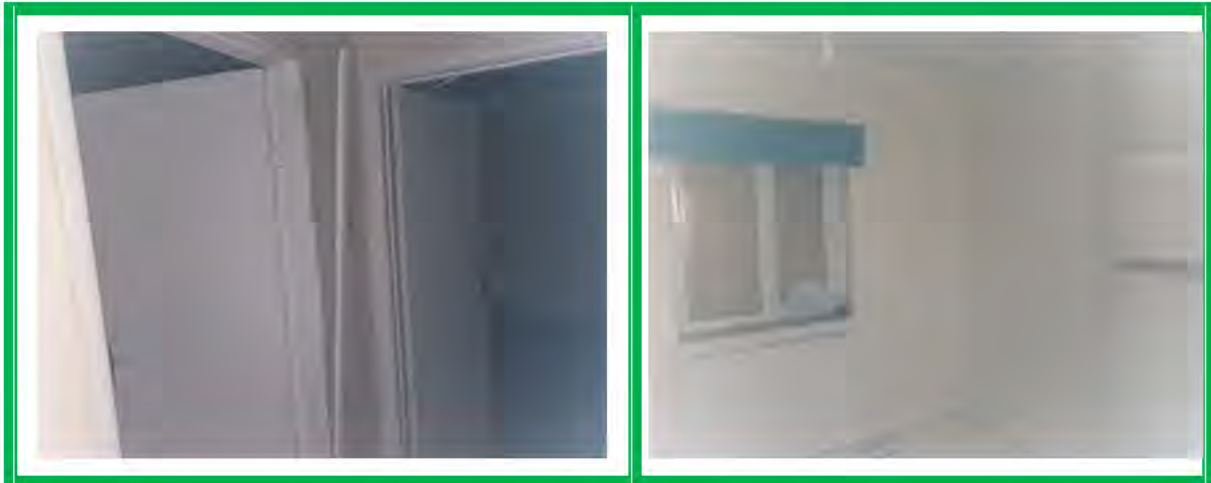
| Item No: | 6 | Sample No: | N/A |

| Location: | Ground Floor - Bungalow 1 - Bedrooms x 3 006 | | |

| Material Description: | No Suspect Materials Found | |

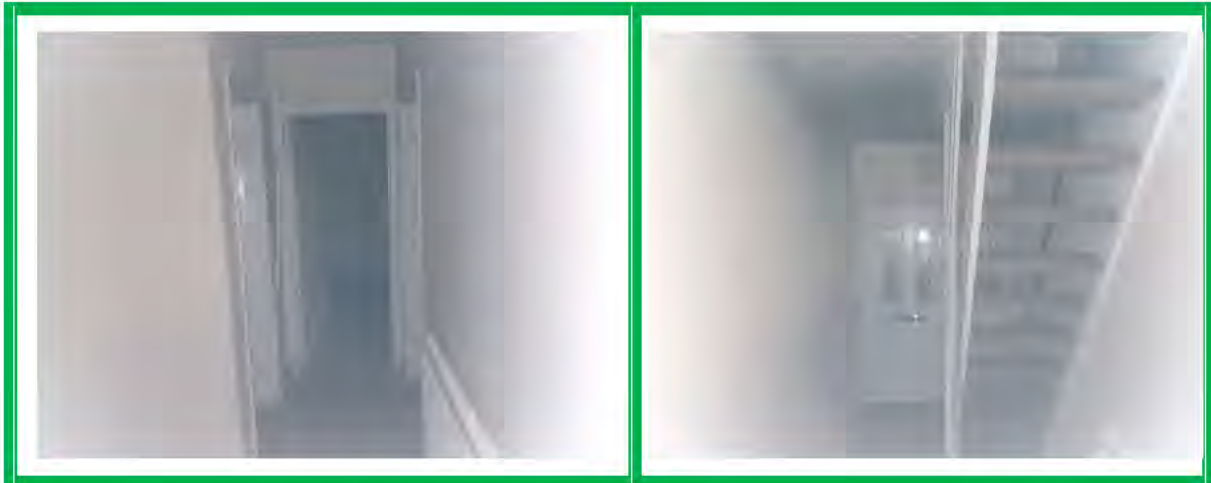
| Item No: | 7 | Sample No: | N/A |

| Location: | Ground Floor - Bungalow 1 - Hallway 007 | | |

| Material Description: | No Suspect Materials Found | |

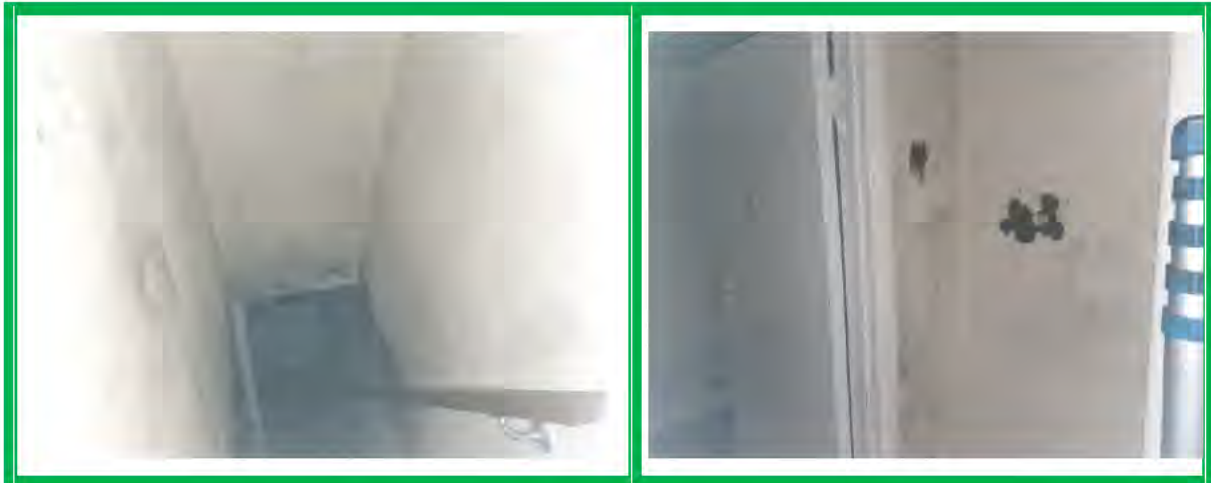
| Item No: | 8 | Sample No: | N/A |

| Location: | First Floor - Bungalow 1 - Stairwell & Landing 008 | | |

| Material Description: | No Suspect Materials Found | |

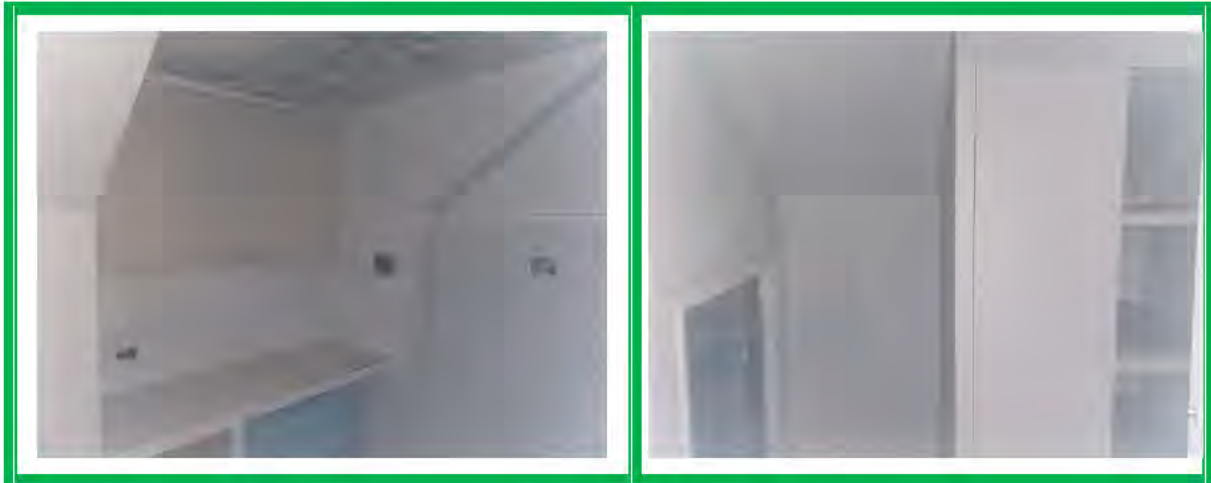
| Item No: | 9 | Sample No: | N/A |

| Location: | First Floor - Bungalow 1 - Bedroom and Cupboard 009 | | |

| Material Description: | No Suspect Materials Found | |

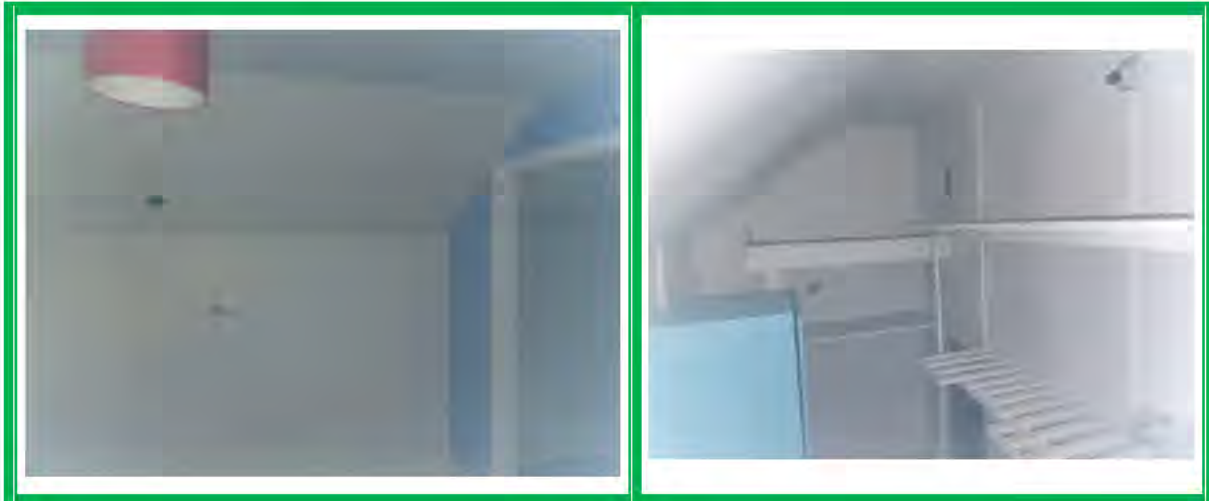
| Item No: | 12 | Sample No: | N/A |

| Location: | First Floor - Bungalow 1 - Bedroom, Store and Void 012 | | |

| Material Description: | No Suspect Materials Found | |

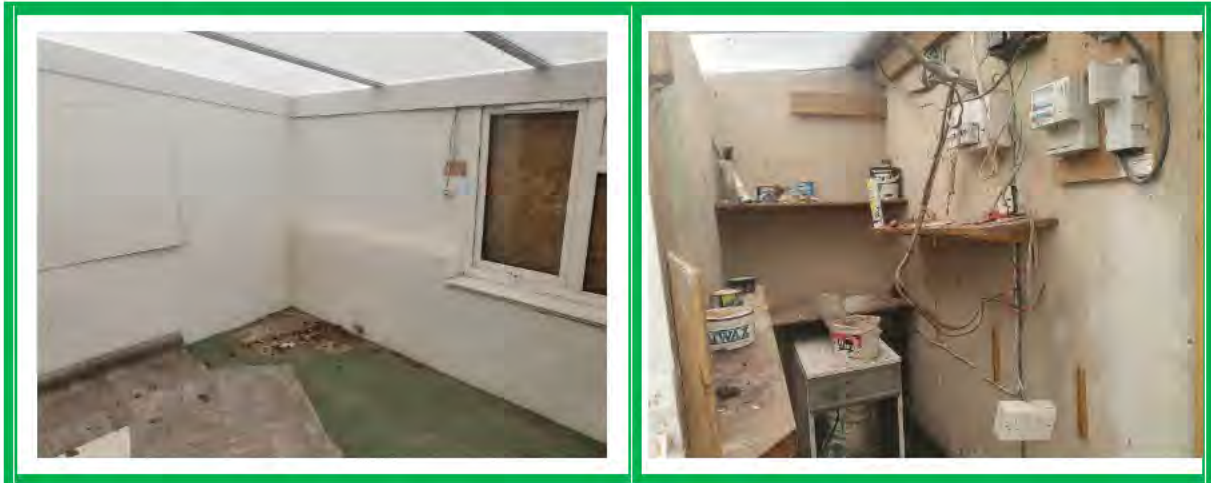
| Item No: | 17 | Sample No: | N/A |

| Location: | Ground Floor - Bungalow 2 - Lobby, WC and Boiler Room 017 | | |

| Material Description: | No Suspect Materials Found | |

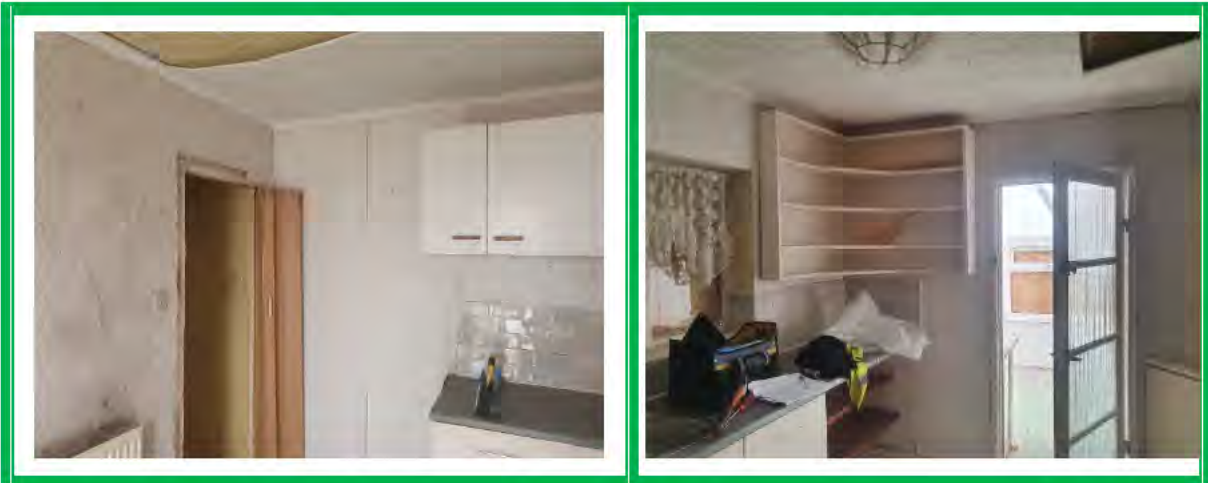
| Item No: | 18 | Sample No: | N/A |

| Location: | Ground Floor - Bungalow 2 - Kitchen 018 | | |

| Material Description: | No Suspect Materials Found | |

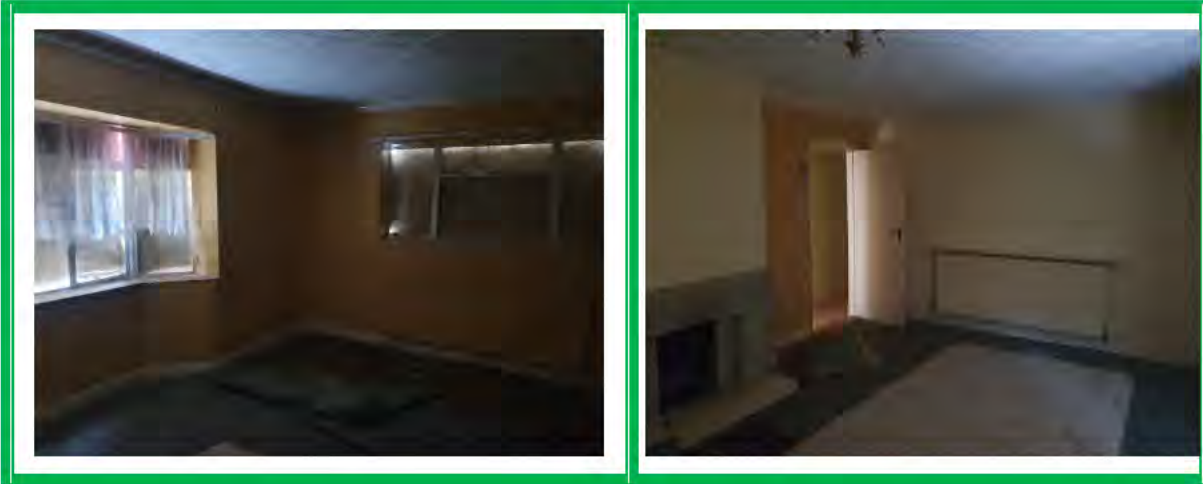
| Item No: | 19 | Sample No: | N/A |

| Location: | Ground Floor - Bungalow 2 - Living Room 019 | | |

| Material Description: | No Suspect Materials Found | |

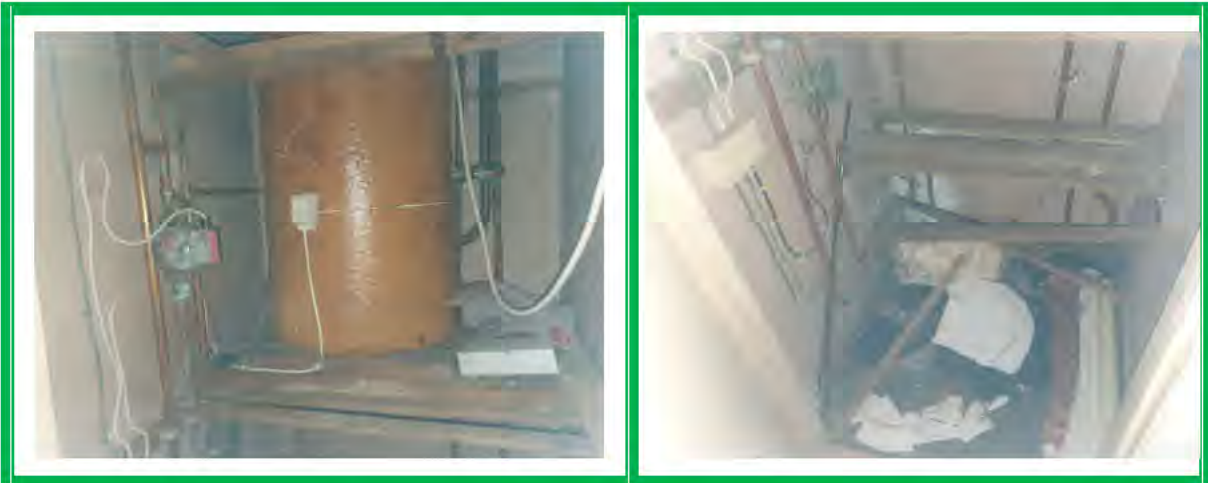
| Item No: | 20 | Sample No: | N/A |

| Location: | Ground Floor - Bungalow 2 - Cupboard 020 | | |

| Material Description: | No Suspect Materials Found | |

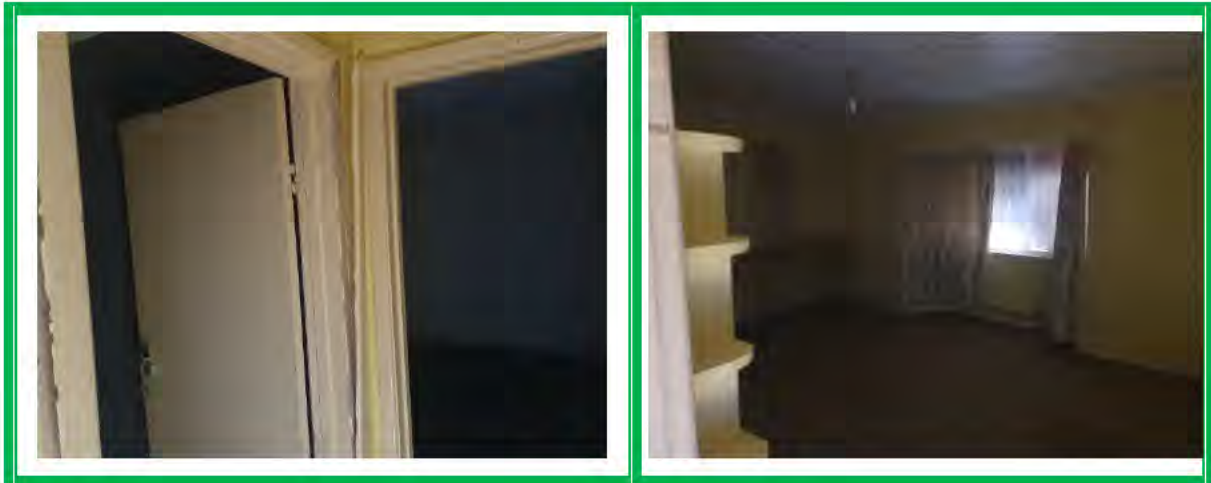
| Item No: | 22 | Sample No: | N/A |

| Location: | Ground Floor - Bungalow 2 - Bedrooms x 3 022 | | |

| Material Description: | No Suspect Materials Found | |

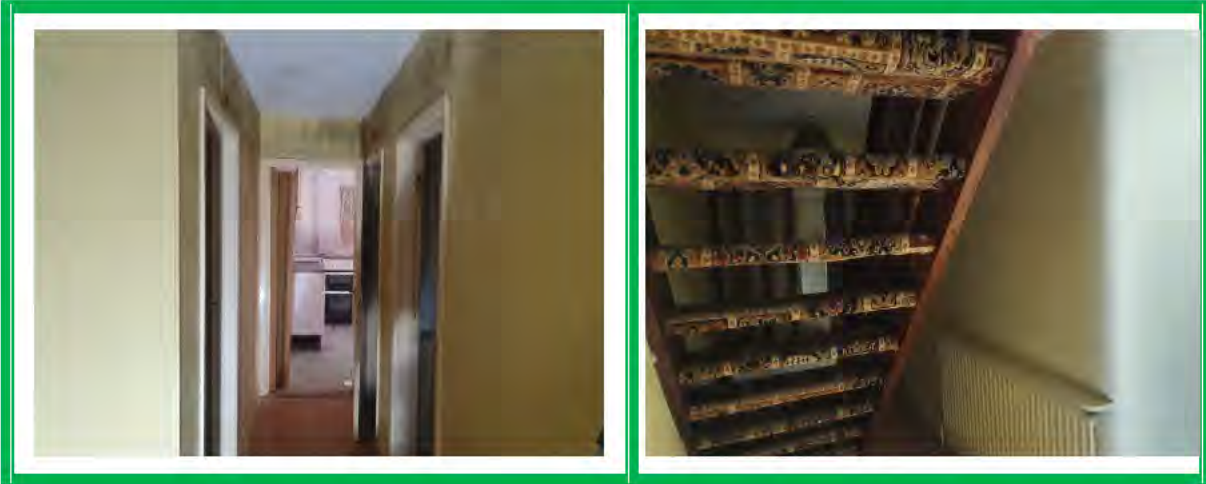
| Item No: | 23 | Sample No: | N/A |

| Location: | Ground Floor - Bungalow 2 - Hallway 023 | | |

| Material Description: | No Suspect Materials Found | |

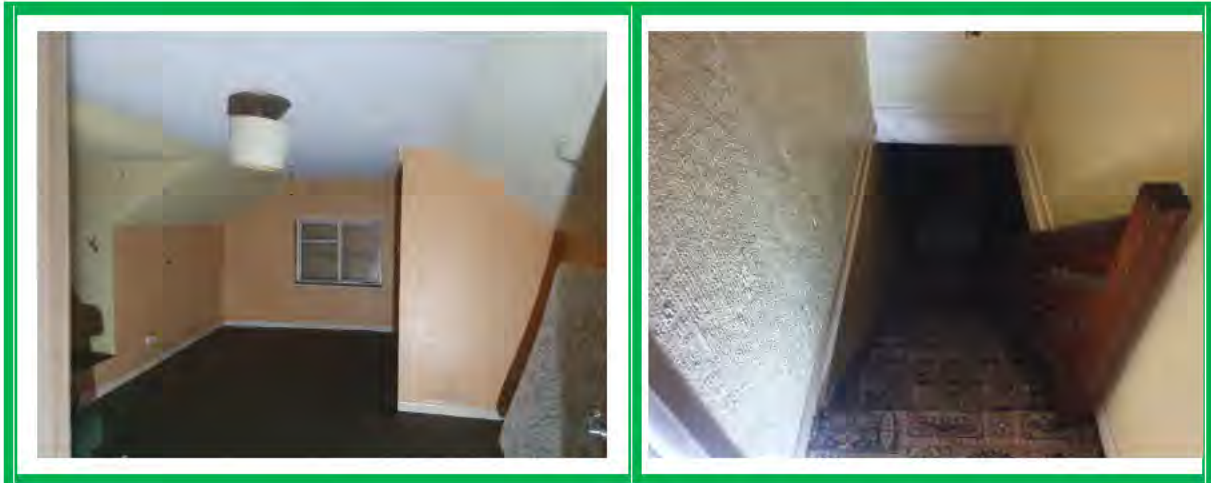
| Item No: | 24 | Sample No: | N/A |

| Location: | First Floor - Bungalow 2 - Stairwell, Bedroom and Store 024 | | |

| Material Description: | No Suspect Materials Found | |

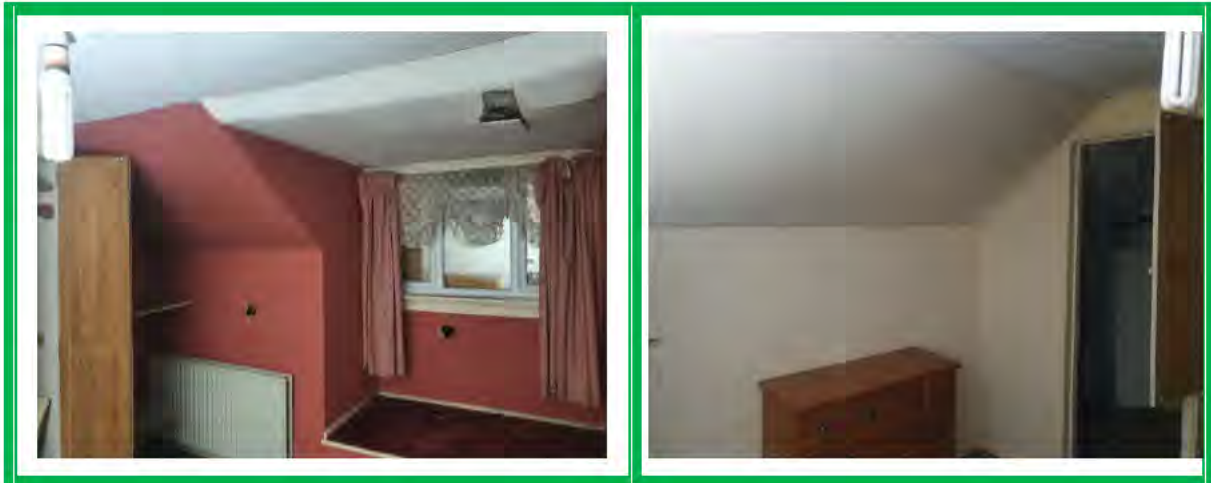
| Item No: | 25 | Sample No: | N/A |

| Location: | First Floor - Bungalow 2 - Bedroom 025 | | |

| Material Description: | No Suspect Materials Found | |

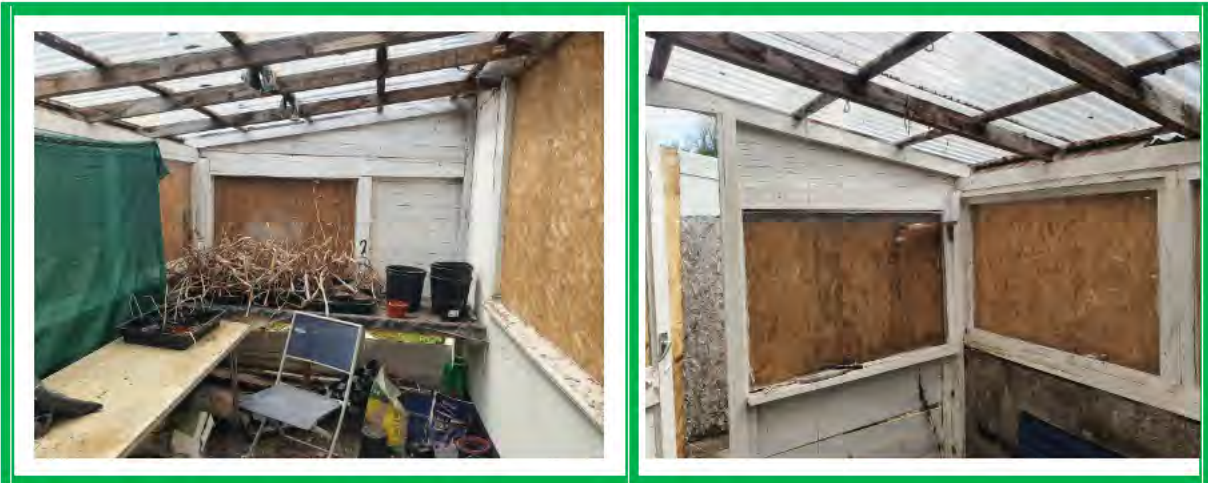
| Item No: | 28 | Sample No: | N/A |

| Location: | Ground Floor - Bungalow 2 - Store 028 | | |

| Material Description: | No Suspect Materials Found | |

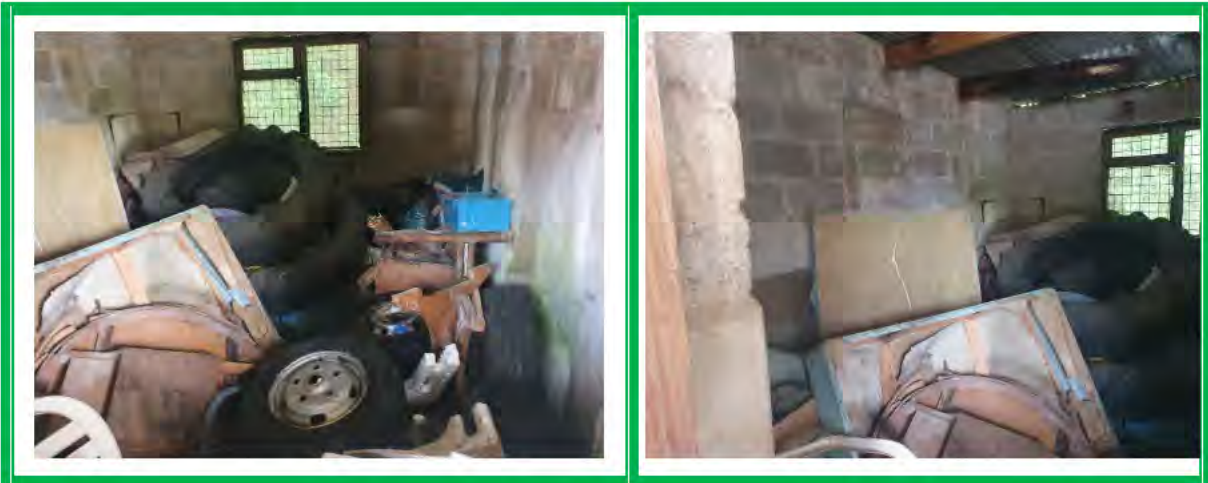
| Item No: | 30 | Sample No: | N/A |

| Location: | Ground Floor - Garage Block - Stable 1 030 | | |

| Material Description: | No Suspect Materials Found | |

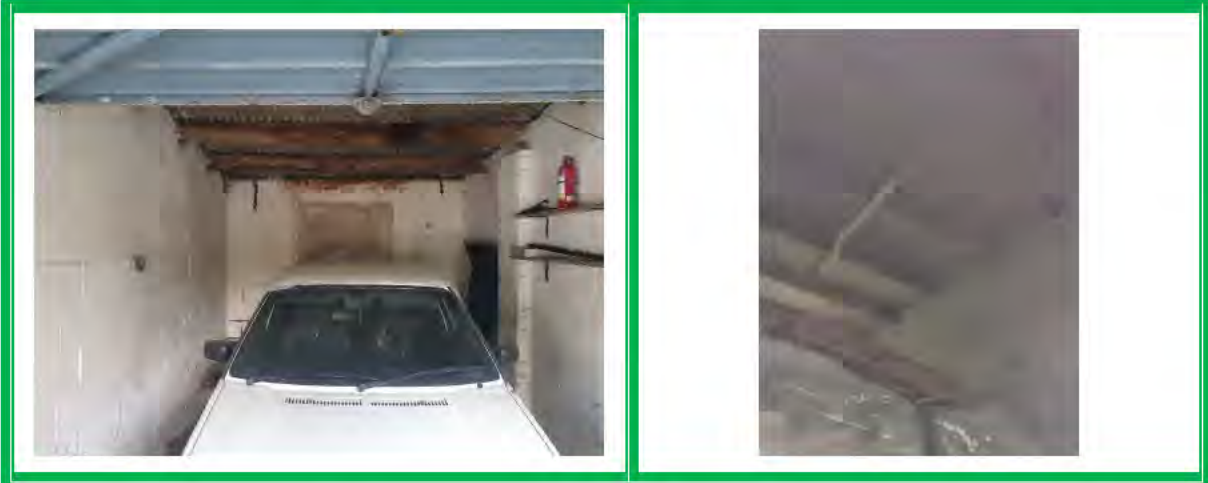
| Item No: | 33 | Sample No: | N/A |

| Location: | Ground Floor - Garage Block - Store and Garages x 4 033 | | |

| Material Description: | No Suspect Materials Found | |

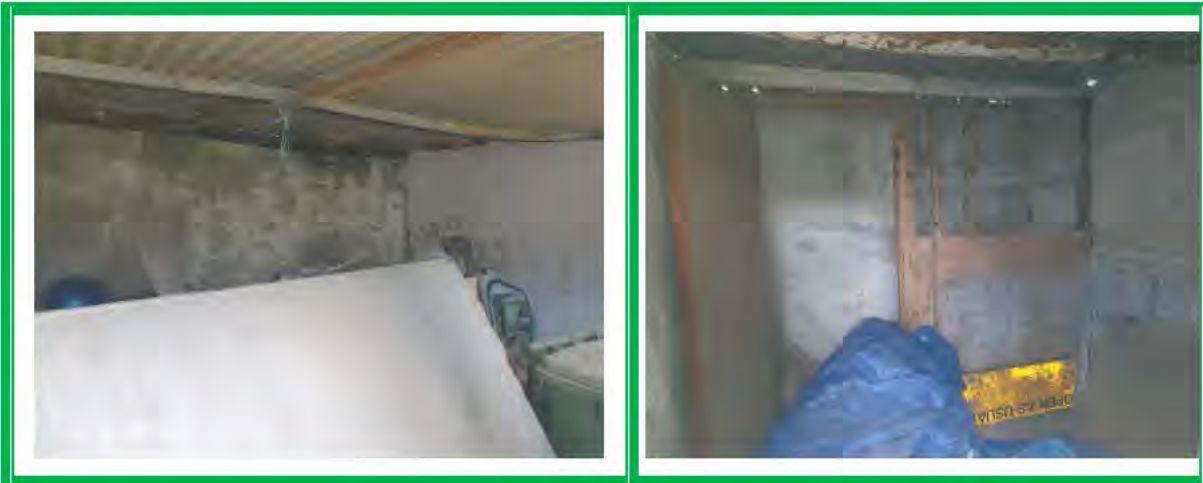
| Item No: | 36 | Sample No: | N/A |

| Location: | Ground Floor - Stable Block - Stable and Store 036 | | |

| Material Description: | No Suspect Materials Found | |
