Laurel Cottage, Tiptoe

Scope of Works and Repairs to Existing Building

Historic Building Condition Survey

**Laurel Cottage, Northover Lane,
Tiptoe, Lymington, Hampshire**

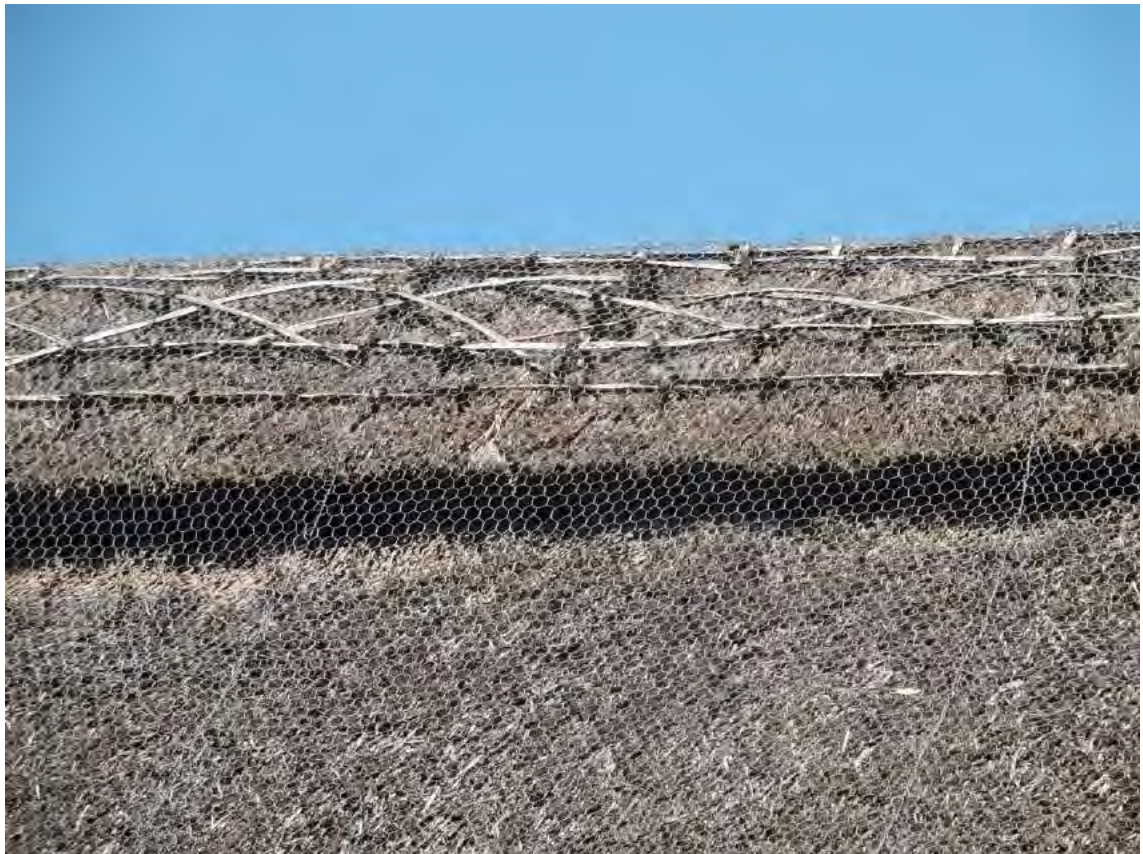
Fig 3.1; Ridge

- 3.1.1 The roof is a hip ended structure covered with thatch, which comprises of a top dressing of water reed over what appears to be a lower or undercoat of long straw thatch. This lower layer could be seen from a small section of the exposed roof within the west end of the house as well as over the east extension.
- 3.1.2 The slopes run up to a heavy block cut ridge with exposed ligger and other hazel work decoration to this. The roof is fully netted with the galvanised netting that is also turned under the eaves and fixed reasonably securely all the way around. The thatch sits tight to the head of the wall over the wall plate particularly on the north elevation.

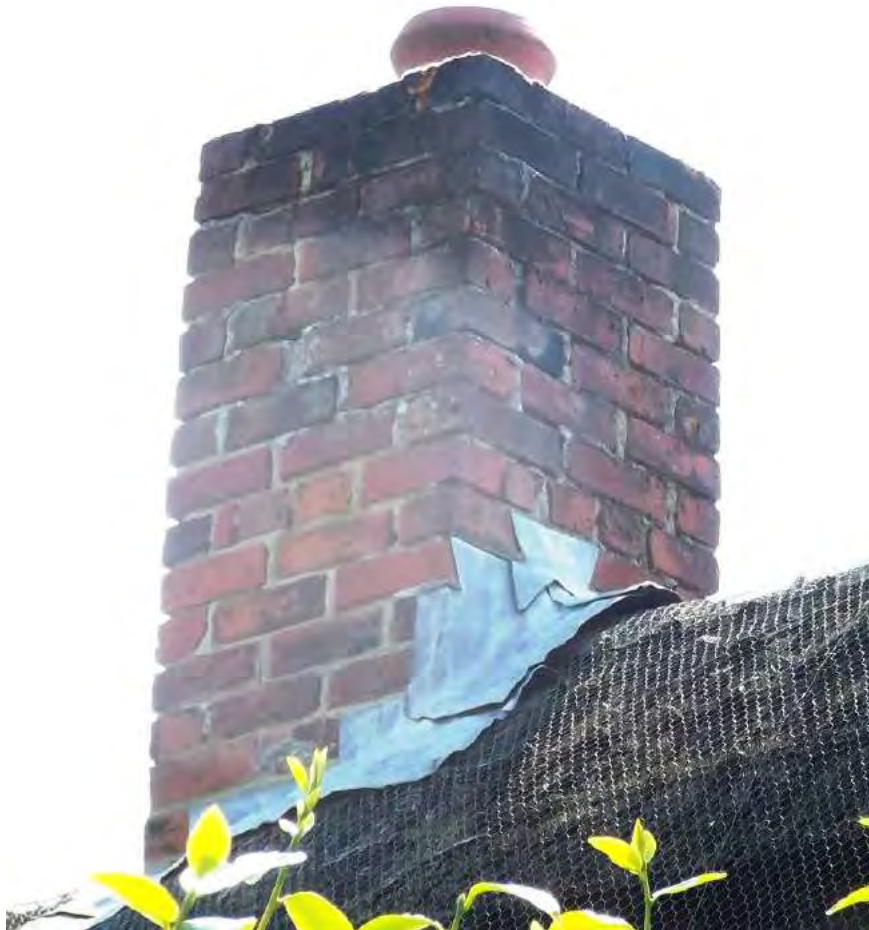
Fig 3.3; Main chimney

- 3.3.1 Two chimneys project up through the roof coverings, one is on the junction between the east extension and the main part of the house and the other is through the west gable.
- 3.3.2 The main chimney towards the east end is a straight brick stack that is surmounted by a single flue terminal (chimney pot) and this appears to be in a reasonable condition including the pointing. This is flashed weathered into the roof with lead sheeting dressed over the top of the netting so that it sits snug on the surface.
- 3.3.3 The chimney on the west end of the house is a small single stack, which projects up to barely the height of the ridge and this is finished with a stone cap stone on corner supports.

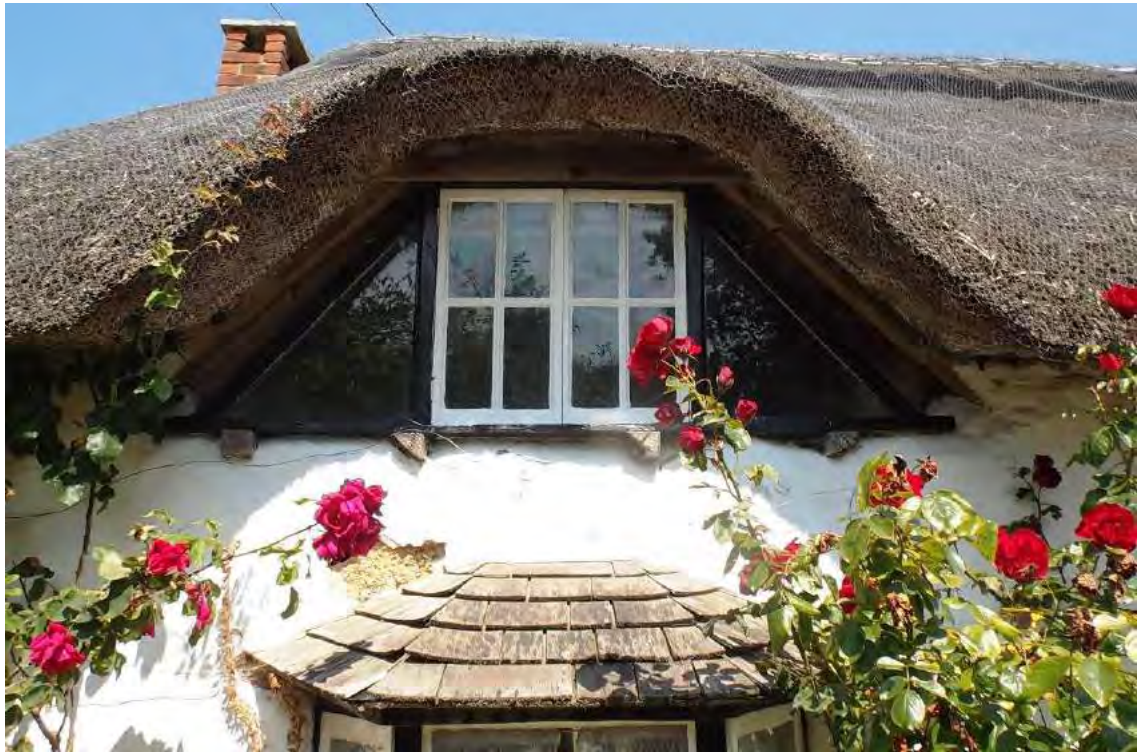
Fig 3.5.12; West eyebrow window over shingle roof to kitchen oriel window

- 3.5.10 At first floor level on the front elevation there are eyebrow windows set within the thatch. These have small pane casement windows set centrally with fixed pane glazing on either side of a triangular shape.

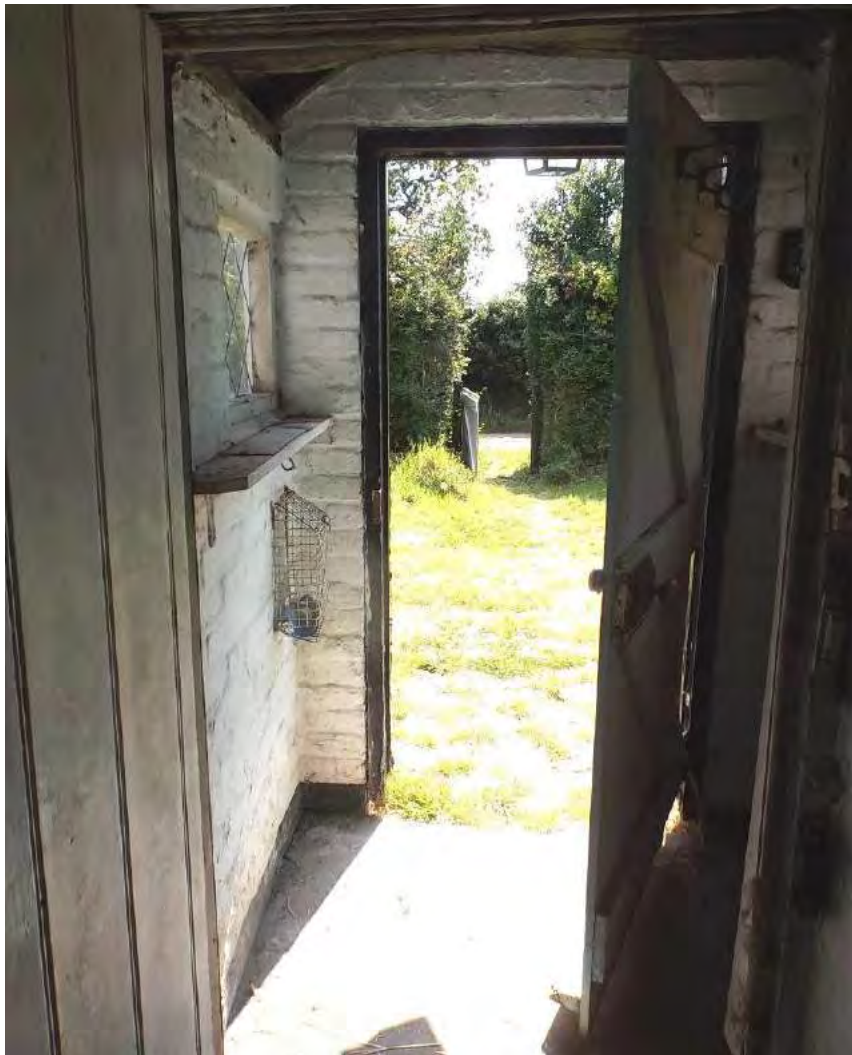
Fig 4.1; Porch from living room

- 4.1.3 The ceiling is of timber sarking board to the underside of the porch roof coverings under the shingles and on top of the rafters.
- 4.1.4 Leading off of this space is a timber ledged and braced door hung within a door frame that appears to be the former external door to the house. This is fitted with

a brass knocker, spy hole, Yale type rim latch, lever latch set and a security lock set bolted into position with a metal plate. There is a timber threshold to the base of this and there is applied weather stripping around the frame externally.

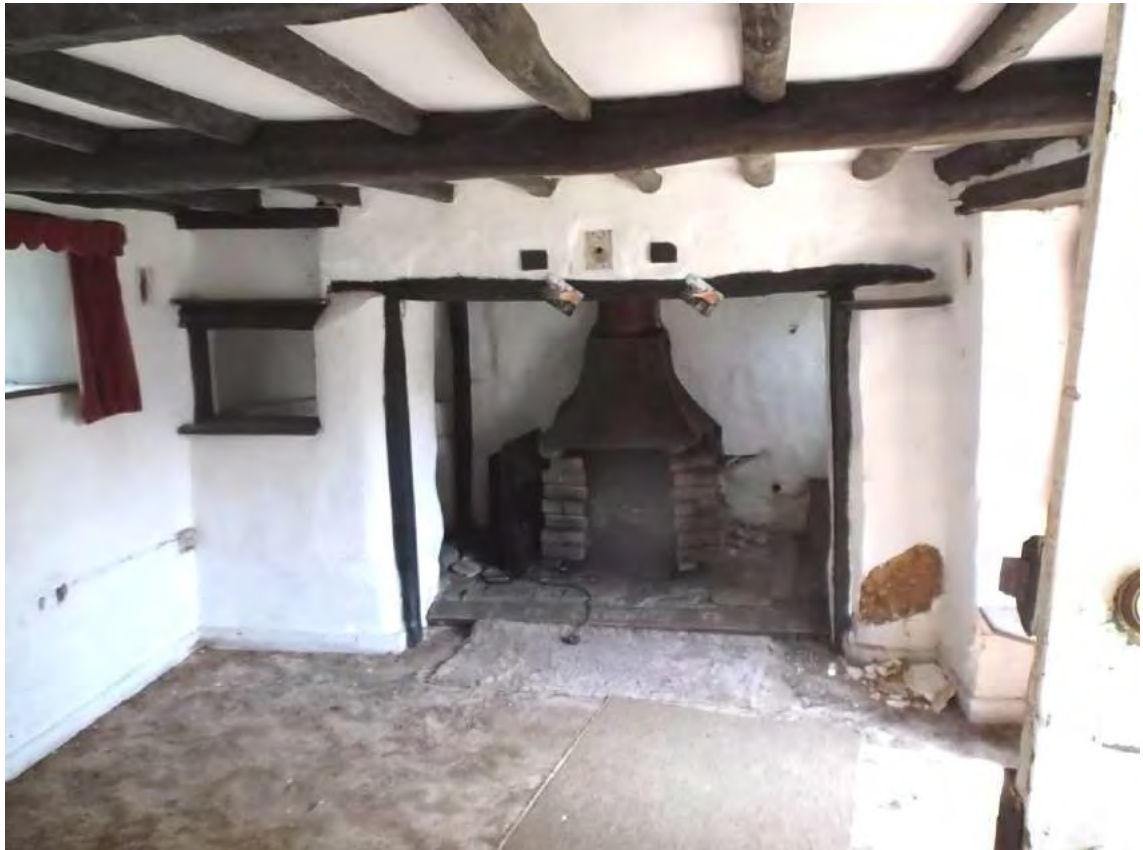
Fig 4.2; Living room looking from kitchen

- 4.2.1 This is approached by a slight step down from the porch floor onto this floor and it also appears to have a slight run on it towards the rear northwest corner. Most of the floor is covered with fitted carpets, but where a small area had been pulled back, it showed the structure was of cement-grit type screed over a solid base.
- 4.2.2 The walls are all of solid construction with a finish that varies from cement render to traditional lime renders.
- 4.2.3 On the east side of the room there is an inglenook type fireplace formed across the full width of the house with seating areas within it. The opening between the

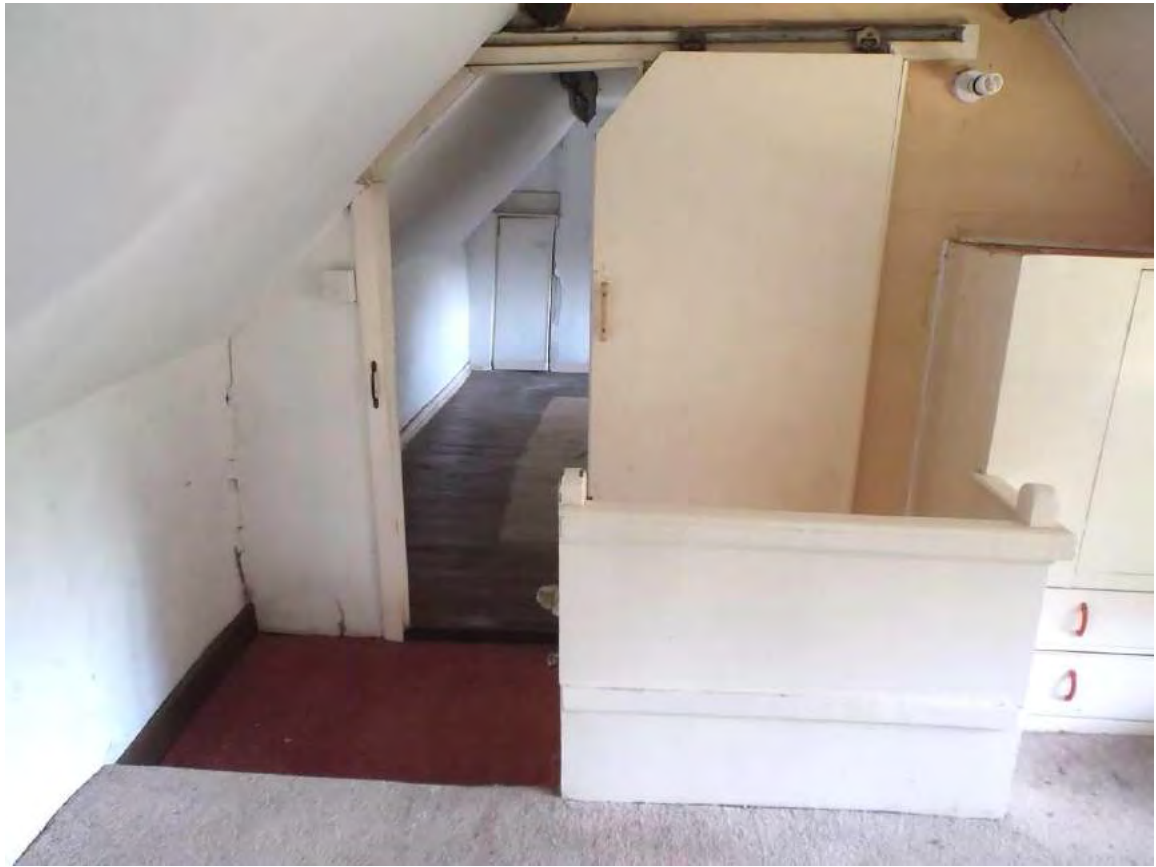
Fig 4.8; Landing looking towards head of stairs

- 4.8.1 This is a large area with an initial landing at the head of the stairs and a step up of approximately 100 mm (4") onto a slightly higher level.
- 4.8.2 There is a balustrade to the open side of the stairs which is low but adequately secure.
- 4.8.3 The walls are all of solid construction to the exterior but to the interior and the bedroom there is a traditional timber board wall that has subsequently been faced with hard board and papered to form a decorative feature.
- 4.8.4 The ceiling has skillings (where the ceiling follows the underside of the roof structure) on either side and a flat soffit to the centre and the underside lining to the eyebrow window on the south side. The general appearance to the north skilling and central section is that it is formed in plasterboard.

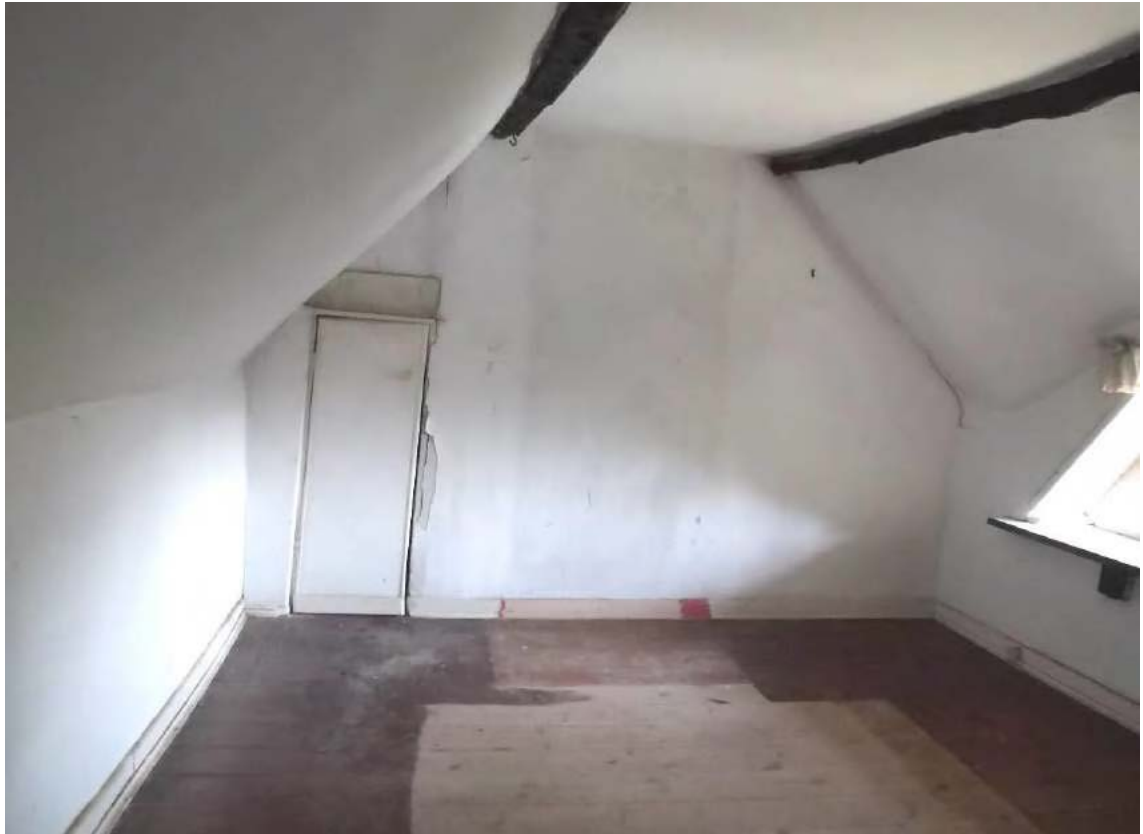
Fig 4.9; Bedroom looking from head of stairs

- 4.9.1 This is approached by a step up of approximately 75 mm (3") onto a floor covered with softwood floorboards and from the style and width it would suggest that this is a modern installation possibly dating to the 1950s or 60s.
- 4.9.2 The walls are all cob to the exterior and faced timber boarding to the interior, generally as that described as for the landing area.
- 4.9.3 In the north east corner of the room is a small cupboard that has been formed from the recess against the chimney breast where this rises up to the east gable in this location.

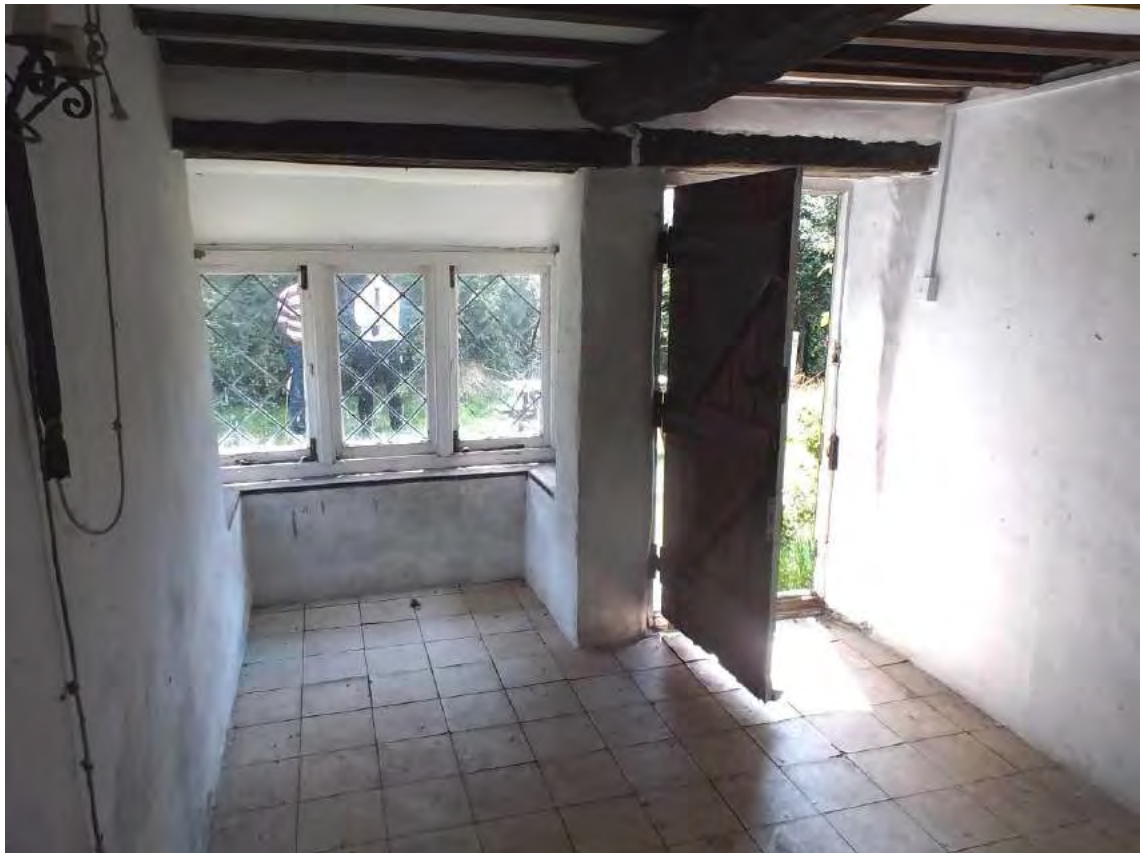
Fig 4.10; East extension room looking from rear to front

- 4.10.1 This is a single storey structure that sits against the east chimney gable of the house and is approached by a door from the outside only.
- 4.10.2 The floor is of concrete or similar solid structure covered with vinyl tiles and similar comments apply as made to the bathroom as these may contain asbestos.

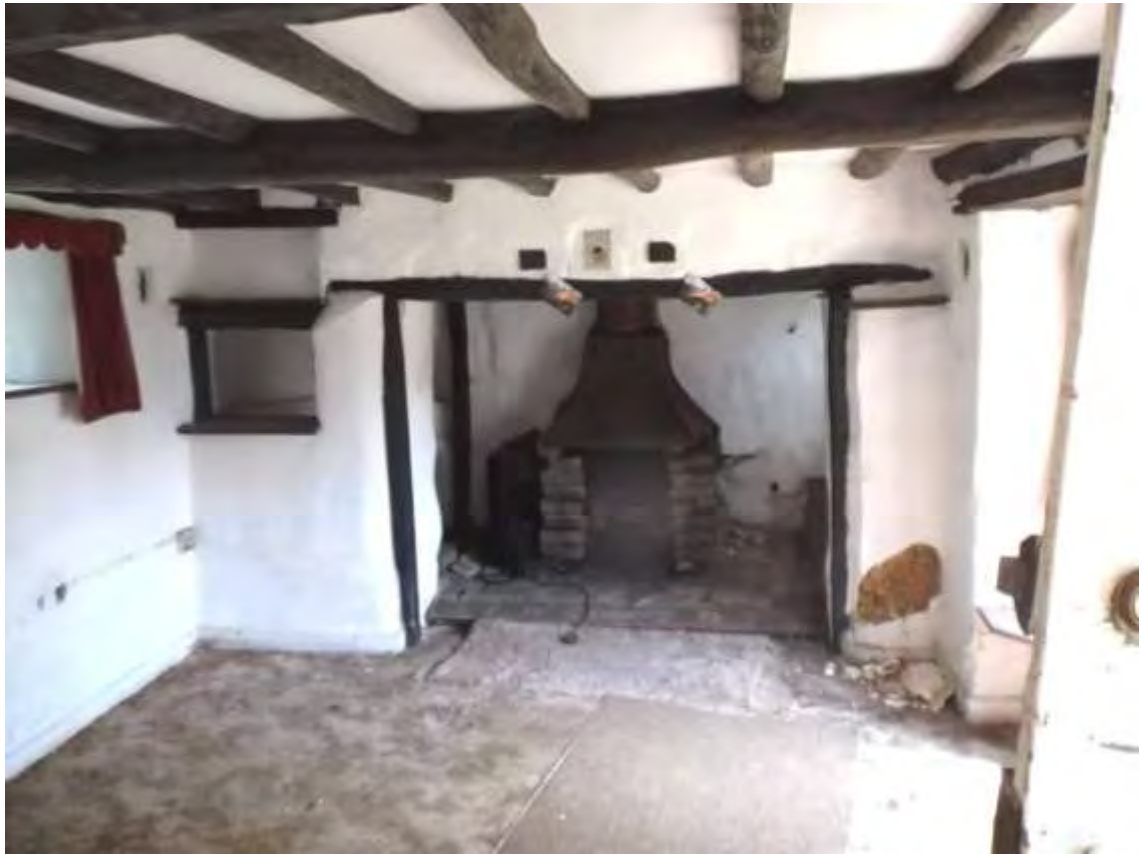
Fig 4.2; Living room looking from kitchen

- 4.2.1 This is approached by a slight step down from the porch floor onto this floor and it also appears to have a slight run on it towards the rear northwest corner. Most of the floor is covered with fitted carpets, but where a small area had been pulled back, it showed the structure was of cement-grit type screed over a solid base.

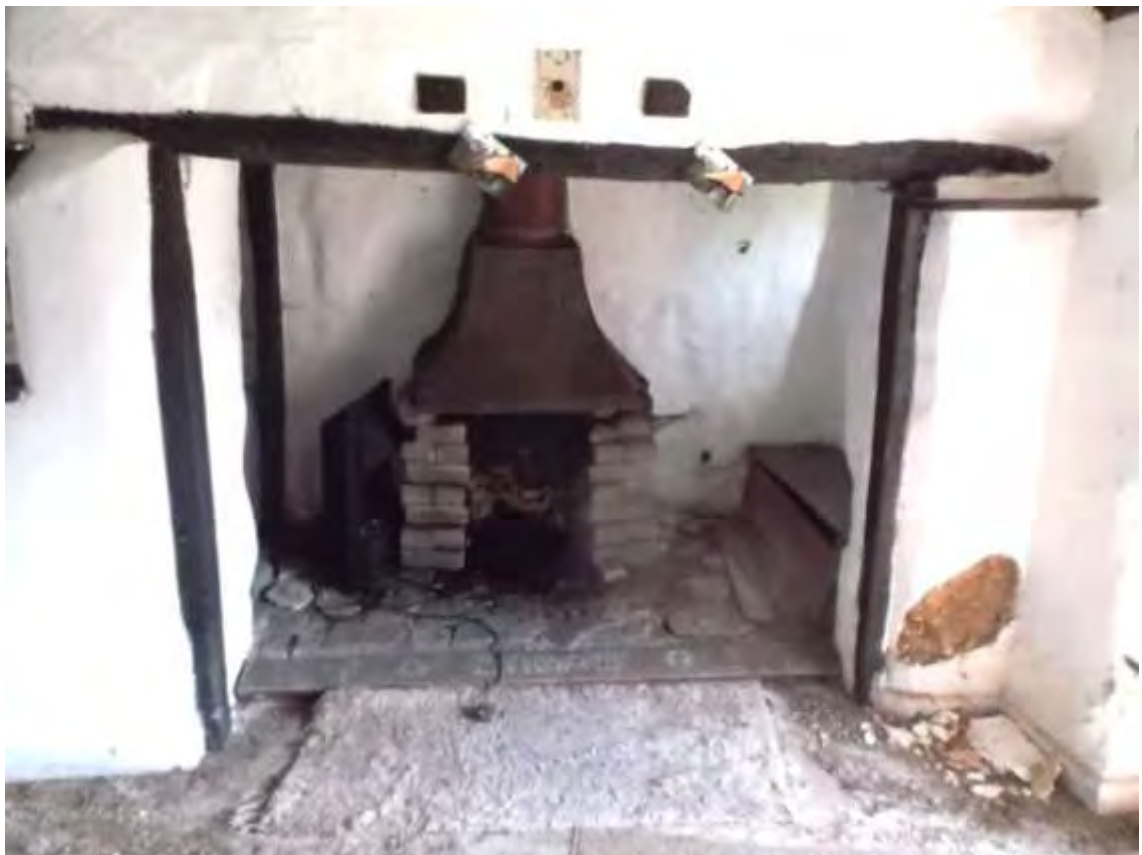
- 4.2.2 There was much evidence for carpet moth or similar infestation within the carpet as was mice within the area.
- 4.2.3 The walls are all of solid construction with a finish that varies from cement render to traditional lime renders. Much of the cement render appeared to be hollow when tapped suggesting there had been a loss of adhesion to the material behind.
- 4.2.4 Damp is evident in the base of the walls as shown by dry rot to the skirting particularly along the north side where this area is below ground level and there are soluble salts on the surface and loss and disruption of surface coatings.
- 4.2.5 On the south side there is much indication of where poor quality repairs have been made to the walls internally where the hard cement renders have probably reacted with the cob materials behind.

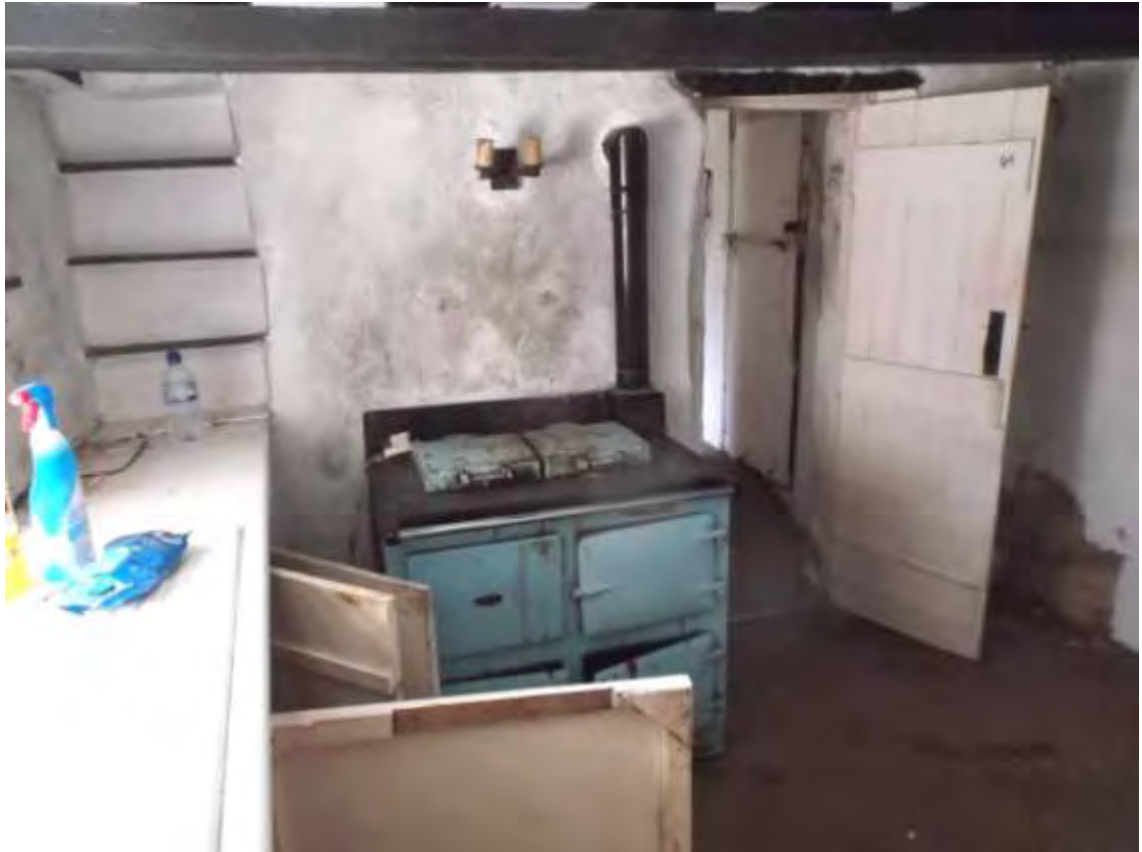
Fig 4.3; Kitchen

- 4.3.7 Against the west wall of the kitchen is an oil fuelled Aga. From this an enamelled metal flue rises, goes through a 90 degree bend and then passes through the wall to connect to the chimney behind. This appears to be in a very poor condition. The flue configuration would now not be acceptable for a modern installation and the whole appliance is very dirty and grimy and would require a thorough restoration and service by a competent heating engineer.

- 4.3.8 The ceiling is generally as that described for the living room although there is a more distinct slope on the beams from the north wall to a lower level on the south side and so may be connected with the movement in the front wall. The west beam is apparently a modern replacement timber as it is of flat sawn and dressed timber whilst the east beam is possibly original being a converted round log and showing where there has been wood boring insect attack to the outer sap wood.

- 4.3.9 There is a timber lintel that spans across the wall internally on the north side over the head of the window.
- 4.3.10 Kitchen units are all apparently DIY standard units and are in very poor condition and not capable of restoration. Set into the laminate work top is a plastic composite single bowl single drainer sink.
- 4.3.11 Opening off this room on the west side is a timber door generally as that described for the entrance into the kitchen and this leads to the bathroom lobby area.

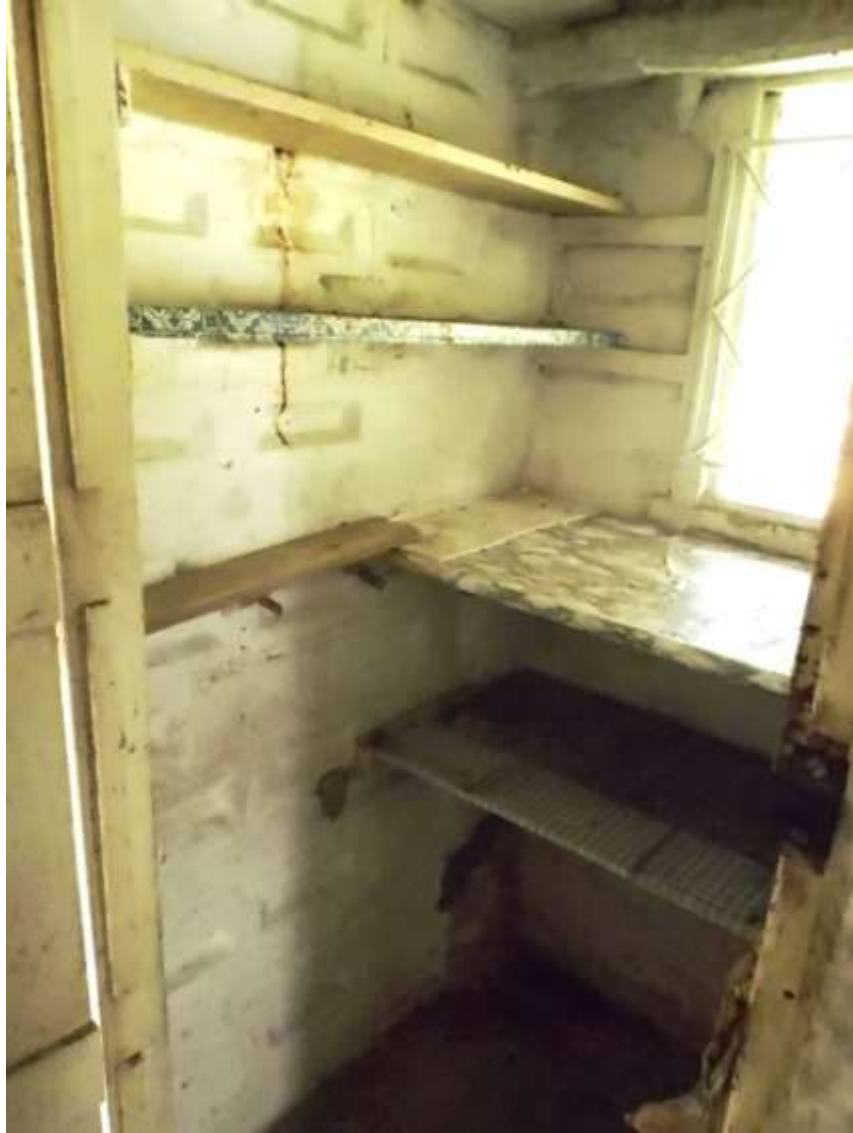
Fig 4.5; Interior of pantry

- 4.5.1 The door appears very poor condition with a towel rail fitted on the outside face.
- 4.5.2 Internally the pantry has a concrete floor much covered with dust and rubbish and is in a poor condition.
- 4.5.3 The rear wall of the pantry appears to be in bricks laid on edge as are the side wall forming the remainder of the lobby and these have all been painted. The use of bricks in the outer wall could suggest that this west extension was originally accessed from the outside by means of a door in the north wall that

we see blocked in this location. That would also explain the higher floor level and the recently formed door opening to the kitchen.

- 4.5.4 The ceiling in this area is hardboard or similar to that noted within the bathroom lobby.
- 4.5.5 Shelving has been applied to the walls in this area in a somewhat untidy manner.

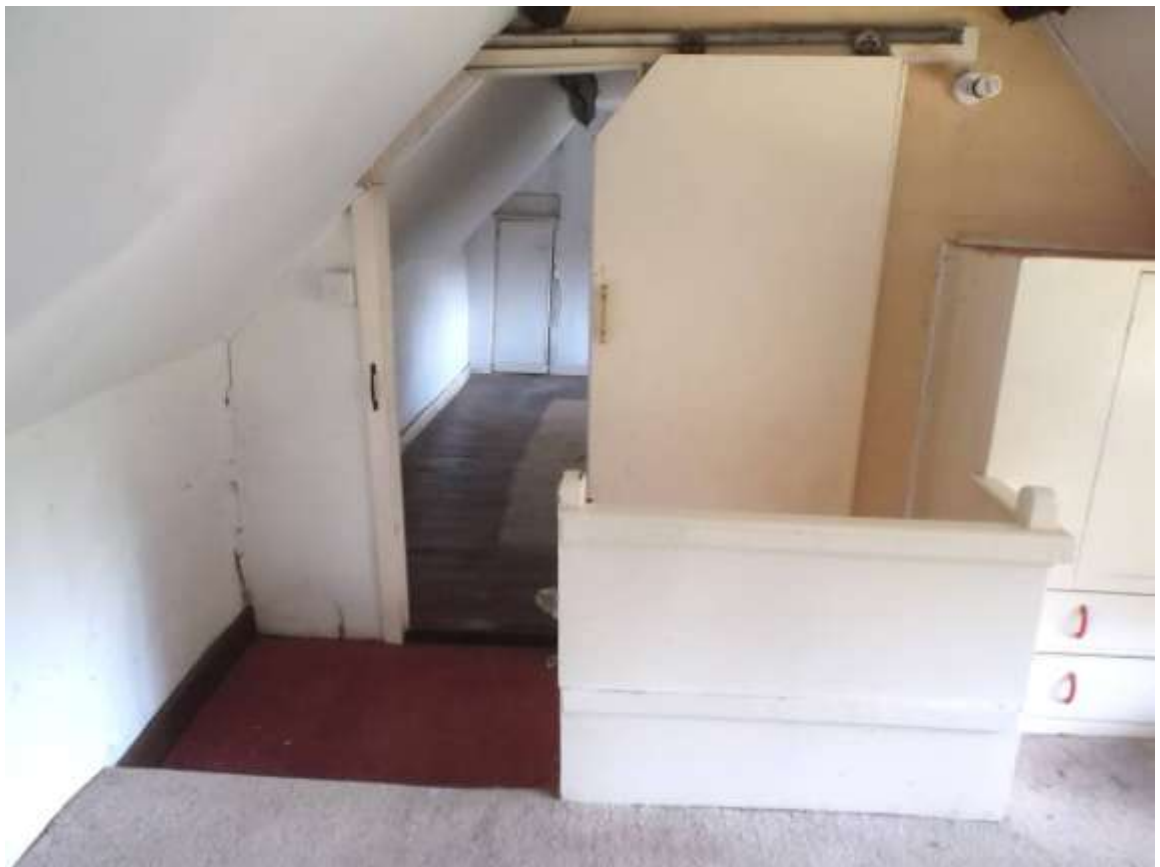
Fig 4.8; Landing looking towards head of stairs

- 4.8.1 This is a large area with an initial landing at the head of the stairs and a step up of approximately 100 mm (4") onto a slightly higher level.

- 4.8.2 There is a balustrade to the open side of the stairs which is low but adequately secure.
- 4.8.3 The walls are all of solid construction to the exterior but to the interior and the bedroom there is a traditional timber board wall that has subsequently been faced with hard board and papered to form a decorative feature.

- 4.8.4 The walls to the main building are in fair condition with no obvious signs of cracking or movement within them although there is some slight cracking on the north wall in the northwest corner and also in the southeast corner of the room where there is some slight movement of approximately 3 – 4 mm where this has moved away from a cupboard unit that has been built into the recess at the head of the stairs.

- 4.8.5 The ceiling has skillings (where the ceiling follows the underside of the roof structure) on either side and a flat soffit to the centre and the underside lining to the eyebrow window on the south side. The general appearance to the north skilling and central section is that it is formed in plasterboard. Whilst there appears to have been some repairs undertaken in plasterboard to the eyebrow ceiling in the front, these are in generally fair condition although with some hairline cracking on plasterboard joints.

- 4.8.6 There is some differential movement between the dividing partition to the main bedroom and the north wall of approximately 3 – 4 mm.
- 4.8.7 Opening off of this space is a standard joinery hard board flush door giving into the bedroom.

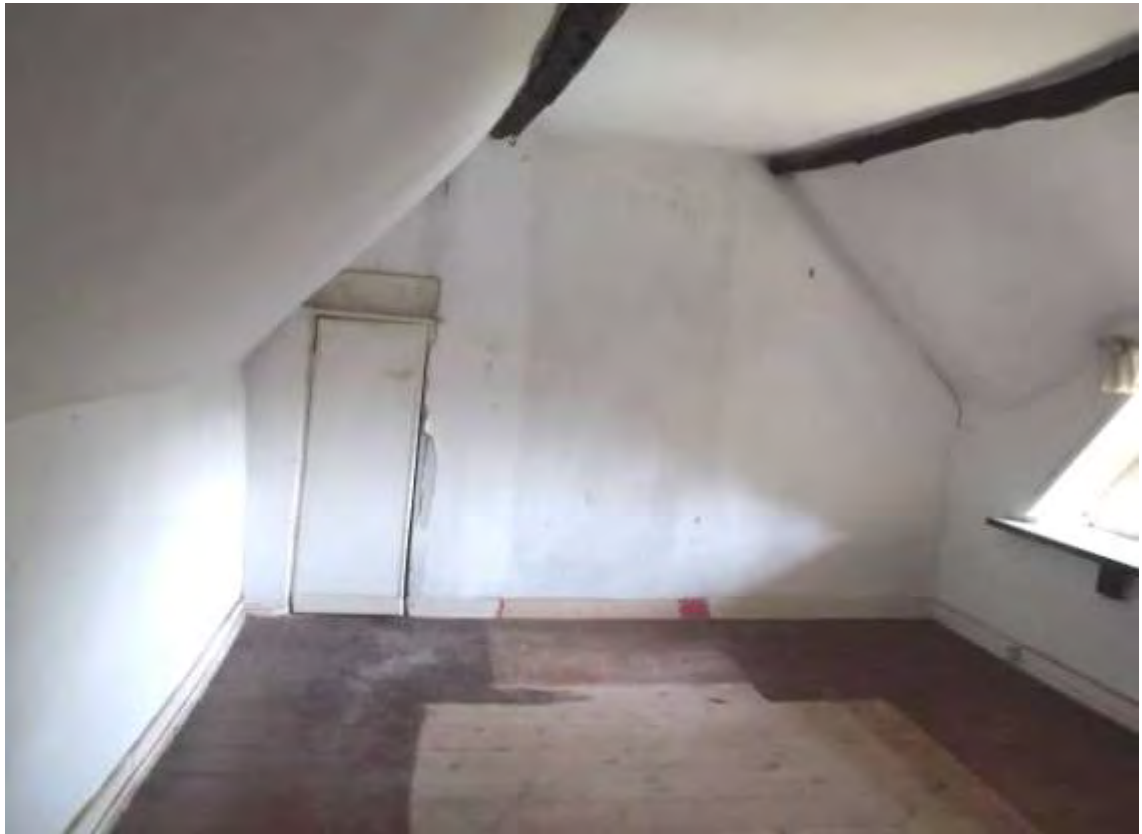
Fig 4.9; Bedroom looking from head of stairs

- 4.9.1 This is approached by a step up of approximately 75 mm (3") onto a floor covered with softwood floorboards and from the style and width it would suggest that this is a modern installation possibly dating to the 1950s or 60s. These are generally in a reasonable condition with no significant signs of movement in the floor structure when walked upon in a normal manner. However there is a slight undulation in some of the floor surfaces where they cross over the beams as seen below.

- 4.9.3 The walls are all cob to the exterior and faced timber boarding to the interior, generally as that described as for the landing area. There is no significant cracking within the walls apart from the junctions with the gable walls on either side and with a vertical crack of approximately 1 mm running down in front of the bearer of the eyebrow window towards the western end.

- 4.9.4 There is cracking of 1 – 1½ mm at the junction between the ceiling and the walls in the southeast corner running up towards the upper purlin where it dies out. Similar cracking in a hairline pattern is largely due to use of rigid plasters in the wall that happened around the end of purlin where this enters the wall on the north side at the east end.

- 4.9.7 The ceiling is generally as that described within the landing, all being in modern plasterboard and appears to be in reasonable condition with hairline cracks in the joints except in the junction between the front flat and the eyebrow start where the joint width is approximately 2 mm.

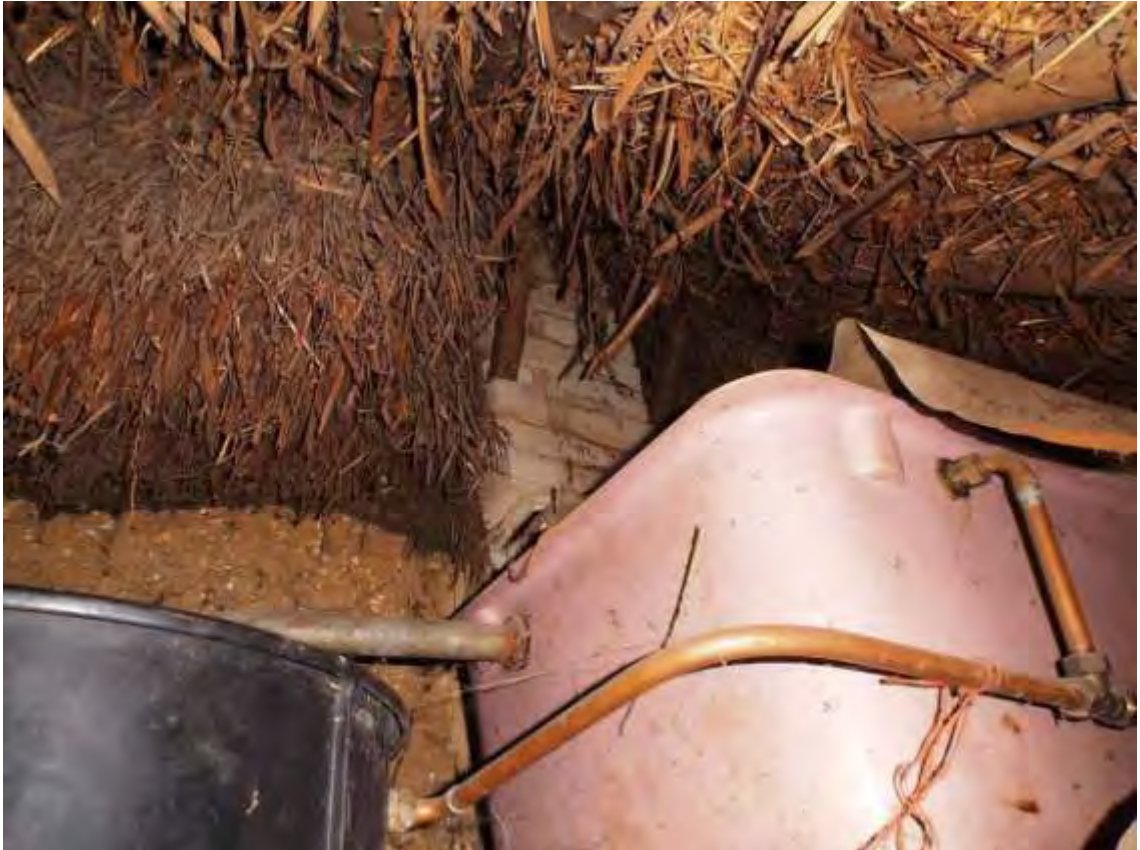
Fig 4.11.2; West extension roof structure and original half hip to main house

- 4.11.2 This structure is a typical vernacular style pole roof with a simple rafters supporting the thatch that appears to be long straw type to the base. This thatch is quite bright and clean and so suggests it is reasonably modern and perhaps less than two hundred years old.
- 4.11.3 The roof space over the east extension is a modern roof with sawn timbers some of which show nail holes to the faces that could suggest they have been re-used from elsewhere. These are reasonably bright and clean and from its overall construction, the style could suggest a building date to the first or second quartile of the 20th century.
- 4.11.4 On the wall of the main house it is possible to see where the lower part of the wall is of raw cob and above that the remainder of the gable is coated with a hard type render. At the bottom of the render is what appears to be the remains

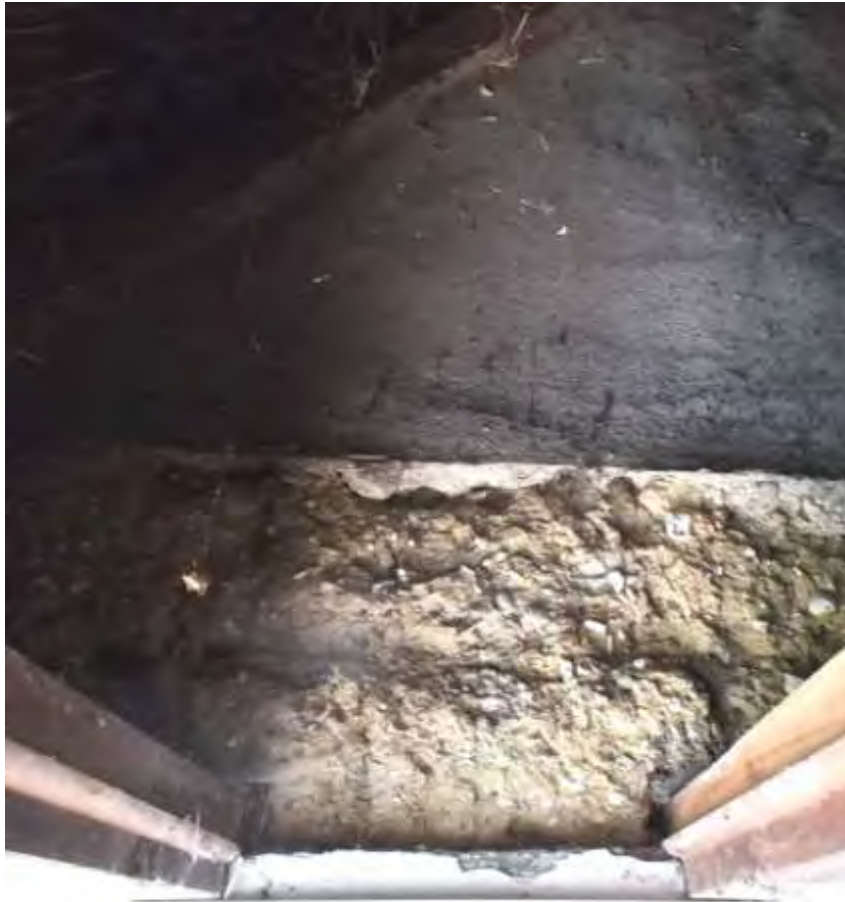
Fig 4.11.4; East end of main house above east extension ceiling

of a mortar fillet flashing. Together this would suggest that there was an extension on this end of the building with a low pitch roof, possibly corrugated iron, before this extension was built.

4.11.5 The base coat of thatch over the battens appears to be long straw and is in a fair condition.

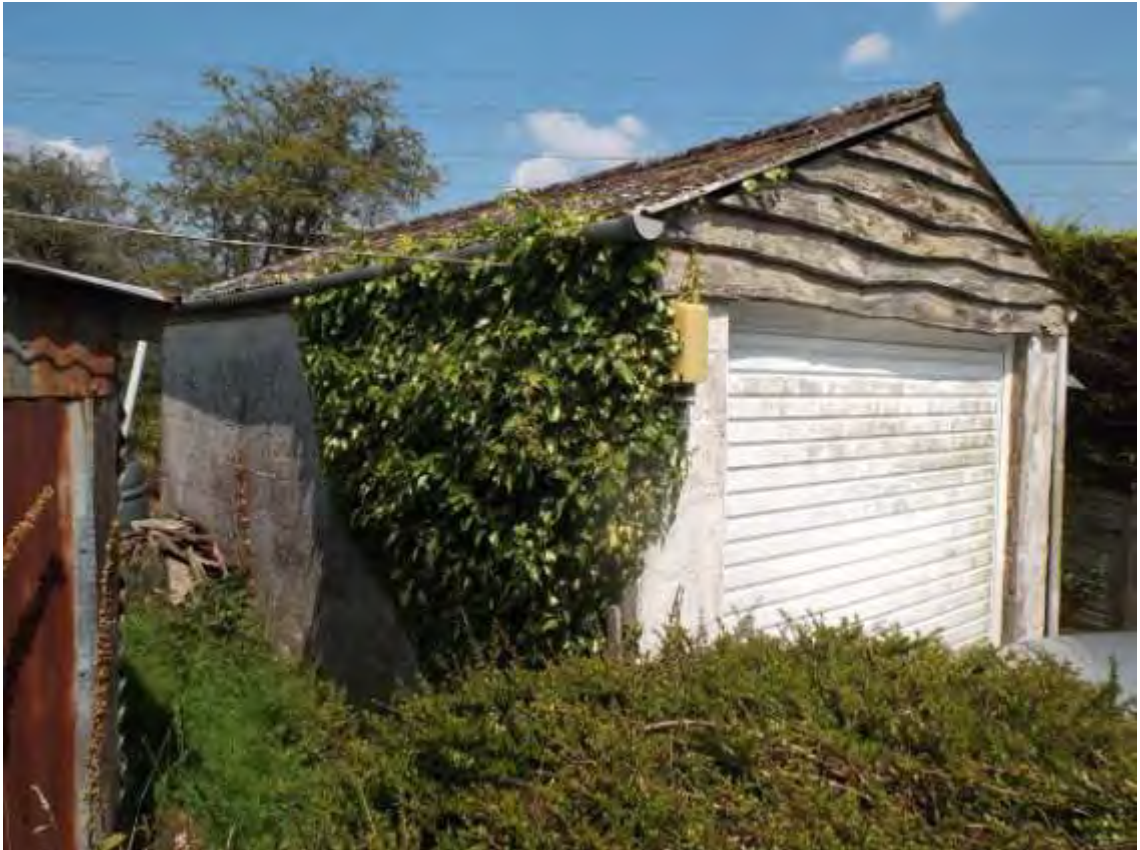
Fig 6.2.3; Garage

- 6.2.2 At the east end of the shed there is a small extension based on an insubstantial timber frame clad with corrugated metal sheeting to the walls and roof. Due to the condition of this structure no further inspection was undertaken for this.
- 6.2.3 Against the east boundary is a single car garage with walls of concrete blockwork and a roof of corrugated asbestos sheeting and a metal up and over door to the front. As this was considered to be outside the remit of this survey of the house, this was omitted from the survey as agreed with the client on site.
