**CCTV REPORT FOR: 9 RUDLANDS
IPSWICH
SUFFOLK
IP8 3RQ**

Insured: Mrs J Oakley
Reference: DLG-SN-20-002038 Ins Ref: 074634619

1st Site Visit: 13-Oct-20
1st Report Date: 25-Nov-20

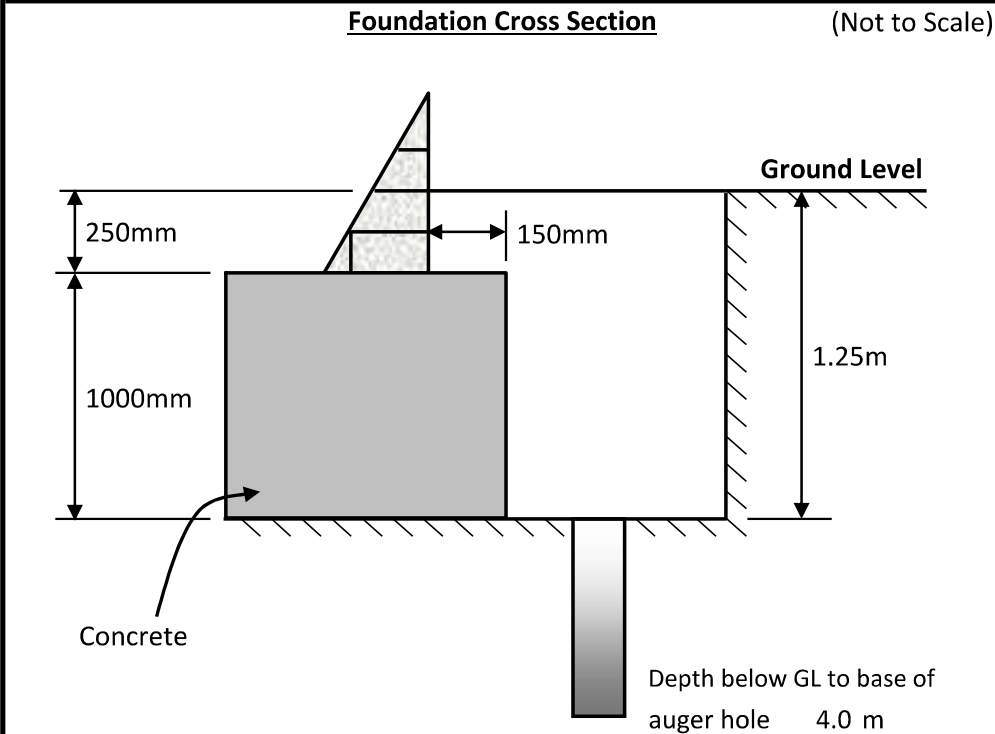
Location: **Rear Right Corner of House** T/H No. **1**
 Ground Surface: **Damp** Weather: **Dry** Date: **13-Oct-20**

Roots Depth & Diameter:
 Down to 1.5m

Water Depth Hit & Rise:
 None observed on site

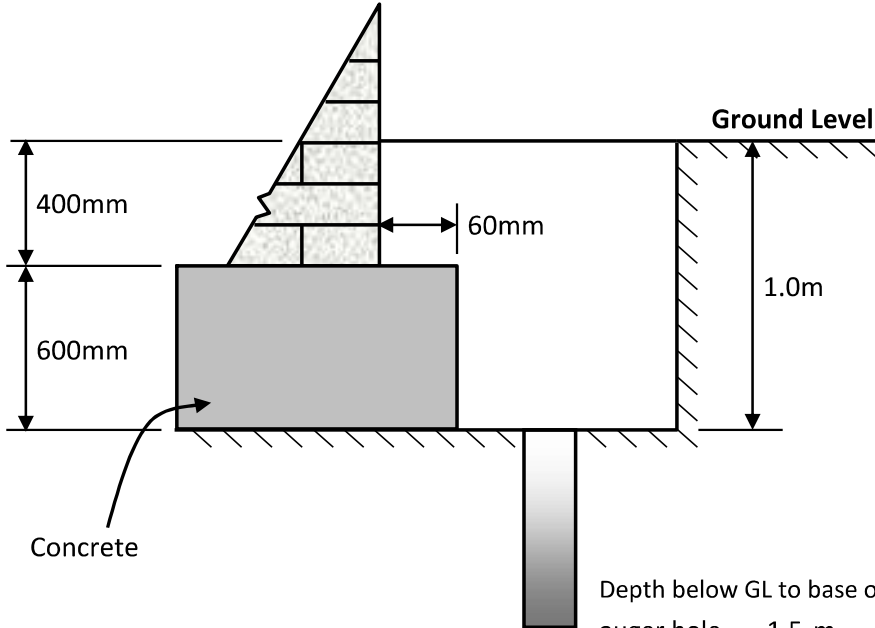
Foundation Cross Section

Roots Depth & Diameter:

Down to 1.5m

None observed on site

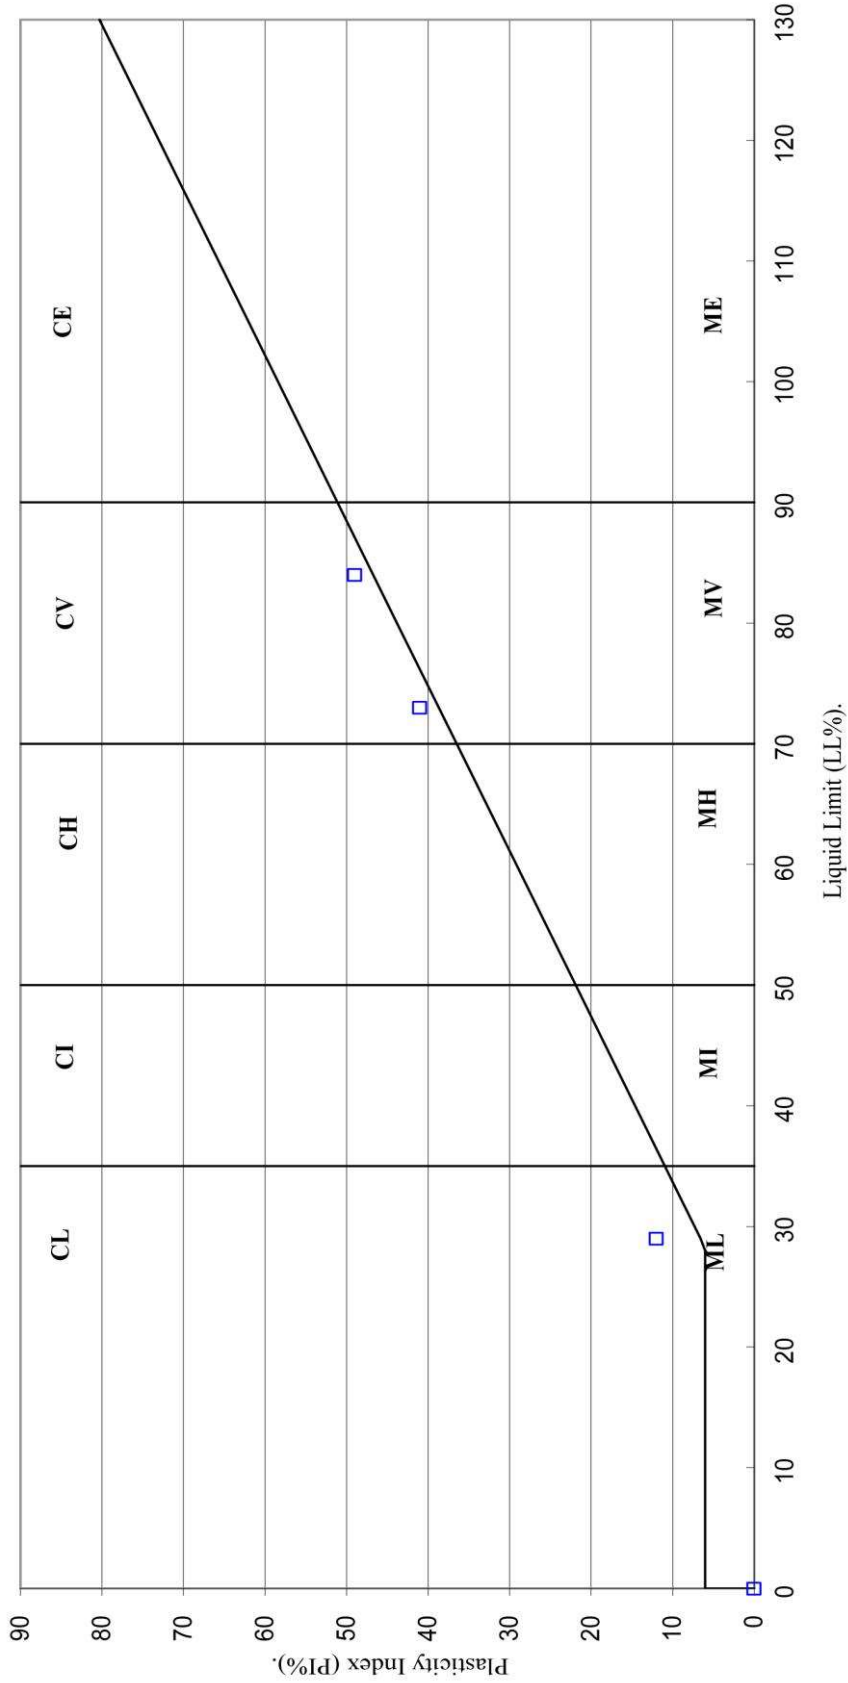
PLASTICITY CHART FOR CASAGRANDE CLASSIFICATION.

Hole Number	Sample Number	Sample Type	Top Depth m	Base Depth m	Moisture Content % Clause 3.2	Linear Shrinkage % Clause 6.5	Particle Density Mg/m ³ Clause 8.2	Liquid Limit % Clause 4.3/4	Plastic Limit % Clause 5.3	Plasticity Index % Clause 5.4	Passing .425mm %	Remarks
TP/BH1			1.20	1.50	19			29	17	12	72	Low plasticity CL.
TP/BH1			1.50	2.00	37							
TP/BH1			2.00	2.50	36		84		35	49	98	Very high plasticity CV.
TP/BH1			2.50	3.00	39							
TP/BH1			3.00	3.50	49		73		32	41	100	Very high plasticity CV.
TP/BH1			3.50	4.00	51

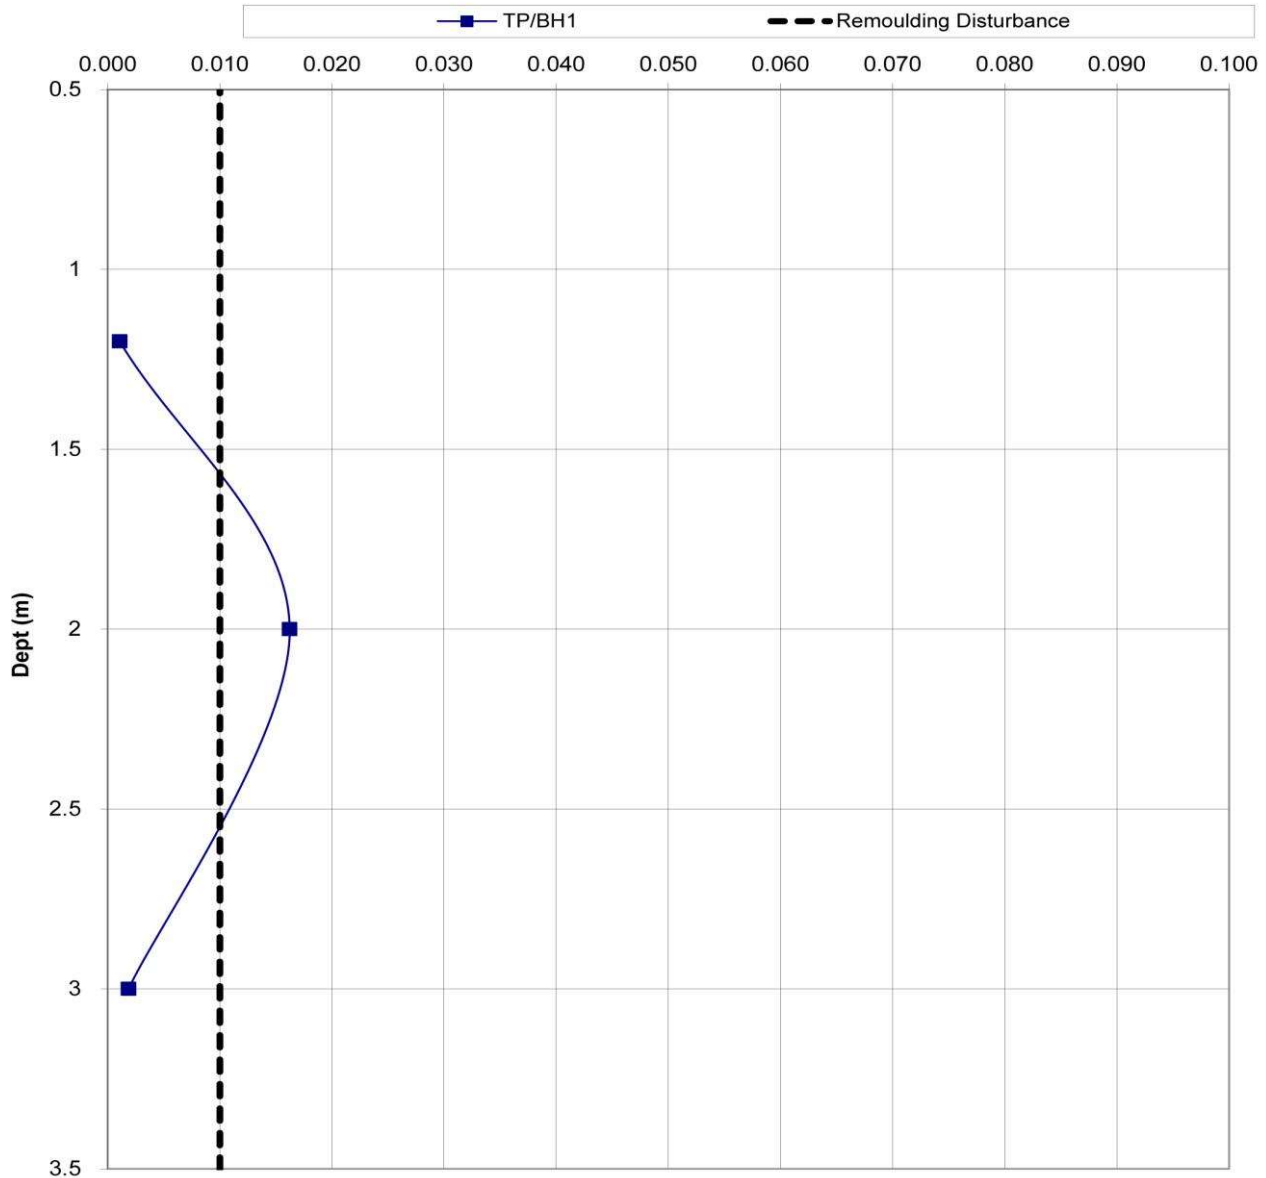
One Dimensional Swell / Strain test - In House Method

Hole Number	Sample Number	Sample Type	Depth m	Strain	Dd (mm)	Moisture Content (%)	Remarks
TP/BH1			1.20	0.0011	0.6	19	
TP/BH1			2.00	0.0162	6.5	36	
TP/BH1			3.00	0.0019	0.9	49	
Total column Dd TP/BH1 =				8.1 mm

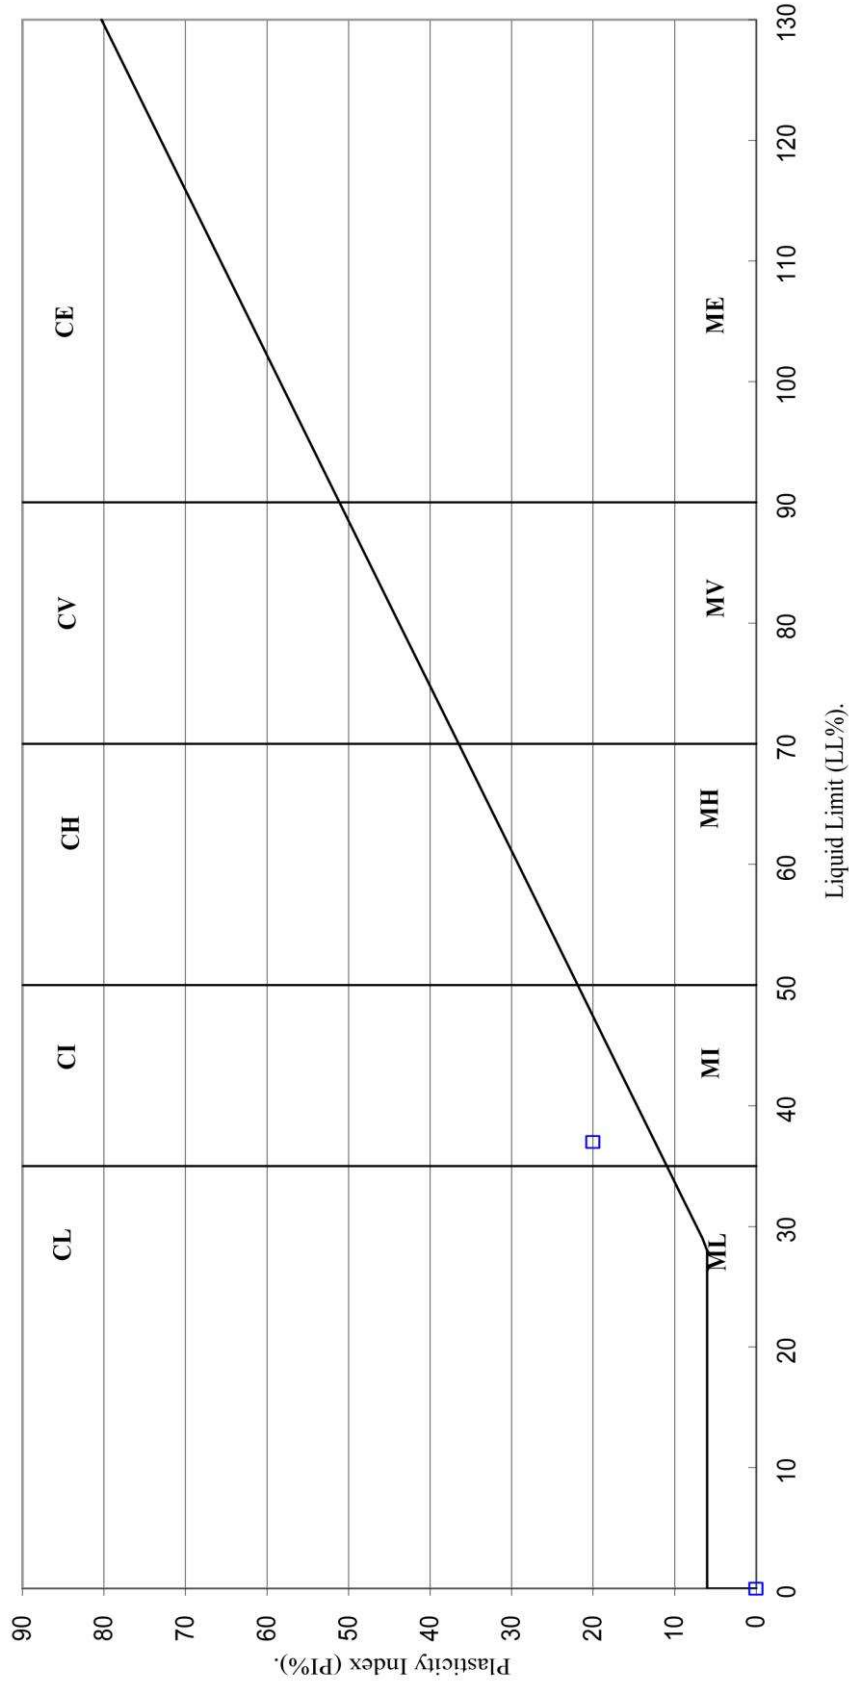
PLASTICITY CHART FOR CASAGRANDE CLASSIFICATION.

Hole Number	Sample Number	Sample Type	Top Depth m	Base Depth m	Moisture Content % Clause 3.2	Linear Shrinkage % Clause 6.5	Particle Density Mg/m ³ Clause 8.2	Liquid Limit % Clause 4.3/4	Plastic Limit % Clause 5.3	Plasticity Index % Clause 5.4	Passing .425mm %	Remarks
TP/BH2			1.00	1.50	17			37	17	20	82	Intermediate plasticity Cl.

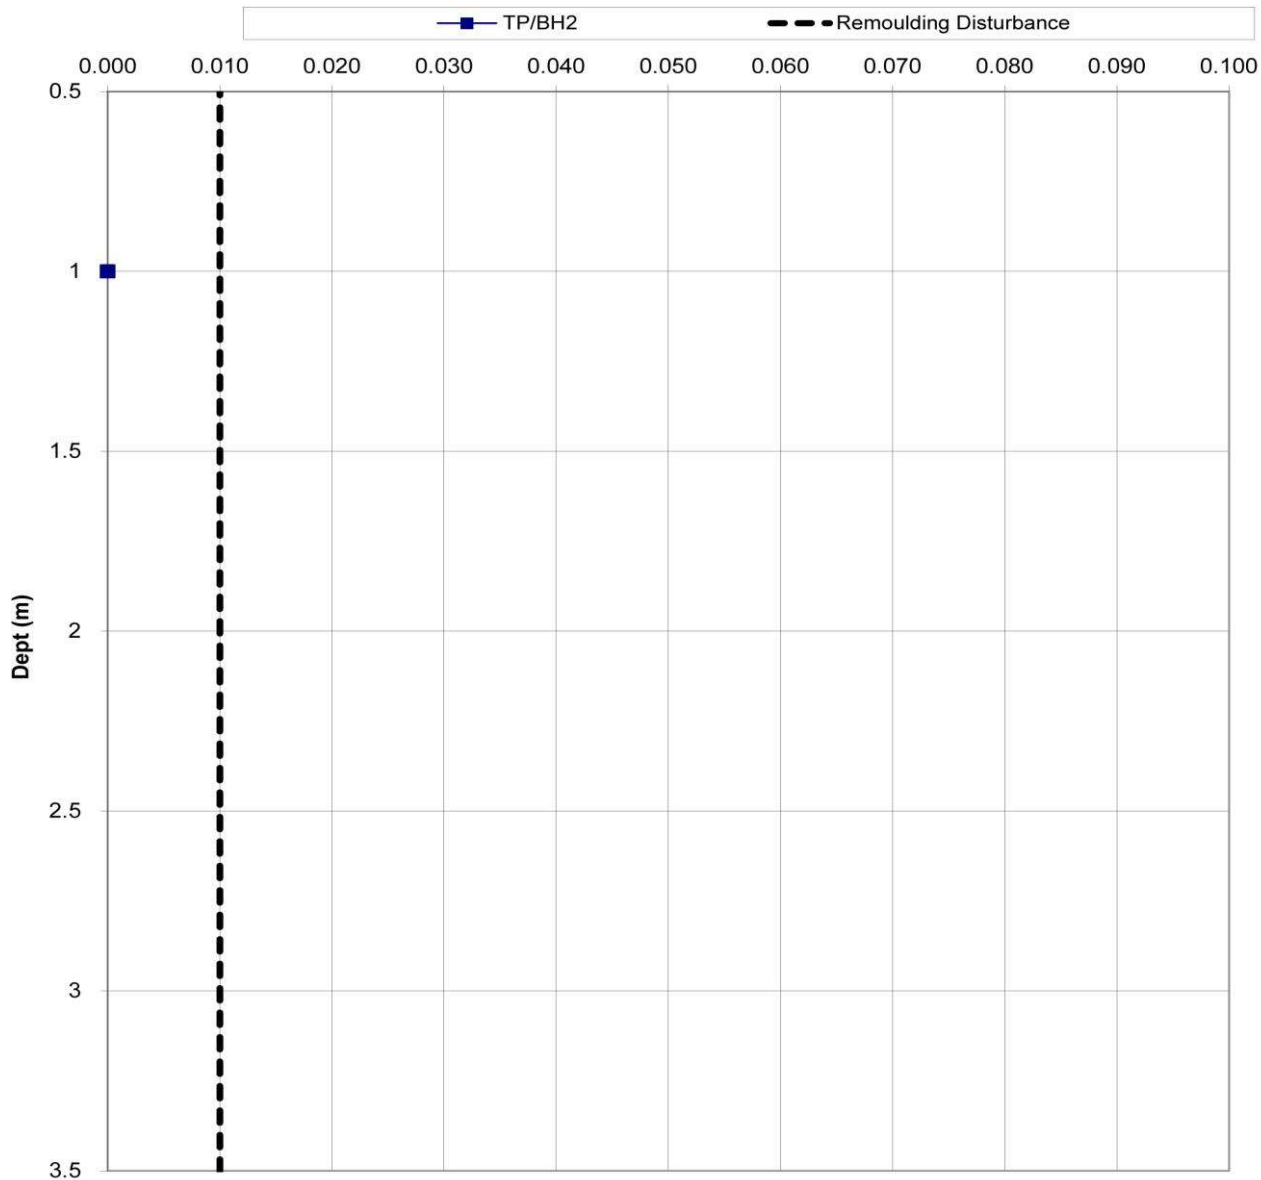
One Dimensional Swell / Strain test - In House Method

Hole Number	Sample Number	Sample Type	Depth m	Strain	Dd (mm)	Moisture Content (%)	Remarks
TP/BH2			1.00	0.0000	0.0	17	
Total column Dd TP/BH2 =				0.0 mm
