Monitoring Visit: 3 of 4

Monitoring Plus Report

Owners name	Mrs. F. Kelman	Suspected cause	To be advised	Monitoring type	Levels & Cracks
Address	14 Buckfast Avenue Kirby Cross Frinton-on-Sea Essex CO13 0PU	Principal area of damage	To be advised	Installed	06/11/2020
		Damage category	To be advised	No of visits / weeks	4 @ 8.7
Home phone		Surface geology	To be advised	Completion date	
Work phone		Feedback from last visit		Status	open
Correspondence address		0			
Comment		Sketch showing location of monitoring points			
Max movement	7.2	<p>Front Elevation</p>			
Focal area					
0

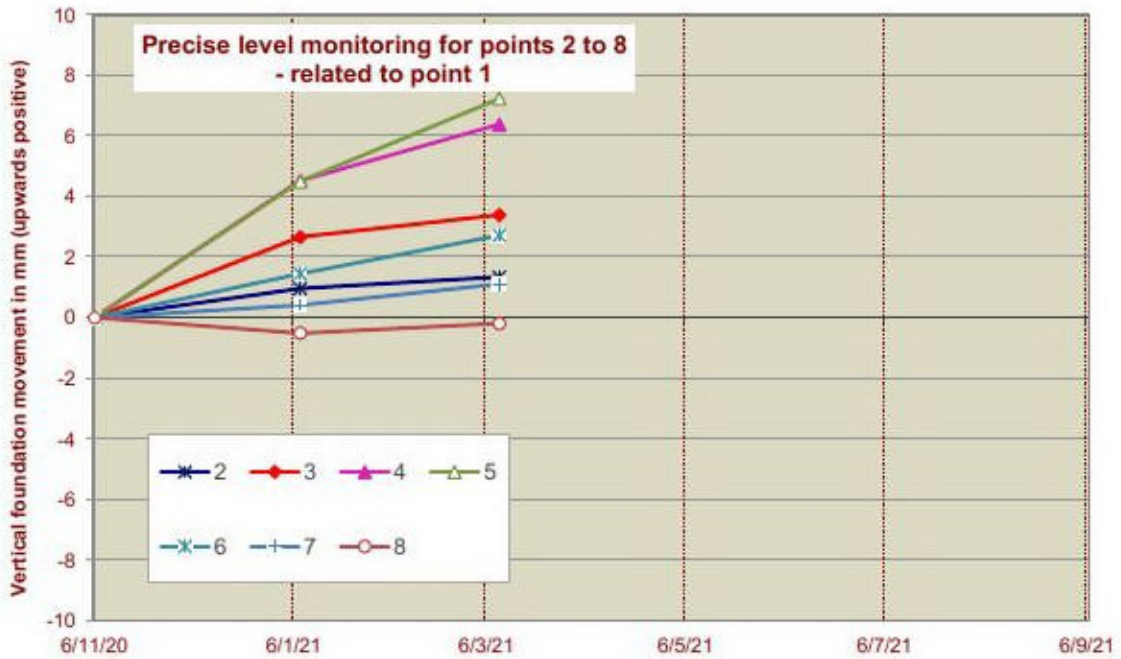
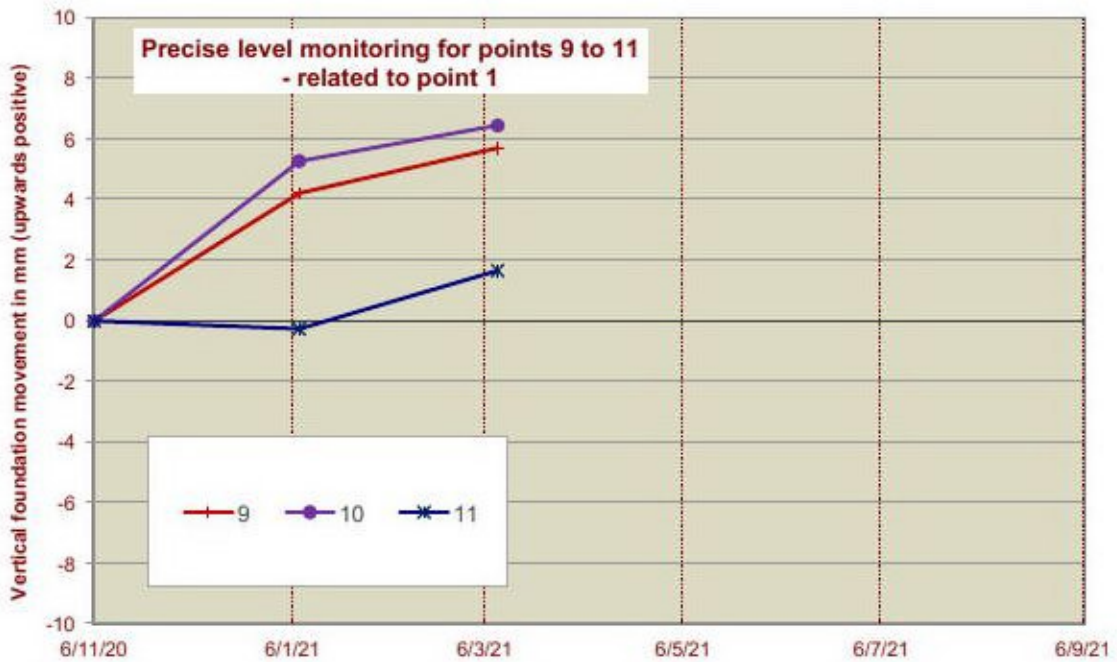
Level monitoring results

Survey: By: Date: Point ID	1 CV 06/11/2020		2 CV 08/01/2021		3 CV 10/03/2021		4		5	
	levels mm	<i>chngs</i> <i>mm</i>	levels mm	<i>chngs</i> <i>mm</i>	levels mm	<i>chngs</i> <i>mm</i>	levels mm	<i>chngs</i> <i>mm</i>	levels mm	<i>chngs</i> <i>mm</i>
1	1000.00	0.0	1000.00	0.0	1000.00	0.0	1000.00	0.0	1000.00	0.0
2	1003.02	0.0	1003.98	1.0	1004.36	1.3				
3	1003.65	0.0	1006.31	2.7	1007.04	3.4				
4	1009.51	0.0	1014.04	4.5	1015.89	6.4				
5	1002.69	0.0	1007.19	4.5	1009.92	7.2				
6	1010.12	0.0	1011.57	1.5	1012.84	2.7				
7	1008.29	0.0	1008.70	0.4	1009.40	1.1				
8	1005.51	0.0	1005.00	-0.5	1005.32	-0.2				
9	933.09	0.0	937.30	4.2	938.80	5.7				
10	1023.44	0.0	1028.71	5.3	1029.89	6.5				
11	1022.15	0.0	1021.89	-0.3	1023.81	1.7

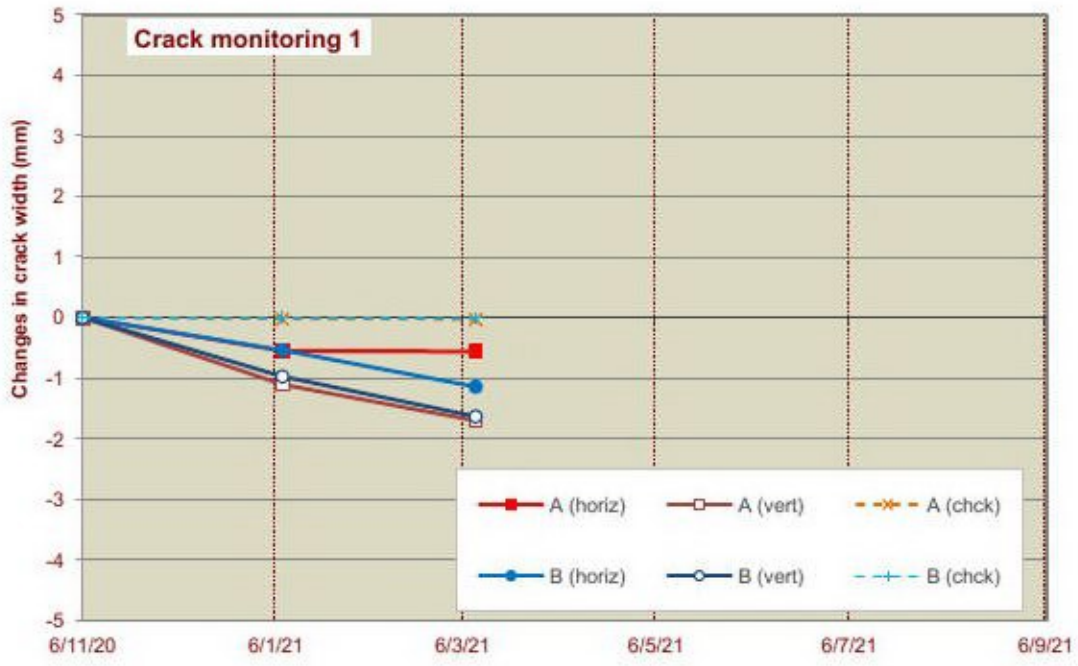
Crack monitoring results

Survey: By: Date:		1 CV 06/11/2020		2 CV 08/01/2021		3 CV 10/03/2021		4	5
Point ID	Initial widths mm		<i>chngs</i> <i>mm</i>		<i>chngs</i> <i>mm</i>		<i>chngs</i> <i>mm</i>		<i>chngs</i> <i>mm</i>
A (horiz)	3.6	70.63	0.0	70.08	-0.5	70.07	-0.6		
A (vert)		73.27	0.0	72.17	-1.1	71.57	-1.7		
A (chck)		101.23	0.0	101.21	0.0	101.20	0.0		
B (horiz)	2.5	89.59	0.0	89.05	-0.5	88.45	-1.1		
B (vert)		84.16	0.0	83.19	-1.0	82.53	-1.6		
B (chck)		122.29	0.0	122.29	0.0	122.28	0.0

A (horiz)	External Crack to rear wall
B (horiz)	External Crack to right-hand wall at rear
