Engineers Report

Risk Address 14 Buckfast Avenue
Kirby Cross
Frinton-on-Sea
Essex
CO13 0PU

360 Reference DLG-SN-20-002040
Claim Refence 074640111
Policy Holder Mrs. F. Kelman

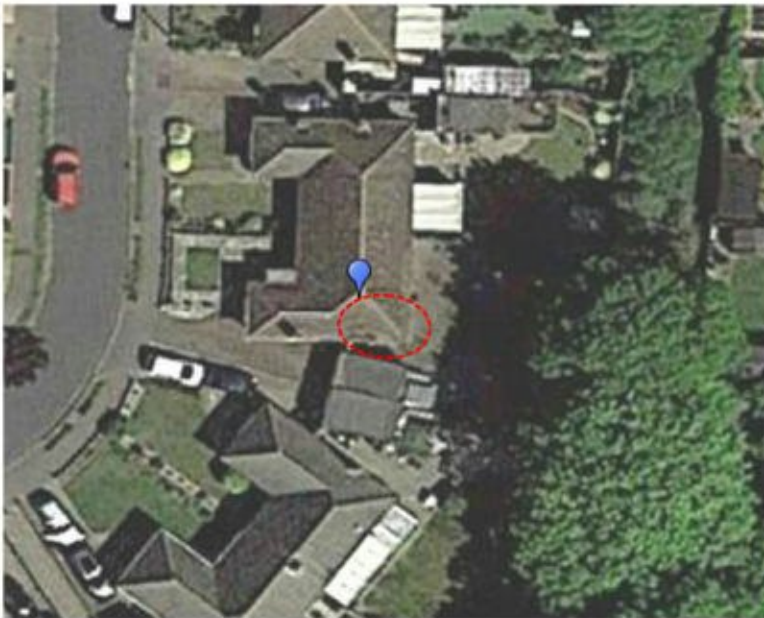
There is a stepped cracking rising up from the rear kitchen door up to eaves level at the corner and the crack then returns around the rear wall down to the kitchen window. The cracking is around 5mm wide.

There is cracking through the wall tiling above the rear of the external door and this is also evident below the adjacent wall unit. Cracking extends through the wall tiles and along the ceiling junction to the rear wall, where significant cracking is evident through the wall tiling down to the window frame. The cracking is around 8mm wide.

At this stage the damage is localised, and repairs will likely entail crack stitching and re-tiling of the affected walls. A detailed schedule of repairs will be prepared following an assessment by a contractor.
