Title: BS5837 Tree Report

Site: Sidcup Library
Hadlow Road
Sidcup
Kent
DA14 4AQ

Client: Hill-Wood & Co. (Kent) Limited

Survey Date: 8th July, 2021

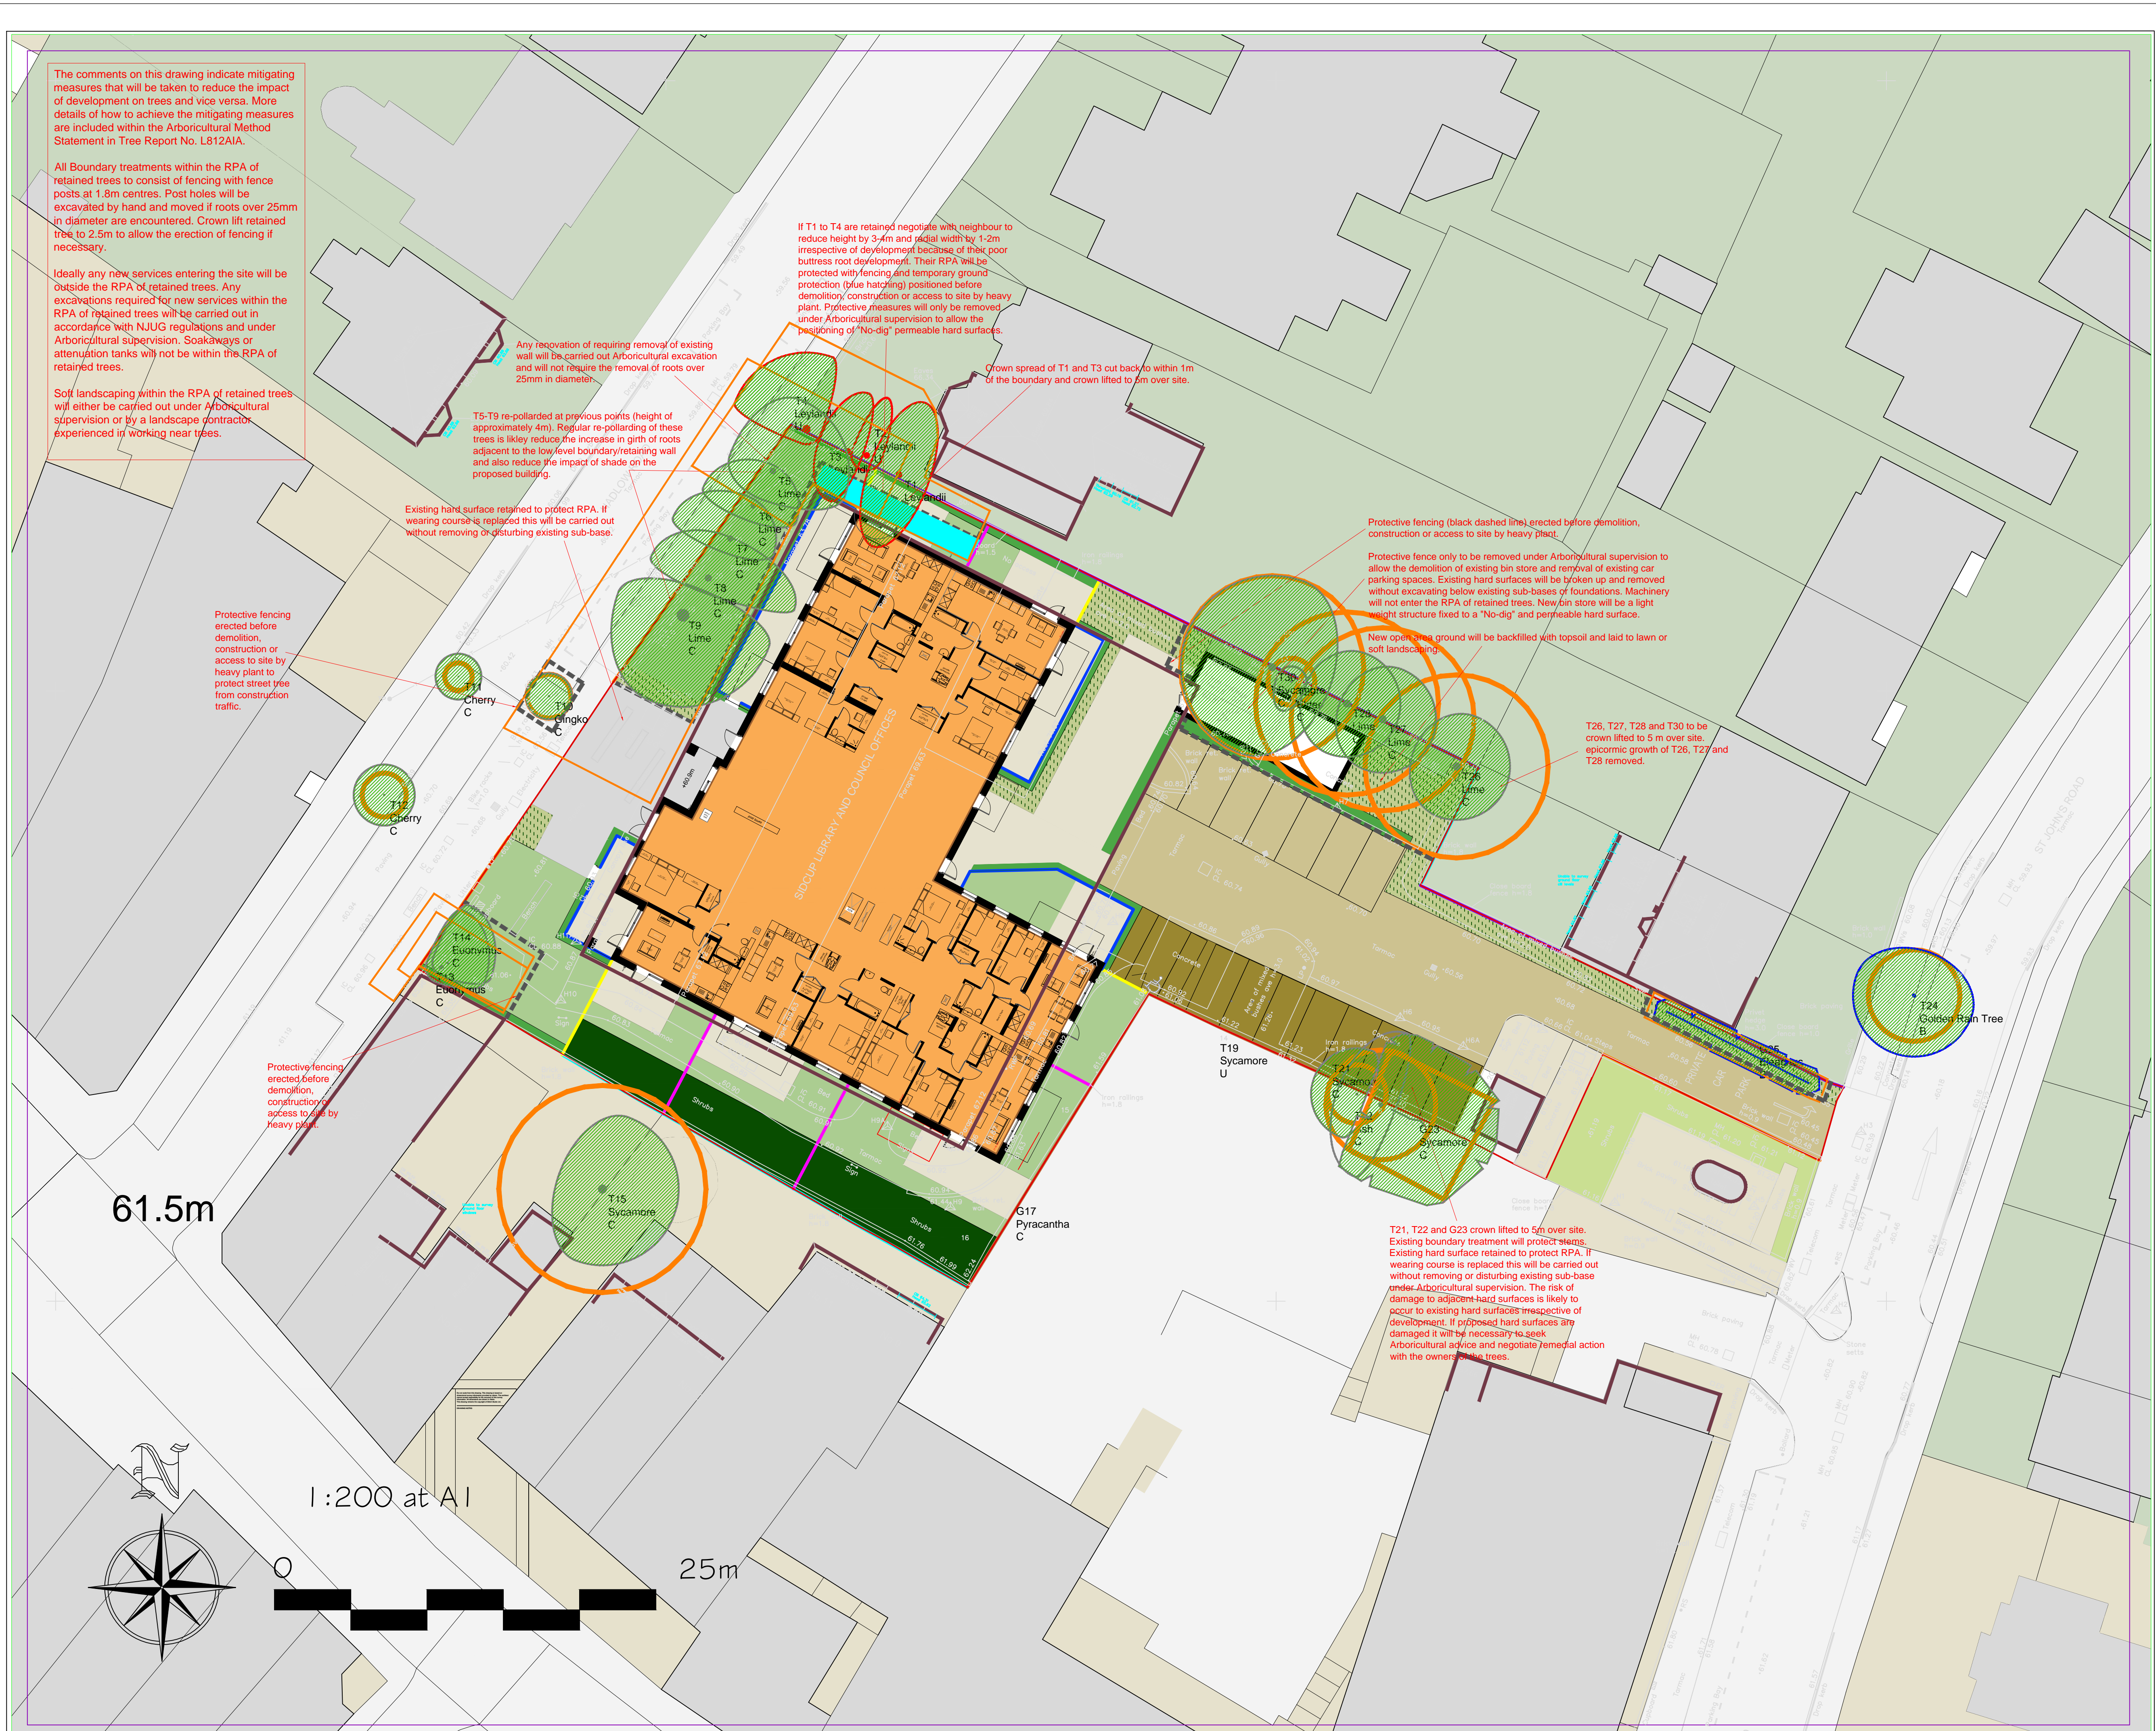
Appendix 7
Tree Protection Plan L812TPP

The comments on this drawing indicate mitigating measures that will be taken to reduce the impact of development on trees and vice versa. More details of how to achieve the mitigating measures are included within the Arboricultural Method Statement in Tree Report No. L812AIA.

All Boundary treatments within the RPA of retained trees to consist of fencing with fence posts at 1.8m centres. Post holes will be excavated by hand and moved if roots over 25mm in diameter are encountered. Crown lift retained tree to 2.5m to allow the erection of fencing if necessary.
