*Report No. BC/MB/10.21.05.*

# **Coal Mining Risk Assessment: Land at Fairview Garage, Pengam.**

***H C Capel and Sons Ltd.***

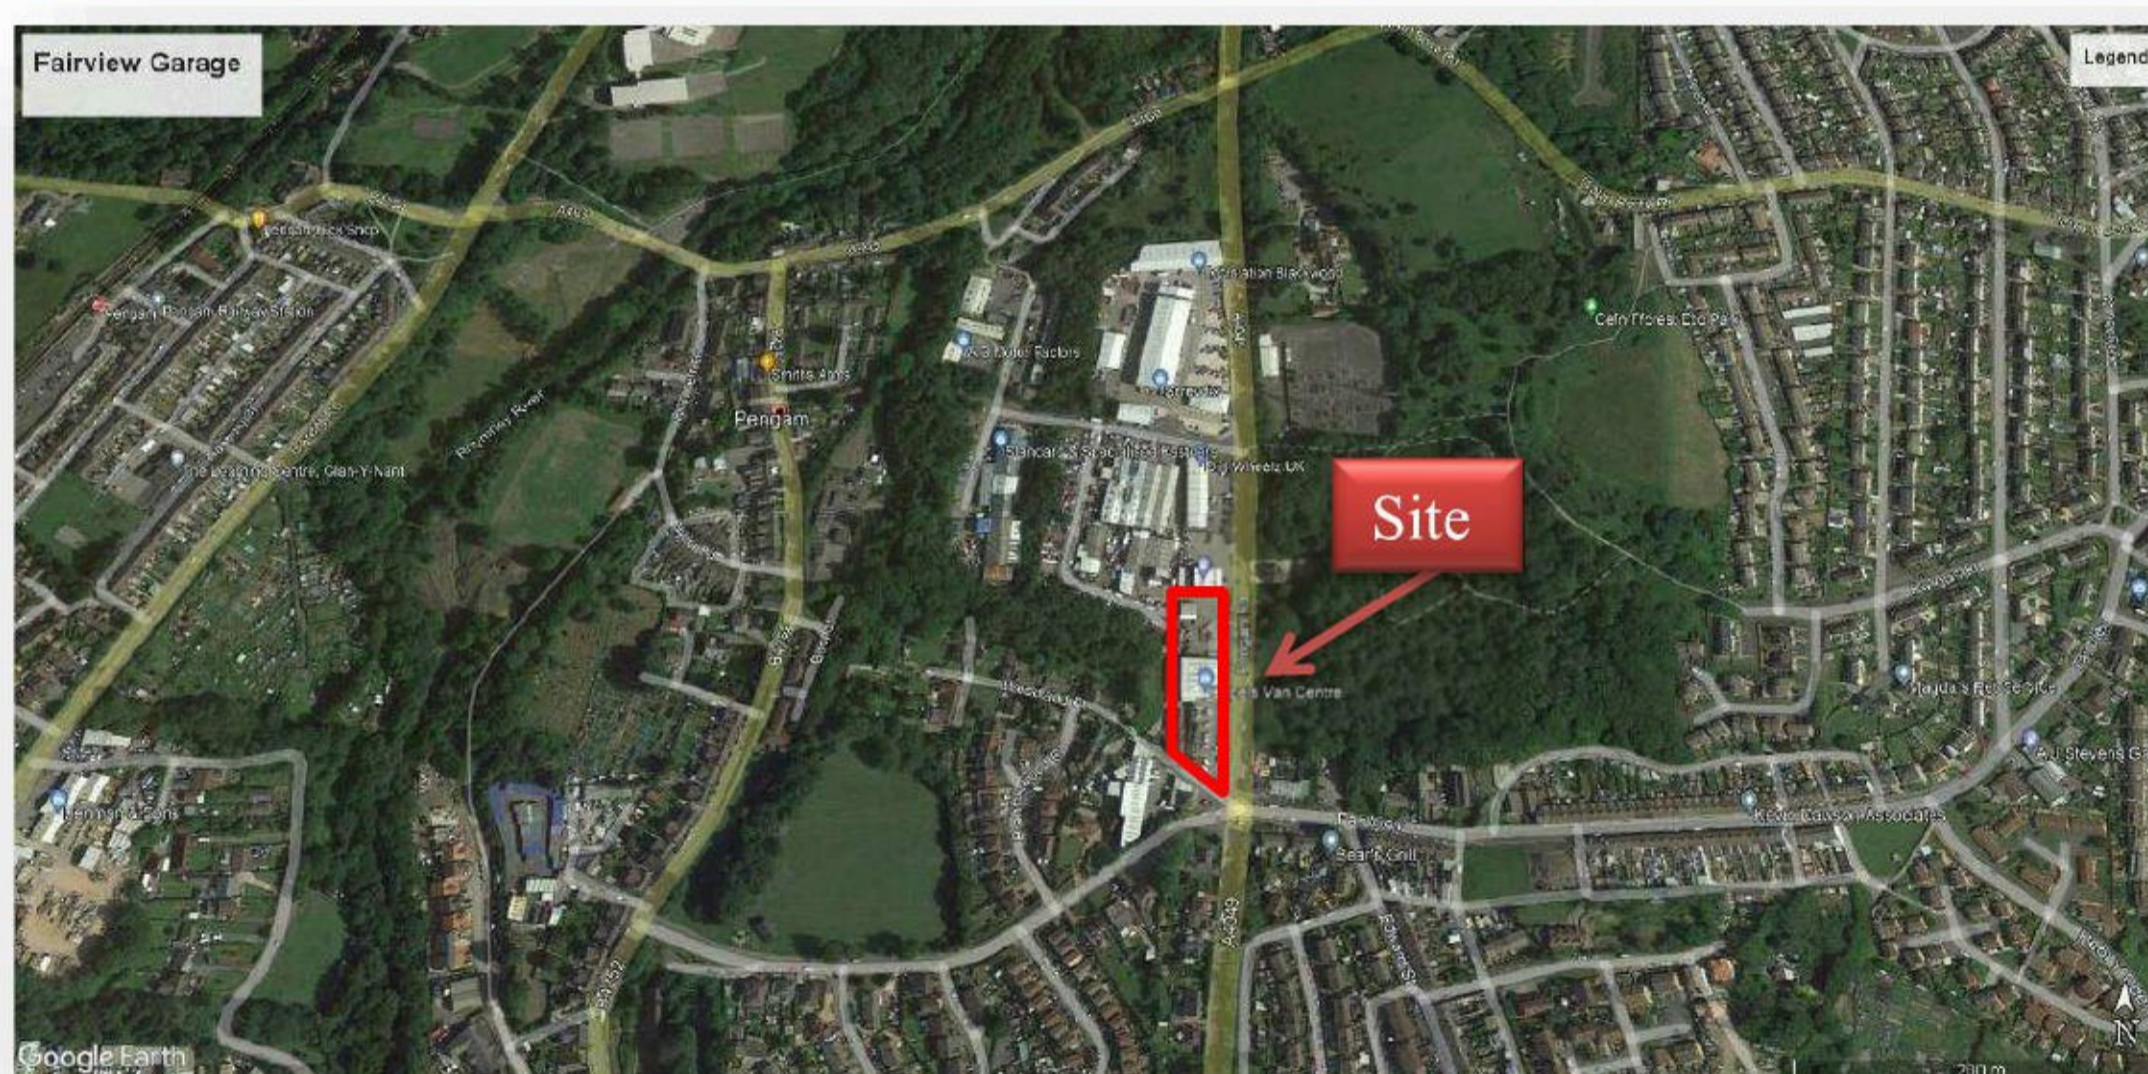
**Figure 1**  
**Aerial View of Site**

The parcel of land that is the subject of this report ('the Site') is situated on the north-eastern fringes of Pengam on westerly facing slopes above the Rhymney River (see Figure 1 and *General Location Plan, drawing no. BC/MB/10.21.05.01*). The Site is roughly rectangular in outline with maximum dimensions of approximately 38m by 134m, it is fairly level at an approximate elevation of 166m aod (see *Detailed Location Plan, drawing no. BC/MB/10.21.05.03*). The Site fronts onto the A4049 and lies within a commercial development of garages and retail outlets at the edge of a mixed residential area. There is an area of woodland to the east, immediately beyond the A4049.
