JP Chick & Partners Ltd
Consulting Civil & Structural Engineers

Fring Barn Complex

VISUAL STRUCTURAL INSPECTION REPORT FOR PLANNING

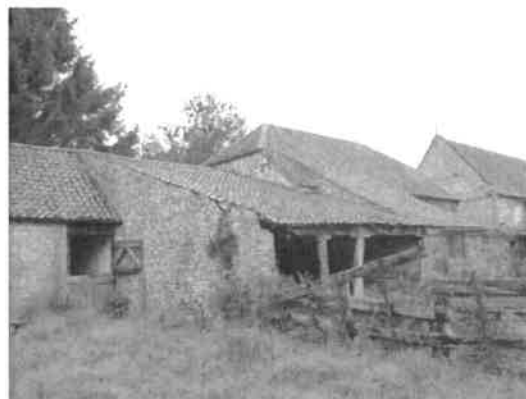
P4: Southern single storey barn: Lateral movement of between 30mm to 40mm evident to internal gable masonry at junction within west wing
