Tree Safety and Condition Survey

West Lodge

**November 26<sup>th</sup> ,2021**

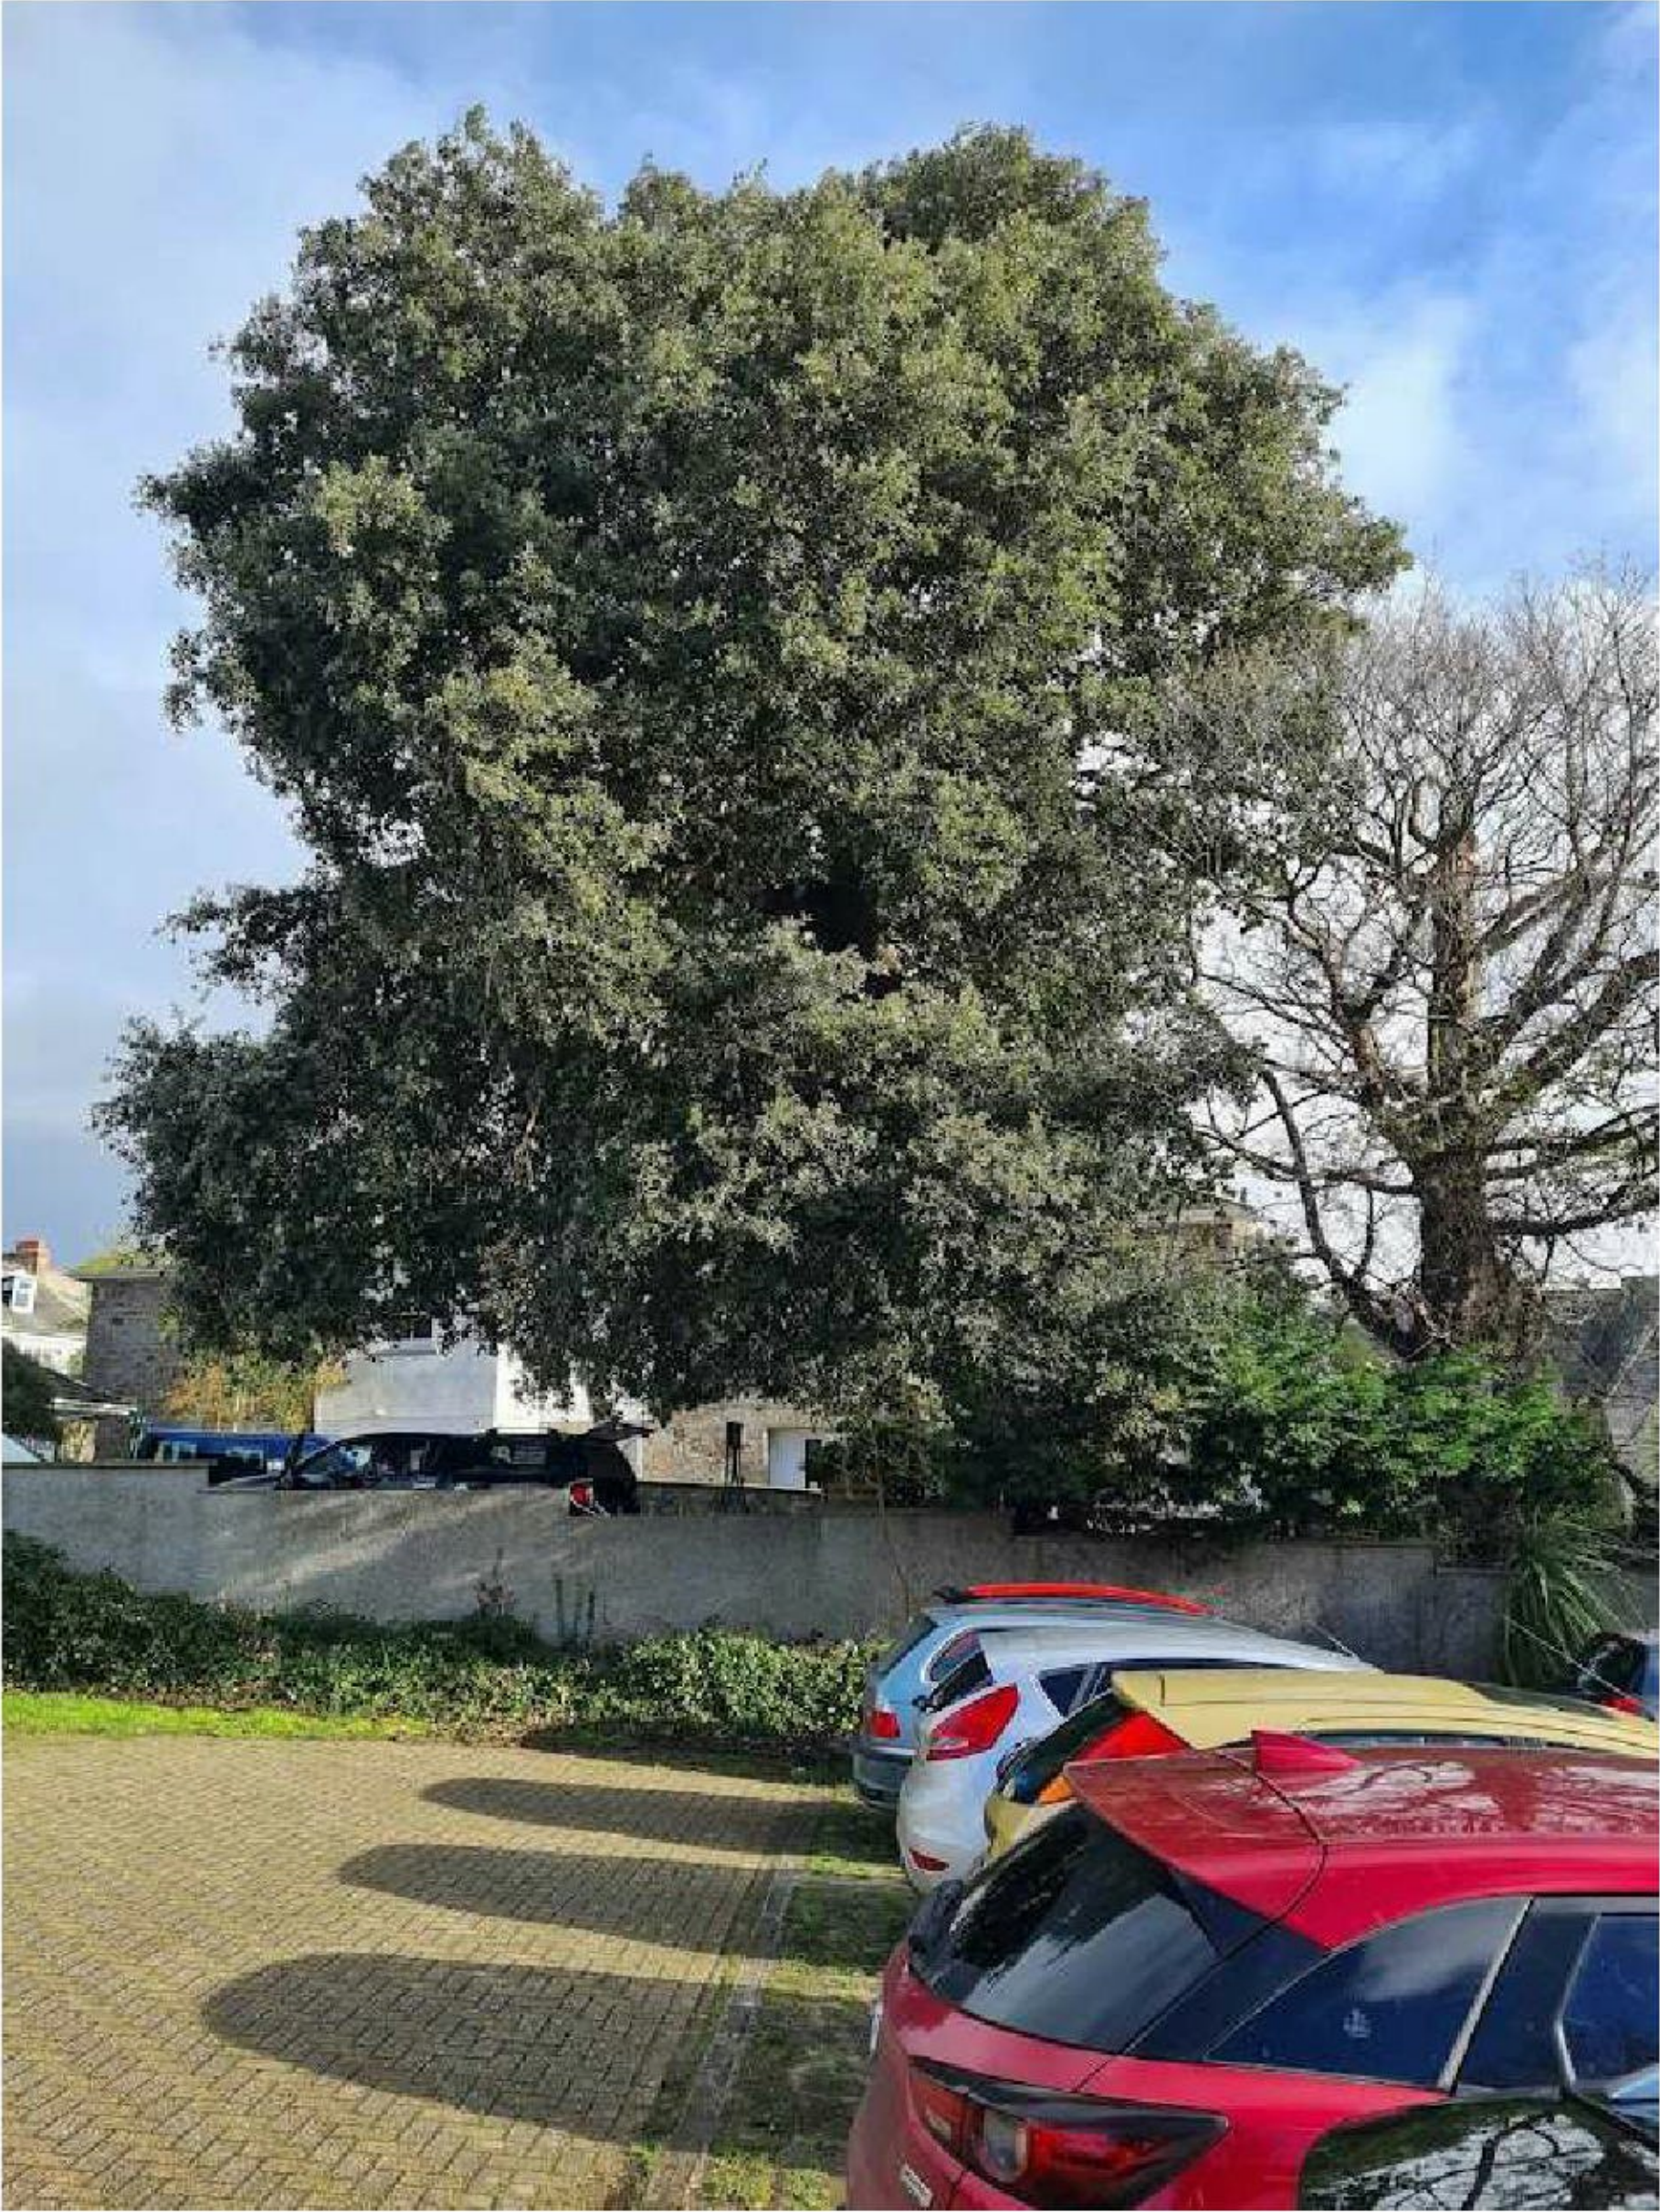
T1 - Holm Oak

- 5.1 The results of the Tomograph Assessment indicated that the tree is adapting to the changes in wood strength by laying down new wood, hence it has a Low chance of stem failure (at 350mm) in its current condition.

- 5.2 Bracket fungus *Ganoderma applanatum* is a heartwood decay pathogen and frequently found on Holm Oak of this age class. Characteristically, the fungus produces a woody bracket forming a single bracket or overlapping in tiers, generally dark matt brown with a white underside. When the action of this fungus reaches an advanced stage an excessive amount of decay can result in the failure of the stem. However, the rate of decay can be slow and take many years to advance leaving the strength of the residual wall within acceptable tolerances for many years.

- 5.6 I recommend that a Tomograph Assessment of the stem (T1) should be carried out again in five years to assess the progression of the decay.
