ARBORICULTURAL ASSESSMENT REPORT

For:	Client:	Sedgwick International UK
	Insurer:	
Site:	Policyholder:	
	Risk Address:	The Old Vicarage, Church Hill, Ramsey, Harwich, CO12 5EU
Refs:	PRI Ref:	179784
	Client Ref:	9170697
	Insurer Ref:

Arborist Name:	Will Hinde	Date:	15/02/2021
QC:	Margaret MacQueen	Date:	17/02/2021

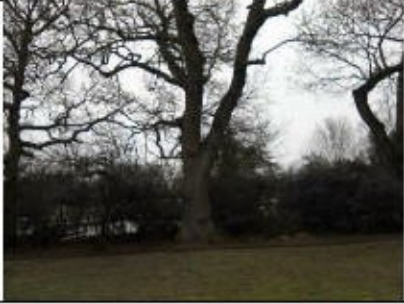
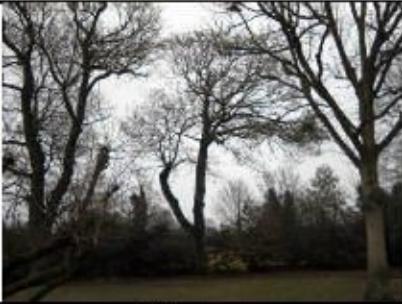
T1 - Oak	T1 - Oak

Tree No	Common Name	Age Class	Condition	Height (m)	Crown Spread (m)	Stem diam. (mm)	Dist to bldg. (m)	Roots Implicated	Pruning history	Recommendation	Tree work constraints	Notes	Owner address	Owner
T1	Oak	Mature	Good	23	12	1000*	28	N	Subject to past management.	No work required.		Unable to accurately measure dbh.	The Old Vicarage Church Hill Ramsey Harwich CO12 5EU	PH
T2	Oak	Mature	Good	15	10	800*	27.5	N	Subject to past management.	No work required.		Unable to accurately measure dbh.	The Old Vicarage Church Hill Ramsey Harwich CO12 5EU	PH
T3	Smokebush	Mature	Good	4	4	255	9	N	Subject to recent management.	No work required.			The Old Vicarage Church Hill Ramsey Harwich CO12 5EU	PH
