Application for Works to Trees Protected by a Tree Preservation Order or in a Conservation Area

ARBORICULTURAL REPORT

Title: **Impact on Tree Stability at No 2 Low Town Arising from Development and Associated Access Construction on Land East and Adjacent to No 8 Low Town, Thornhill, Stirlingshire**
Planning Ref 20/00805/Full

Date: **December 2021**

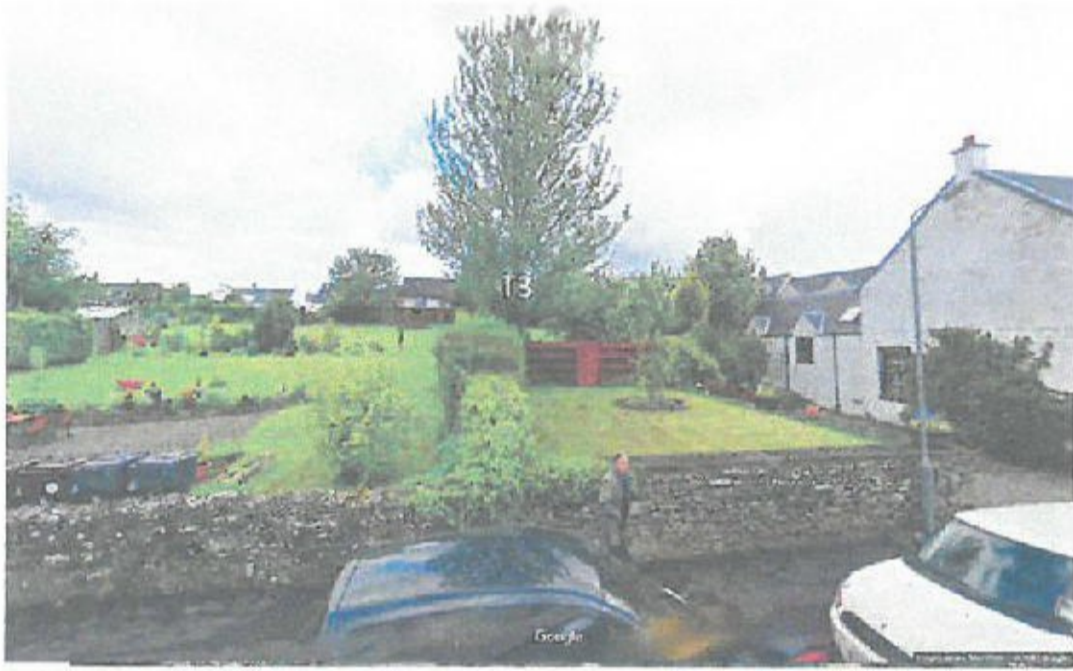
11.3 Roots will generally grow where soil is undisturbed. In the case of T3 the poplar, the Google Earth images mentioned previously do indicate that the soil in this location was mainly laid to lawn. It was concurred by Mr and Mrs Henderson; the soil at this location remained undisturbed for a number of years until the new development created a new entrance road. T3 would under these conditions with an unimpeded soil volume, be expected to form the rope like tension roots described earlier in this report on the windward side.

Source: Google Earth street view image capture May 2009. T3

2. Remove T2 to ground level within the next three months
3. Remove T3 to ground level within the next three months and allow coppice growth.
4. Monitor hedgerow health up to two seasons post development with the developer making good any replacement planting required.

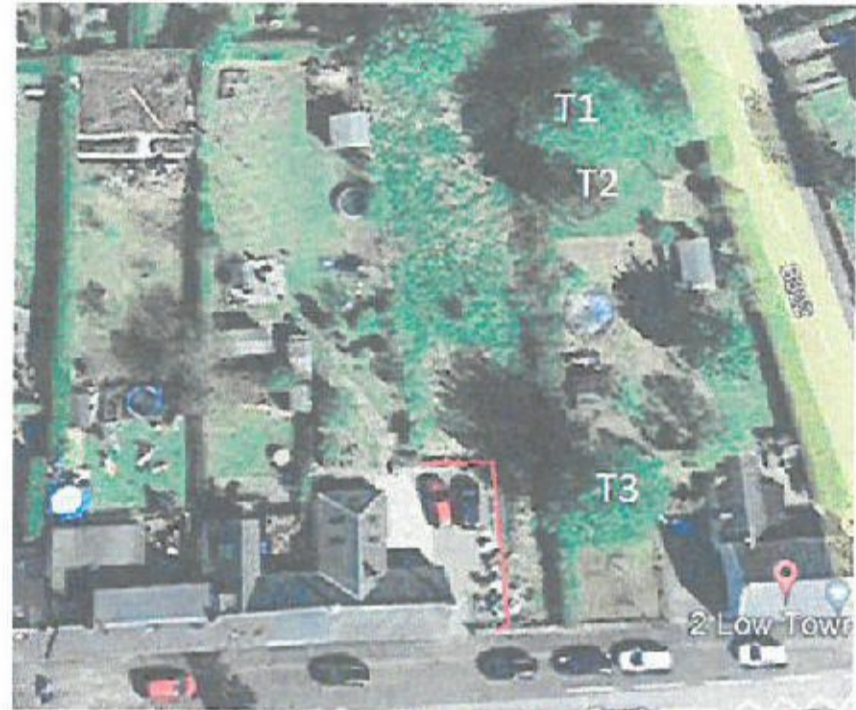
Source: Google Earth image @2017. Red line indicates existing wood panel fence at proposed development pre-excavation/driveway construction. T1-T3

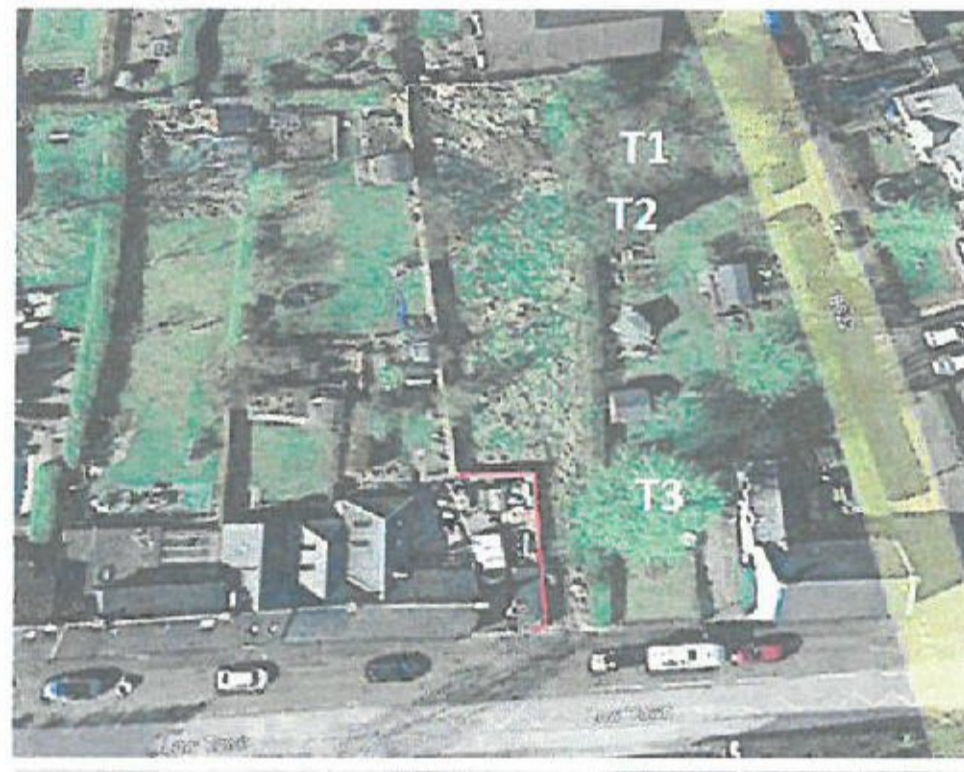
Source: Google Earth image @2021. Red line indicates existing wood panel fence at proposed development pre-excavation/driveway construction. T1-T3

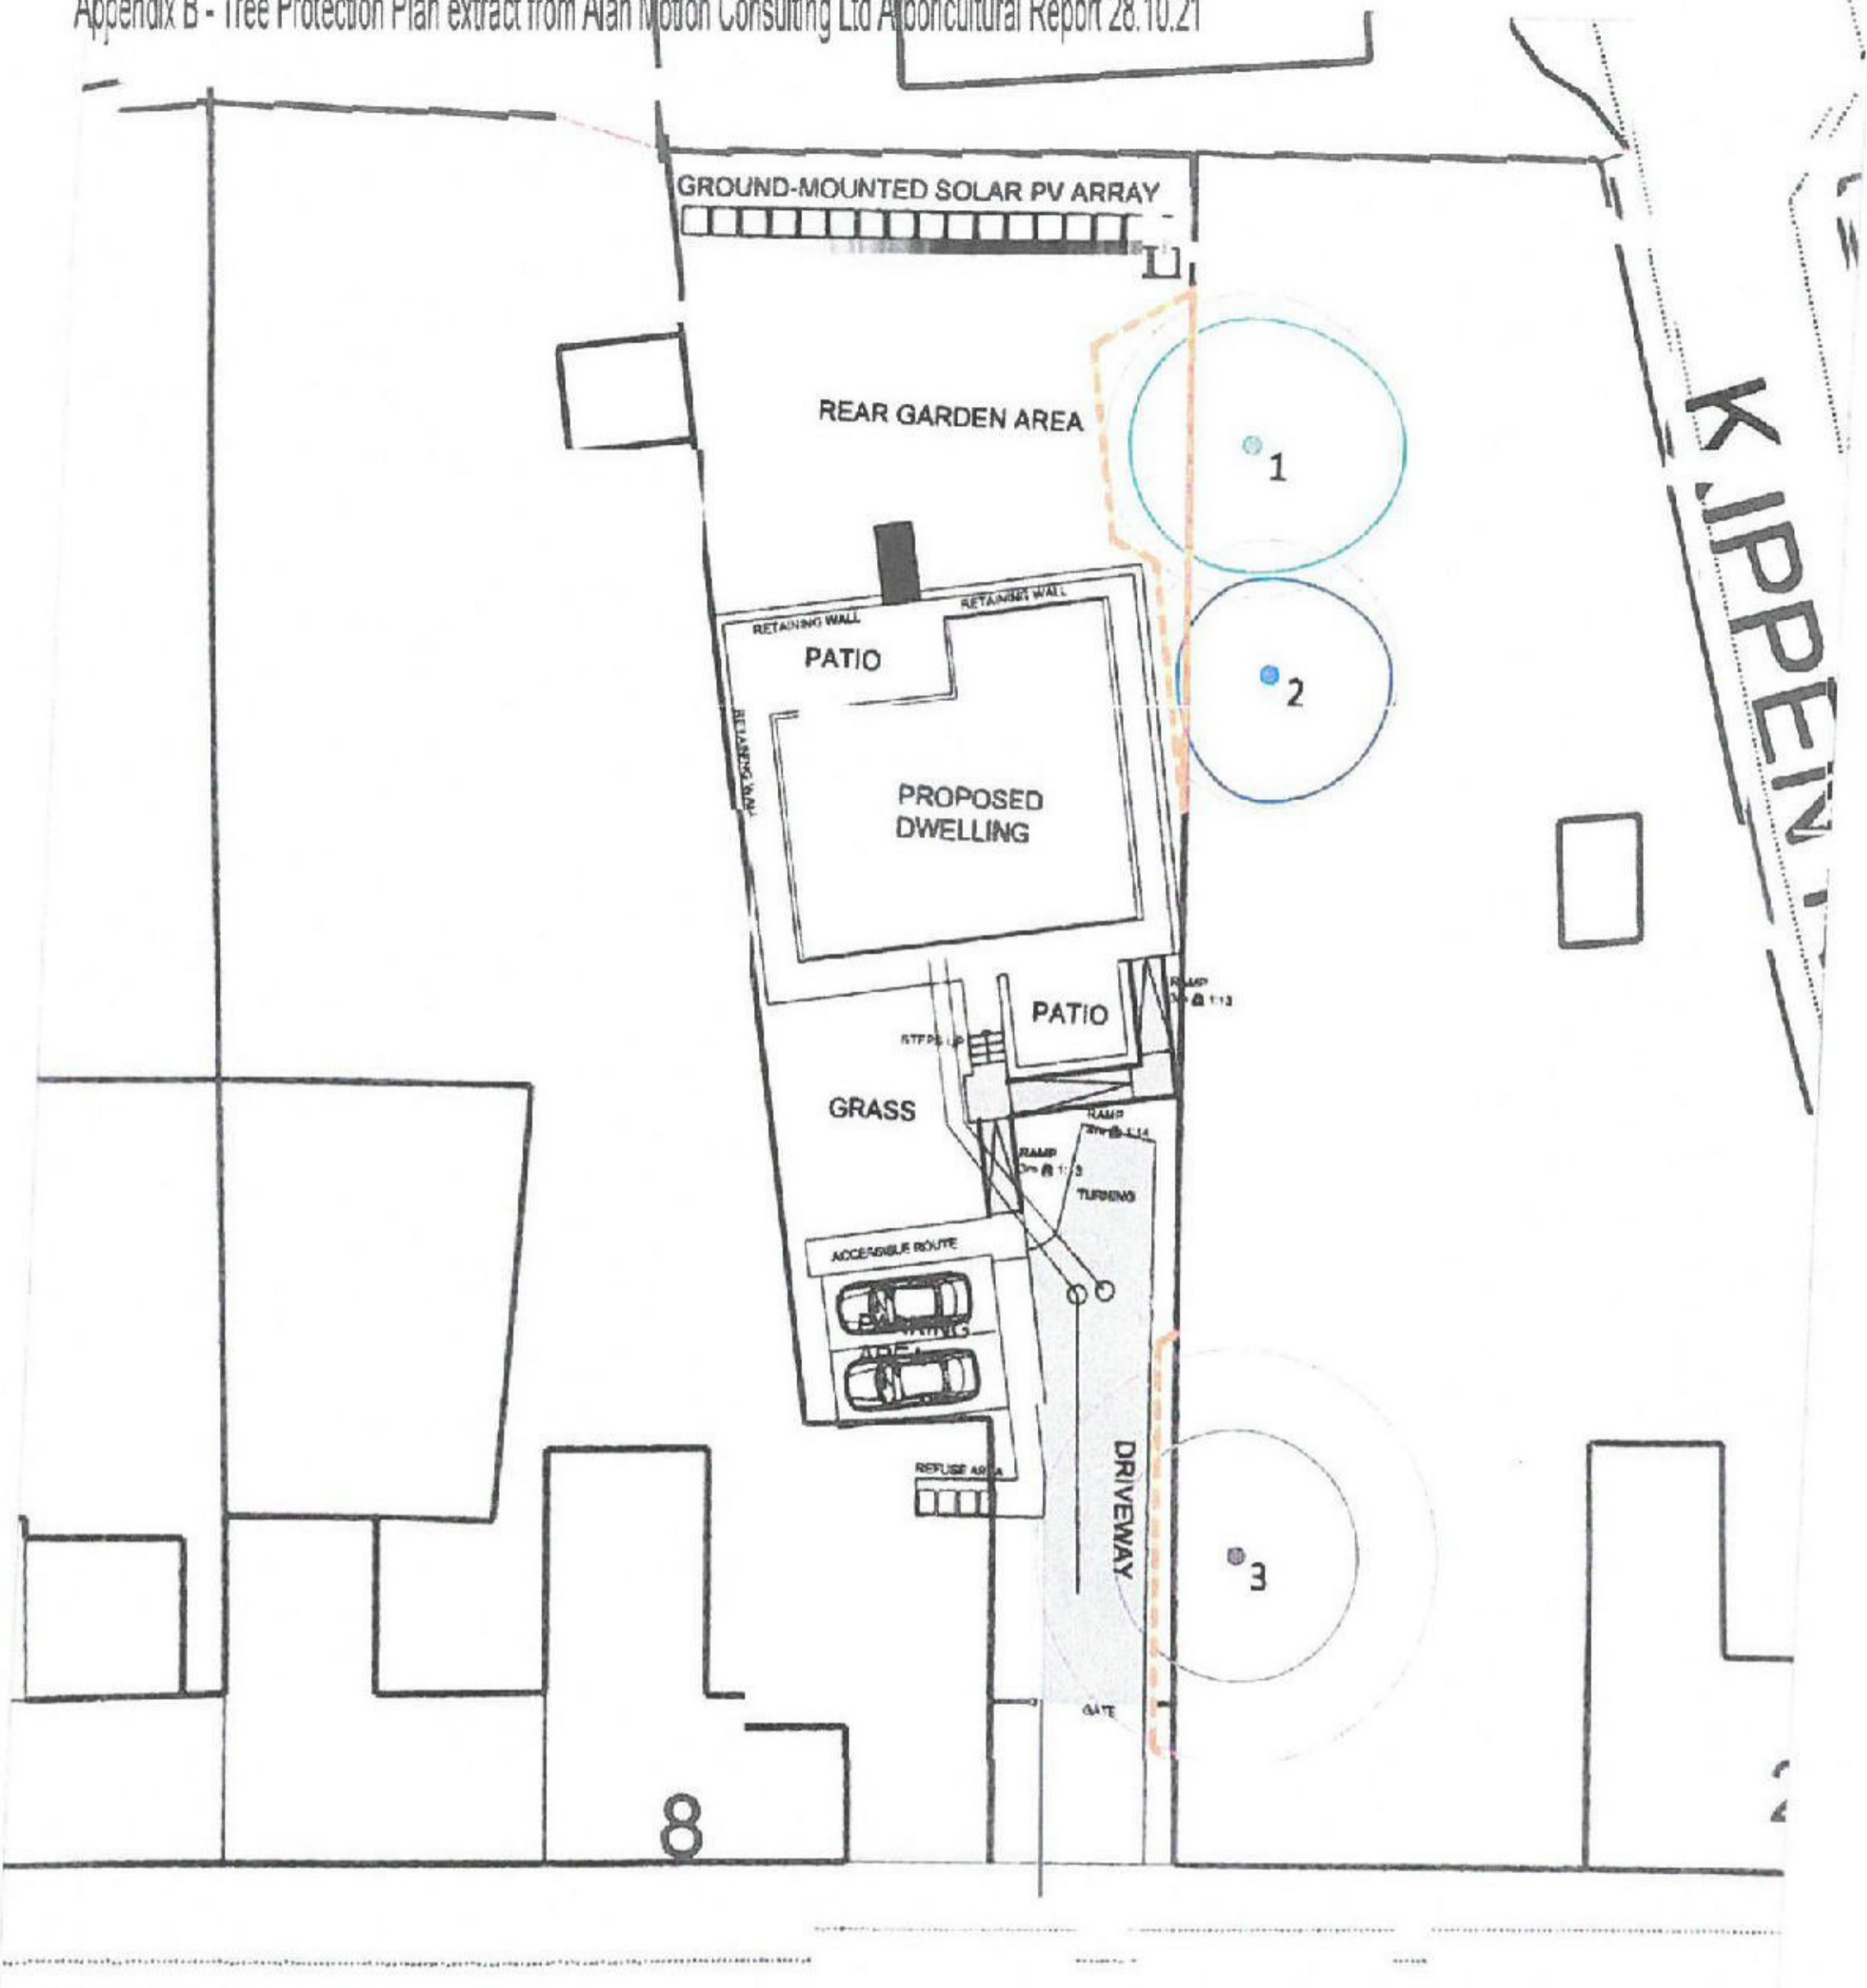
CLIENT: Mrs V Batchelar
PROJECT: 8 Lowtown, Thornhill
DRAWING TITLE: Tree Protection Plan
DRAWING No: TP-01
DATE: 18-10-21
SCALE: 1:500 at A3
REV:

11.4 The RPAs for T2 and T3 shown on the Tree Protection Plan extend across the areas of construction for the retaining wall and the access driveway. The AMTC Ltd report recommends that initial excavations are carried out by hand to expose significant roots prior to construction

and that these should not be removed without prior consultation with the appointed Arboricultural Consultant. The MW Consultants Site Plan states this operation would be supervised by a qualified arboriculturalist. However, I am unaware if any photographic, video or written records exist regarding the recommended hand digging to expose tree roots prior to construction, or if the appointed arboriculturist was consulted prior to root severance of T2 roots which can be identified as significant (>25mm diameter). Mr and Mrs Henderson maintain that a mechanical digger was used from the outset and that no hand digging was observed.

1. T1 erect BS5837(2012) specified protection barriers ASAP to the extent of the AMTC Ltd designated RPA or canopy spread whichever is the greater to prevent soil compaction and/or damage during installation of the ground mounted solar pv panels.
