140 West George Street, Glasgow – 12/05/19

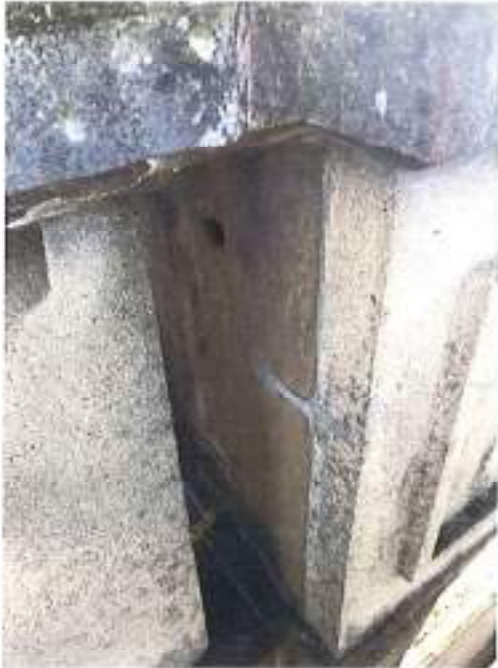
Fig 49: All part concrete replacement's ring boss

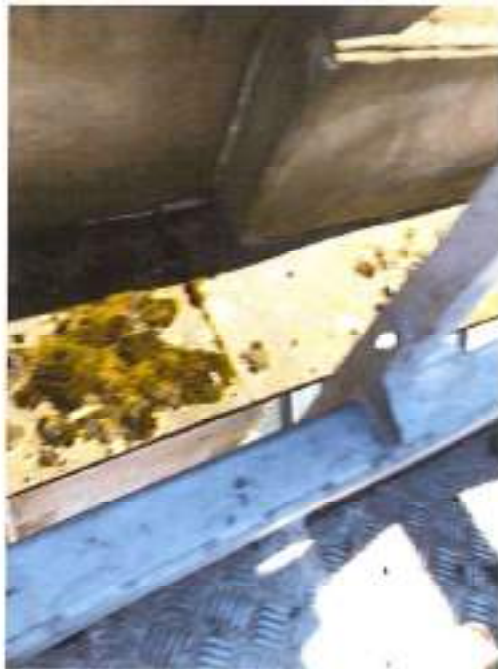
Fig 51: Algae/moss on eaves projecting cornice

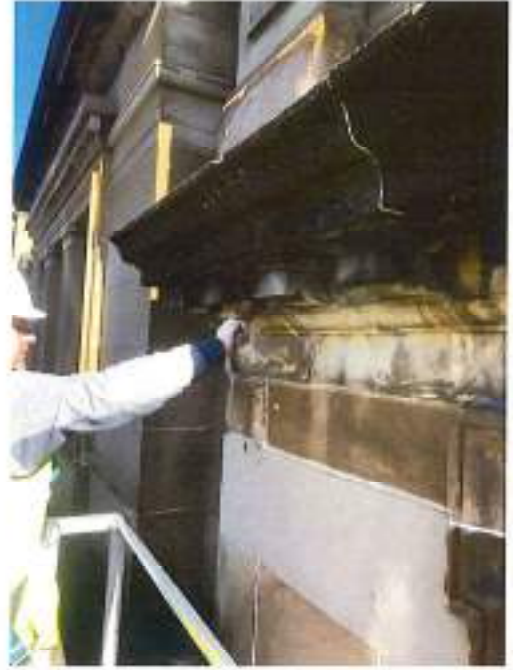
Fig 62: Tap test in progress Eaves projecting cornice

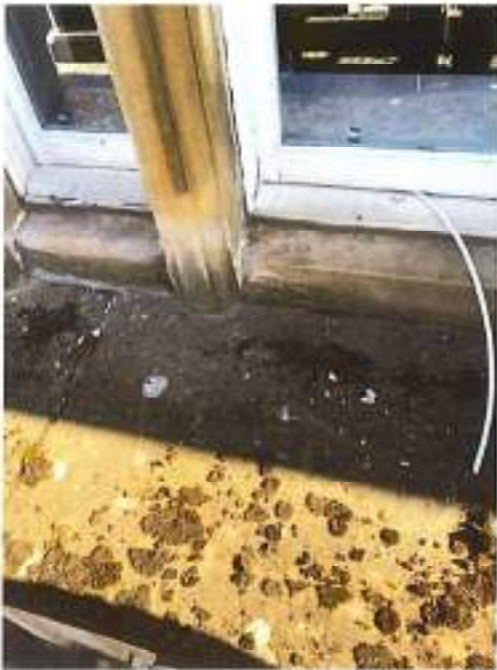
Fig 65: 4th floor cill algae/moss

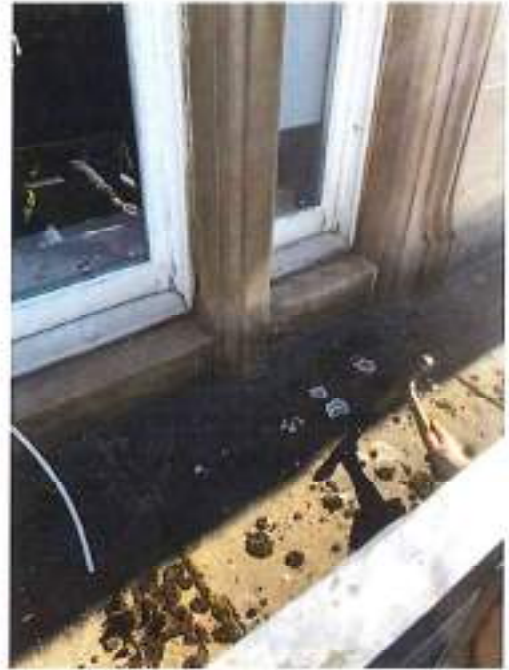
Fig 66: 4th floor cill tap testing

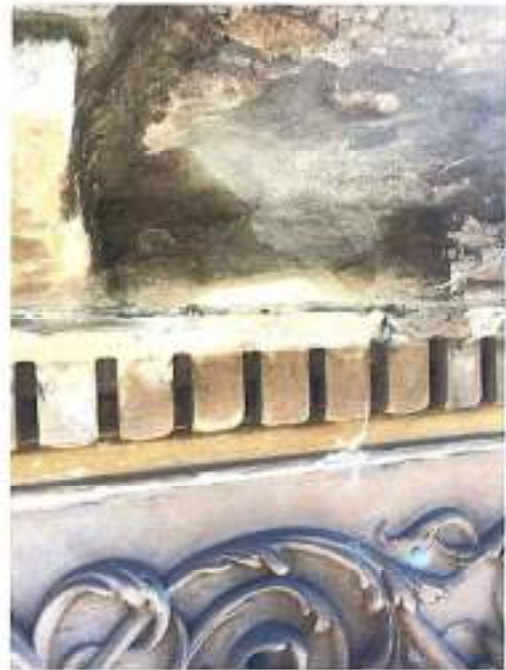
Fig 78: friable stone work

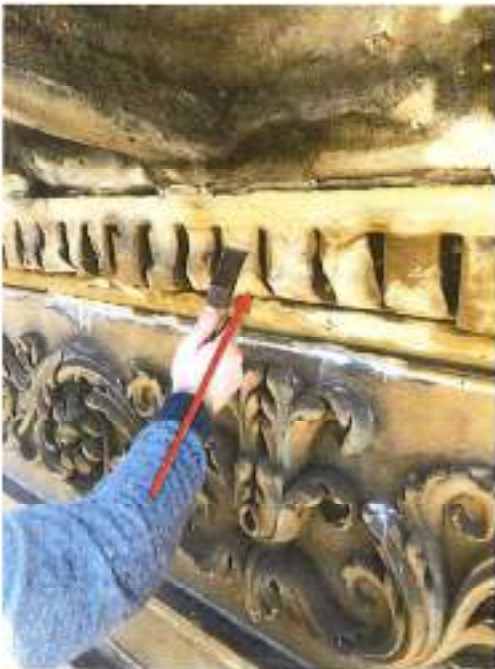
Fig 79: Friable dentil blocks (4th floor projecting cornice)

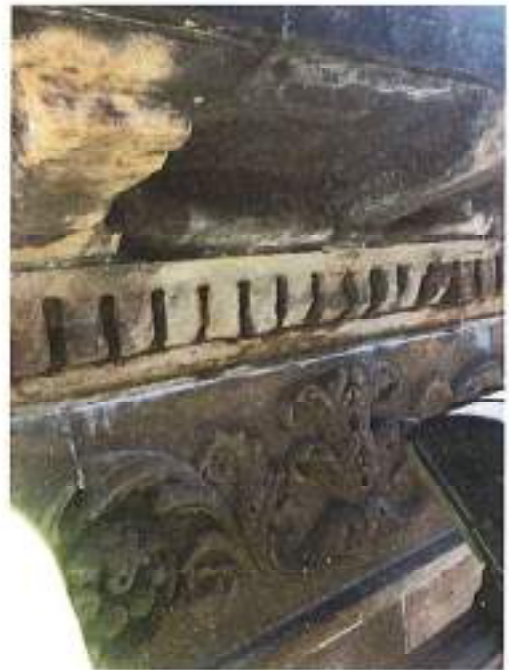
Fig 82: Friable dentil blocks (4th floor projecting cornice)

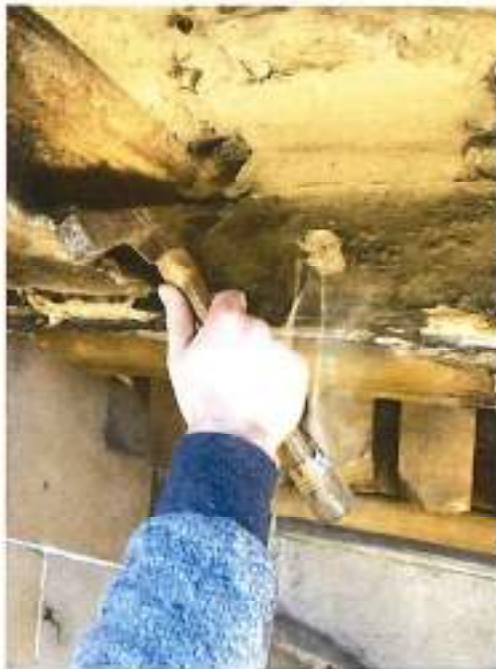
Fig 83: Friable stone under 4th floor projecting cornice

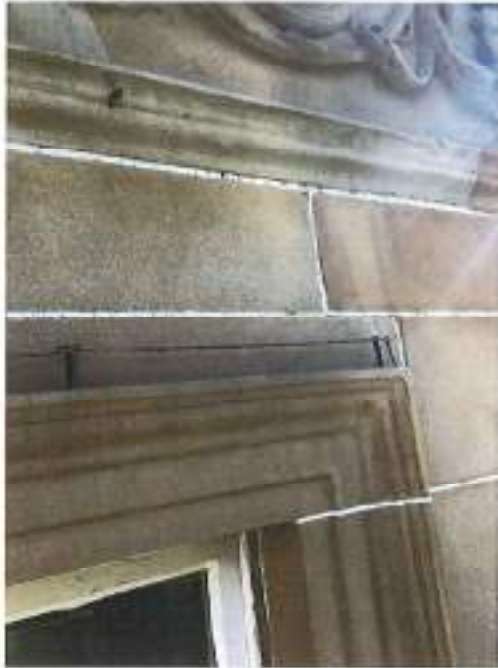
Fig 85: Bird deterrent spikes 3rd floor windows

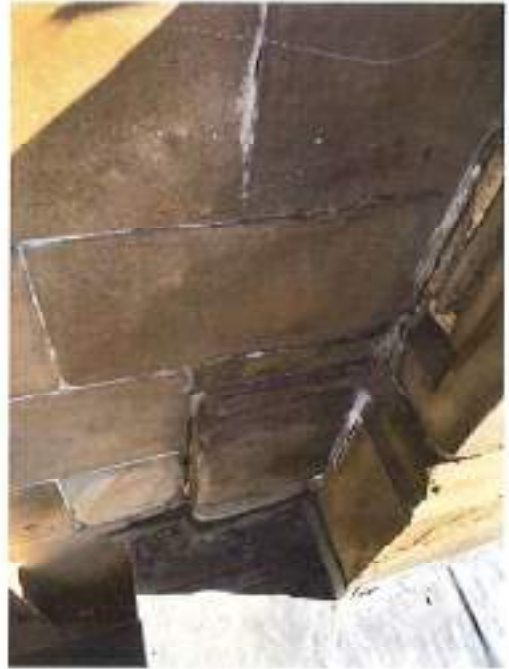
Fig 90: Area of pointing required 1st floor level

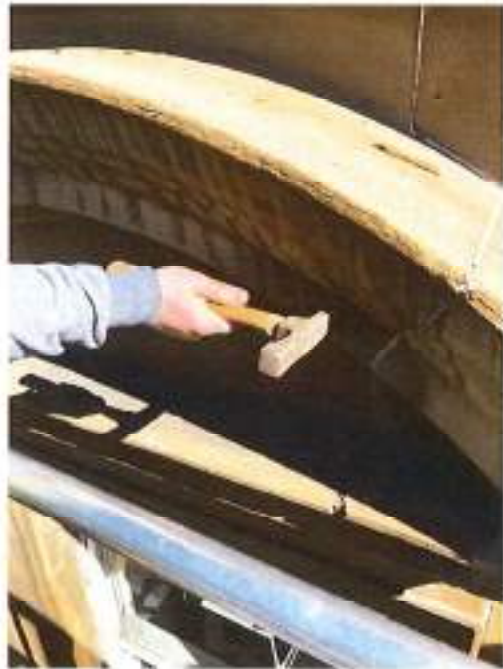
Fig 92: Tap testing 2nd floor hoods

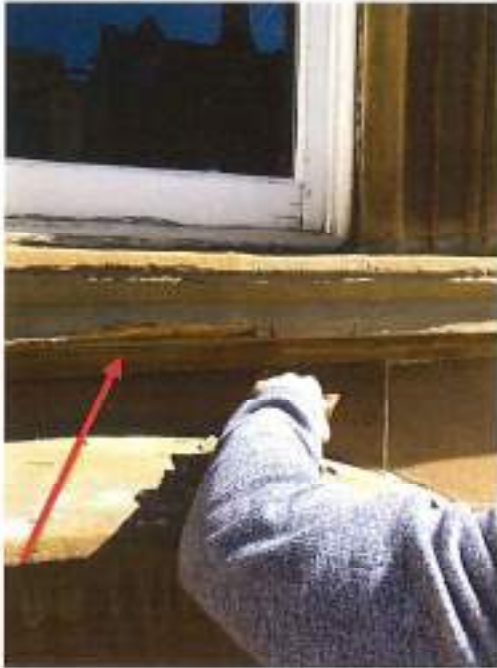
Fig 93: Friable cill 3rd floor level

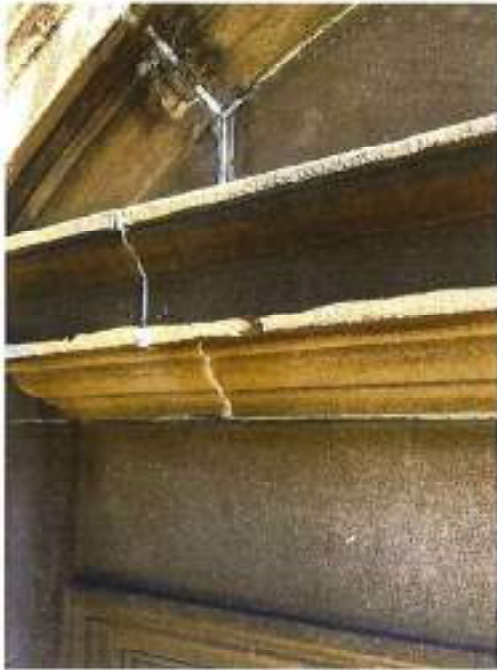
Fig 97: 2nd floor hoods

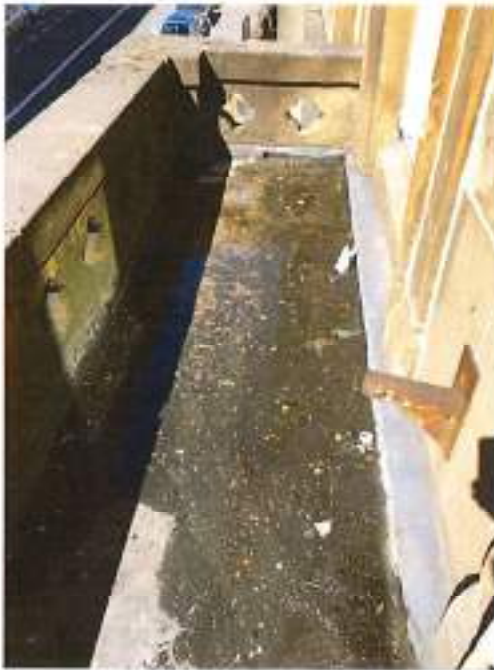
Fig 107: Portico roof behind parapet

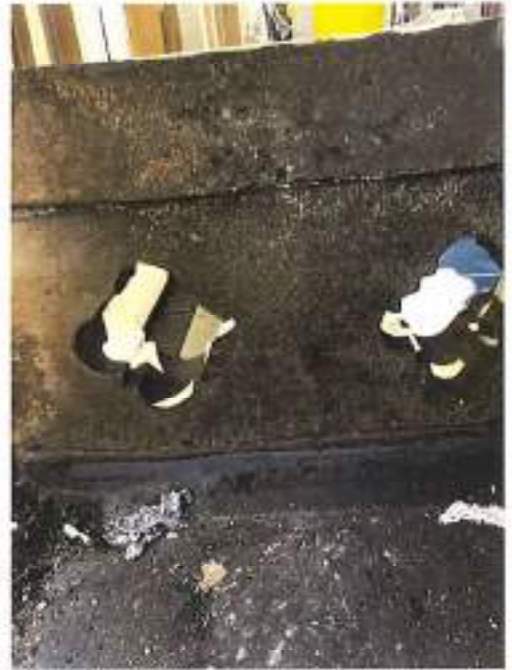
Fig 110: Behind parapet of portico

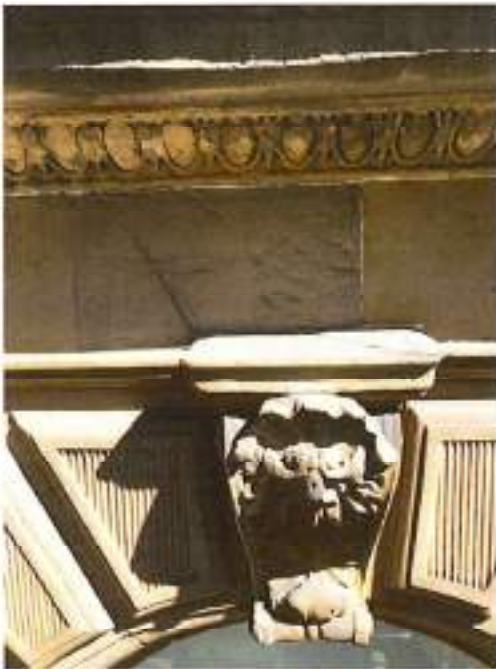
Fig 111: Ground floor window detail
