HOLLYCOMBE HOUSE

LIPHOOK

Paint samples were taken from the six main south facing rooms which were designed by Nash and built in 1802.

The object of the investigation was to find out in general terms how these rooms were decorated when first built and how they have been painted in later years. Only approximately twenty samples were taken from each room, so this cannot be seen as a full survey.

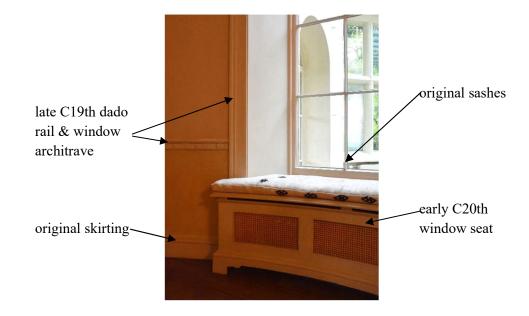
West wall

On the walls, a thin coat of lead white oil paint was applied as a ground layer. This was followed by a pale green distemper, based on a mixture of verditer and ochre [Sample A1, p.17]. This green was found on the upper walls as well as on the lower walls, so there may originally have been no dado rail. The present rail is a late nineteenth-century introduction.

The oak sashes of the west window were stained brown and given a thin coat of varnish.

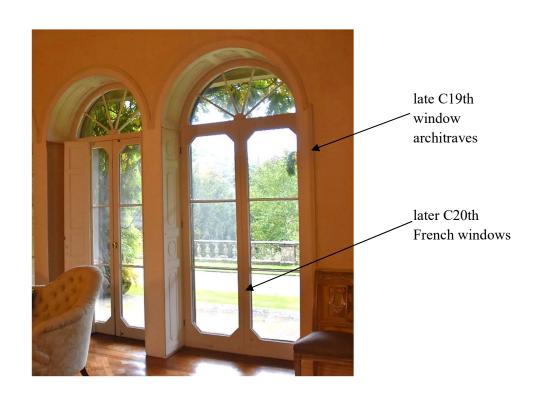
South wall

New window architraves and window reveals on the south wall.
