BUILDING SURVEY REPORT

Havencliffe House, Axmouth, Seaton EX12 4AB

10th December 2015

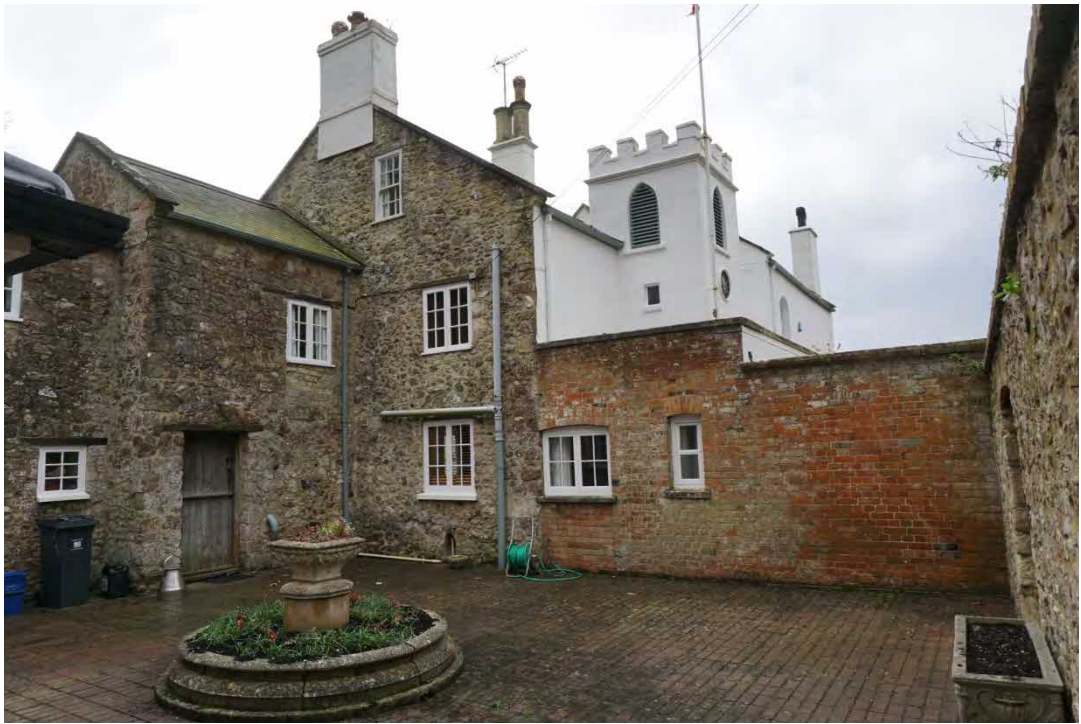
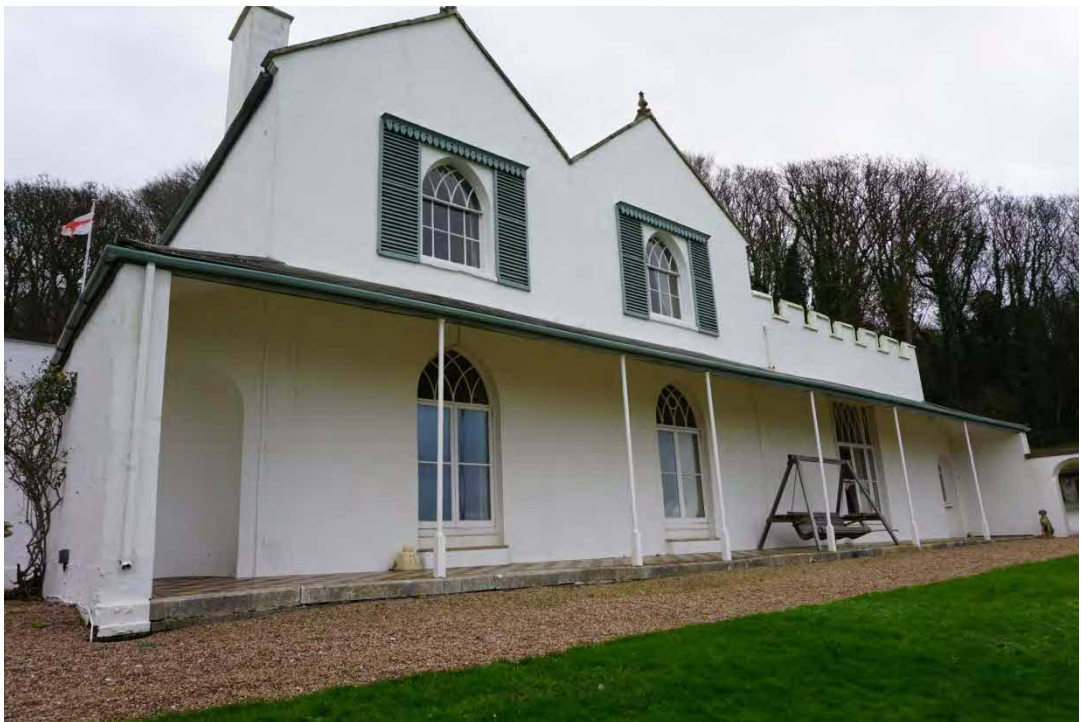
- 2.6 **Construction:** The main walls are principally of solid random stone construction. Parts have internal wall linings and finished thickness varies between 450 and 700mm. Single storey additions i.e. front porch (which may be later 19th century) appear to have solid brick walls.

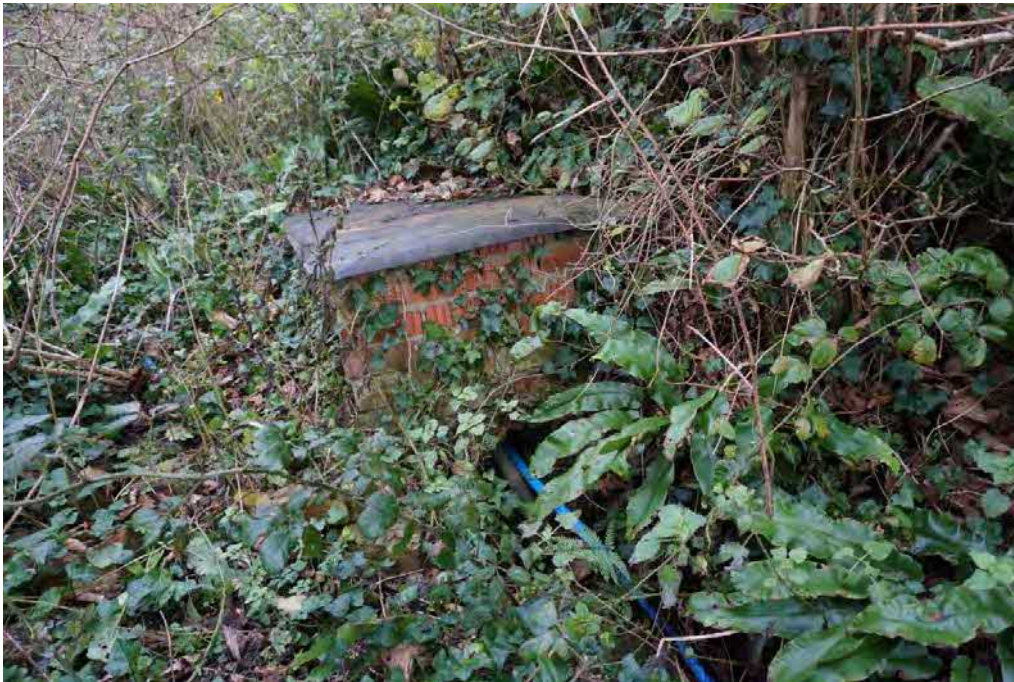
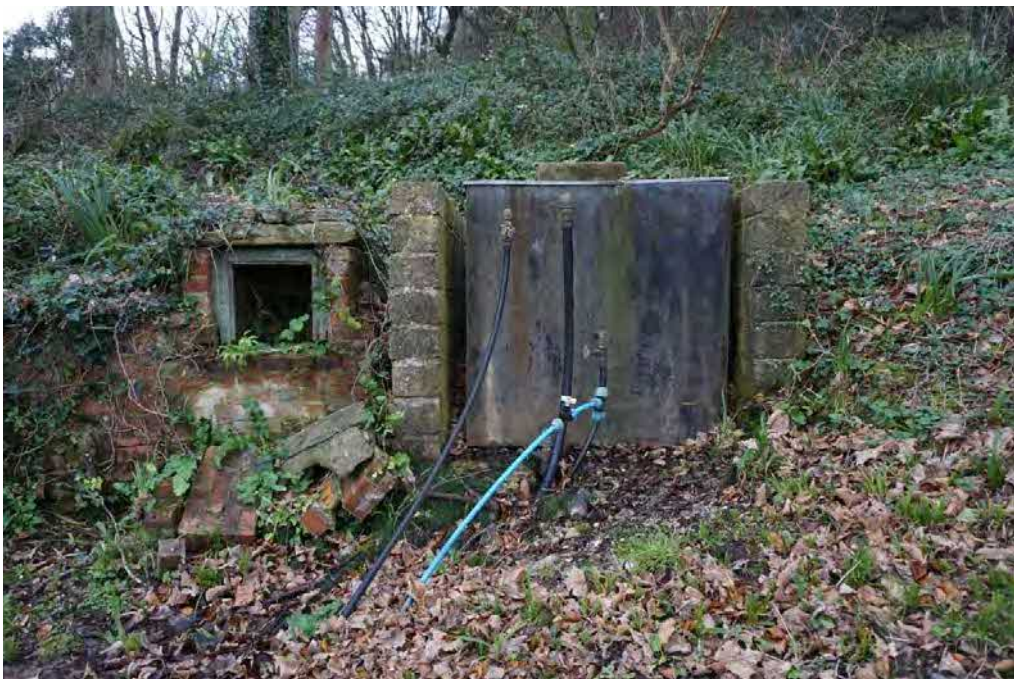
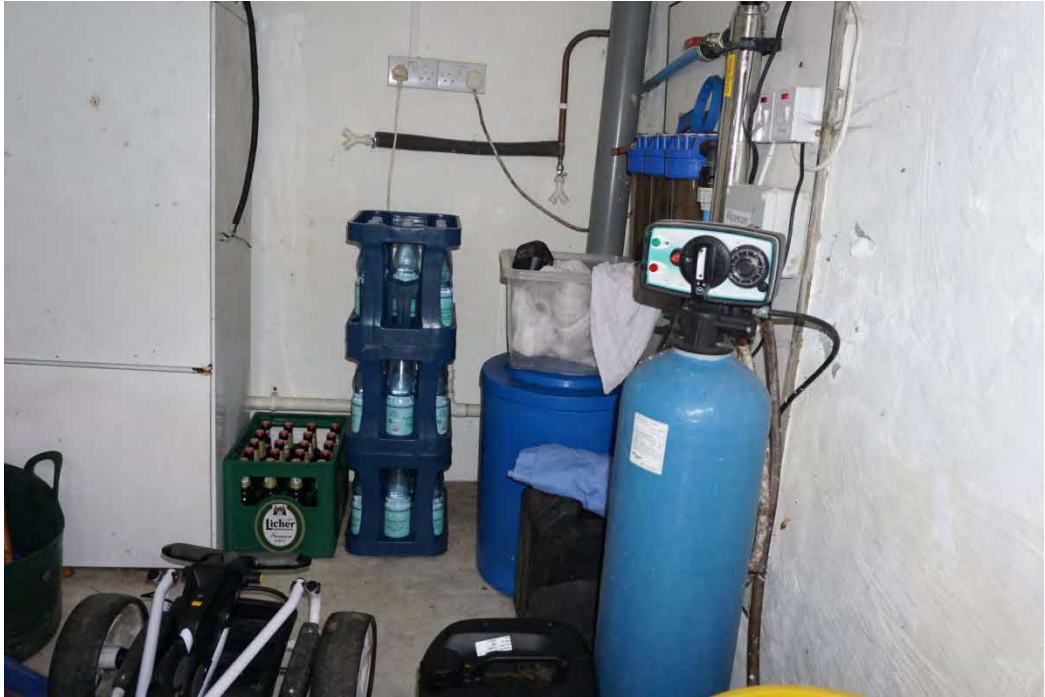
- 6.7 The precise plumbing arrangements could not confirmed but it is assumed there is a direct feed to the kitchen and other ground floor areas, the water then supplying two 50 gallon header tanks in the roof space, in cupboard on second floor. From here water is supplied by gravity to second floor installations and hot water cylinder. (It was noted at time of inspection that one of the tanks was overfull as ballcock not operating properly to cut off supply.)

- 6.8 The supply to the cottage looks to have been recently altered and there is a pressurised pump installation in the adjacent boiler house i.e. to provide water under pressure including for operation of combination boiler. It is assumed (bit not confirmed) that it has a direct feed from the storage tank.
- 6.9 The hot water in the house is provided via a factory lagged hot water cylinder in airing cupboard in the main bathroom heated indirectly by the boiler and with electric immersion backup. Hot water in the cottage is provided instantaneously by the combination boiler.
- 6.10 Plumbing is principally in copper pipe and appears to be reasonably arranged substantially renewed during present owner's occupation. Bathrooms are well fitted.
