PRELIMINARY ROOST ASSESSMENT

Oak House, 21A Acorn Drive, Oakenshaw, Crook, DL15 0TF

February 2022

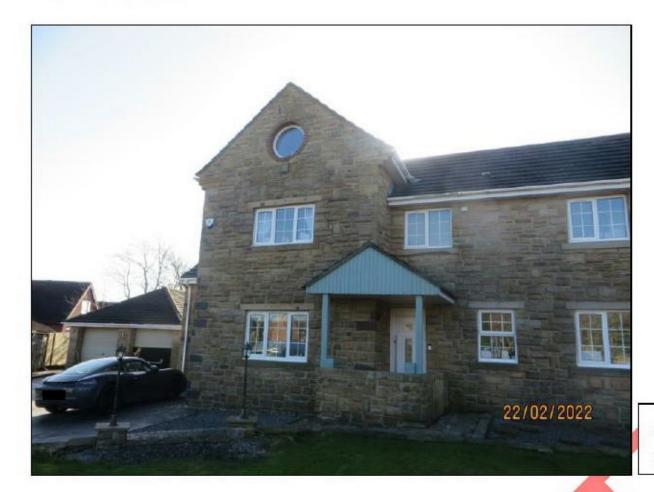
Figure 11. Main house, front (northern) elevation.

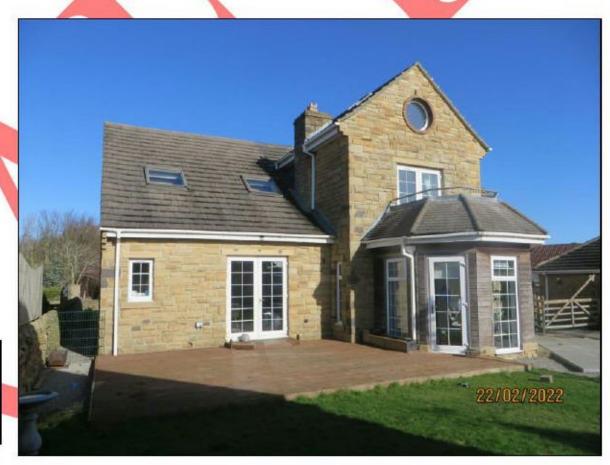
A conservatory (proposed for removal) is present on the rear (southern) elevation (figure 12). This has a pitched tiled roof, with no slipped/misaligned tiles noted. uPVC soffit boxes are present around this section, with a gap present at each end where it adjoins the house (figures 13 and 14). The conservatory external walls are wooden-cladded with no gaps noted.

Figure 12. Main house, rear (southern) elevation, showing conservatory proposed for demolition.

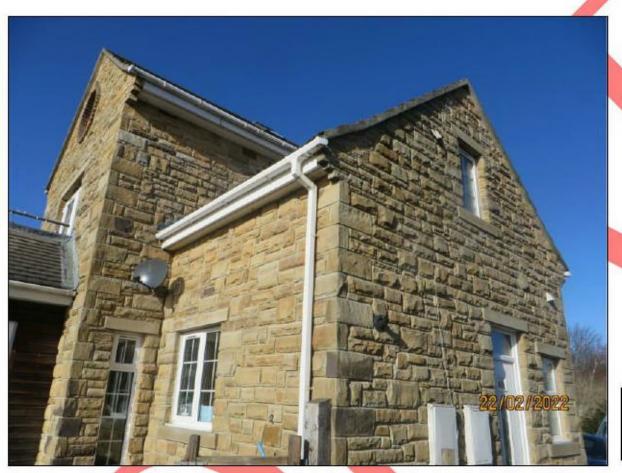
Figure 15. Rear (southern) and side (eastern) elevations.

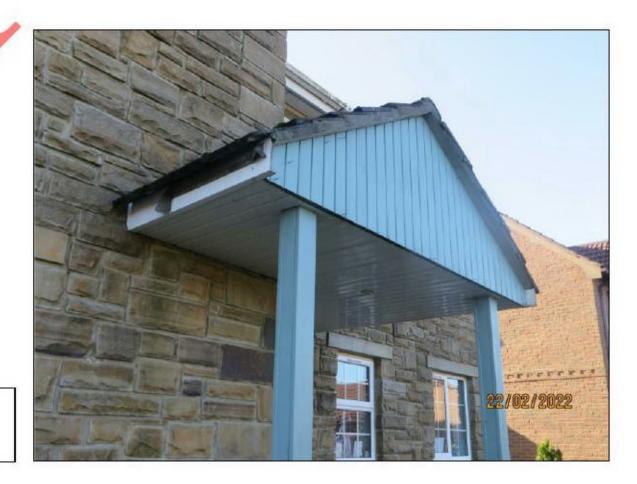
A portico with a pitched roof is present on the front elevation (figure 16). There is no access to the void above it, no gaps into it were noted and is not affected by the development proposals.

Figure 16. Covered portico on front elevation.

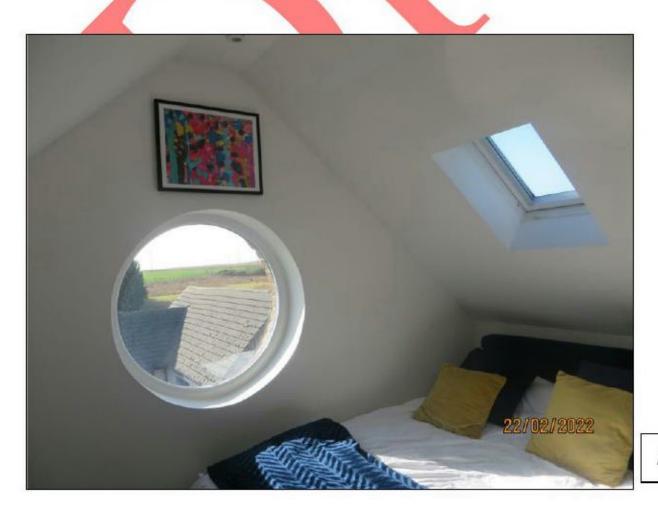
The roof void has partially been converted into two bedrooms (figure 19). A section of traditional loft void is still present (figure 20). Within the loft void insulation is present across the floor and up some of the walls. Bitumen felt is present along the tiles. Light ingress can be seen along the wall tops, suggesting there are gaps present that could be used by bats. A single butterfly wing was found (figure 21), which can be the remains of overwintering butterflies or can be the feeding remains of larger bat species such as natterer's or brown long-eared. No bat droppings were seen.

Figure 19. Room within roof void.

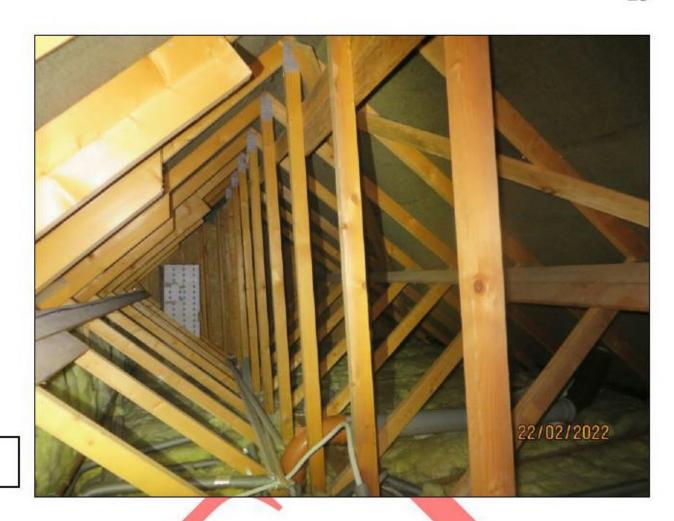
Figure 20. Main house loft void.

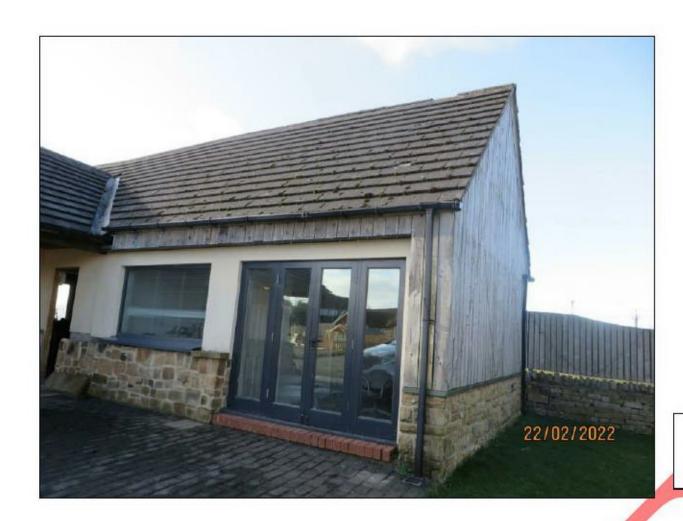
Figure 23. Outbuilding - 'Granny annex', showing wooden cladding.

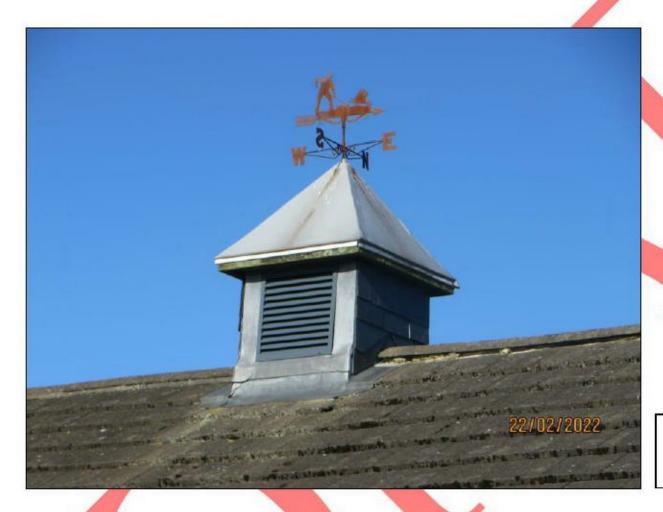
The pitched roof has a small feature with weather vane and vents present (figure 27).

Figure 27. Weathervane on outbuilding.

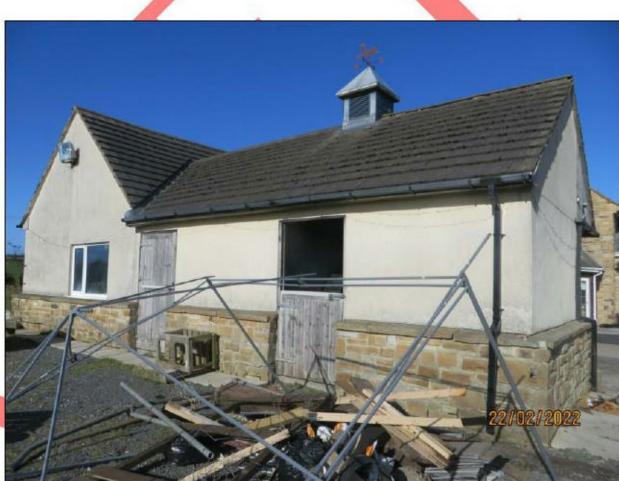
Figure 30. Outbuilding, southern elevation, showing rendered areas.

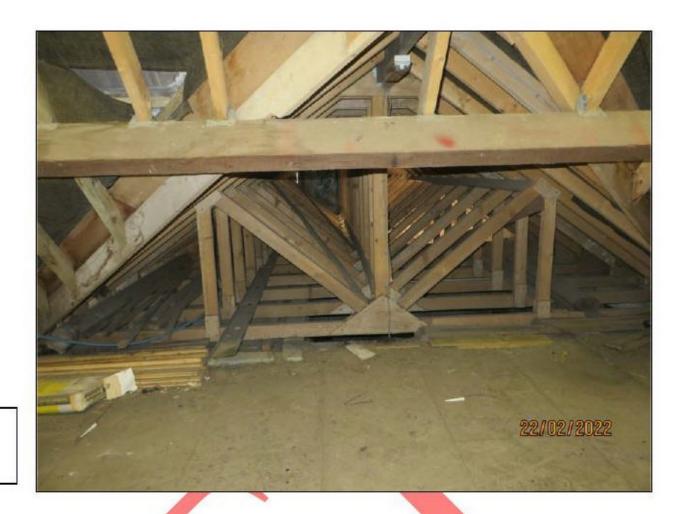
Stable bays - this section is in current use as storage and is open to the roof beams above (figure 32).

Figure 32. Roof void above stable bays.

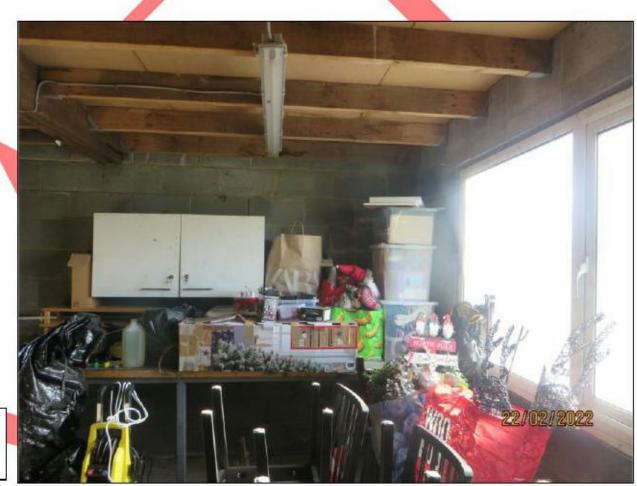
Storage area – This section (figures 33 and 36) has breeze block internal walls and a set of stairs leading to the roof void. Butterfly wings are scattered across both the ground floor (figure 37) and roof void. But droppings were found in the roof void of this section (figure 34).

Figure 36. Storage section of outbuilding.

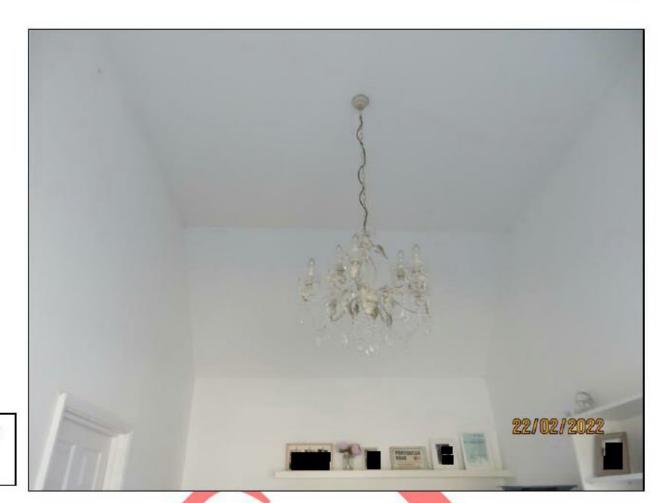
'Granny annex' – This section has been converted into liveable rooms (figure 38) with uPVC doors and windows. The roof void above it cannot be directly accessed, but was viewed from an internal window in the storage area. Numerous bird droppings and the remains of nests could be seen (figure 35). Metal sheeting is present beneath the tiles in this section.

Figure 38. Internal room of 'Granny annex'.

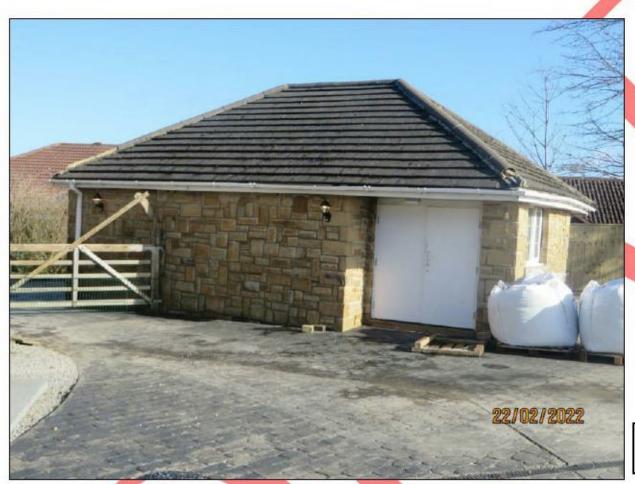
Figure 39. Detached garage.
