**Heritage Assessment for Middle Ripley Farm, North  
Ripley Road, Ripley, Hampshire, BH23 8ES**

August 2021

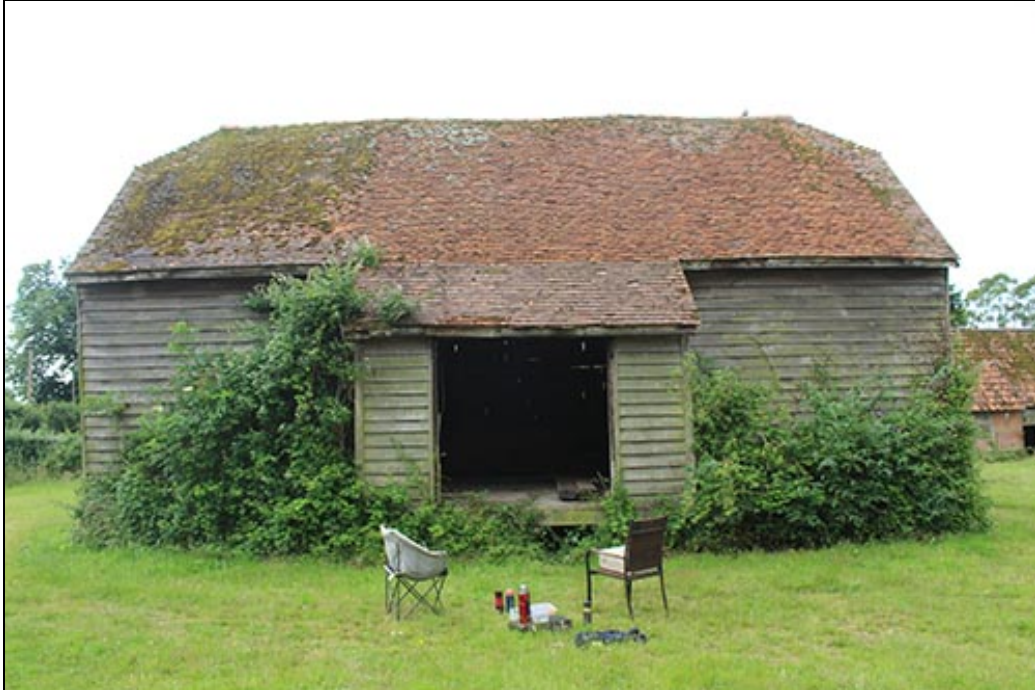
**Figure 11** The Threshing Barn looking south

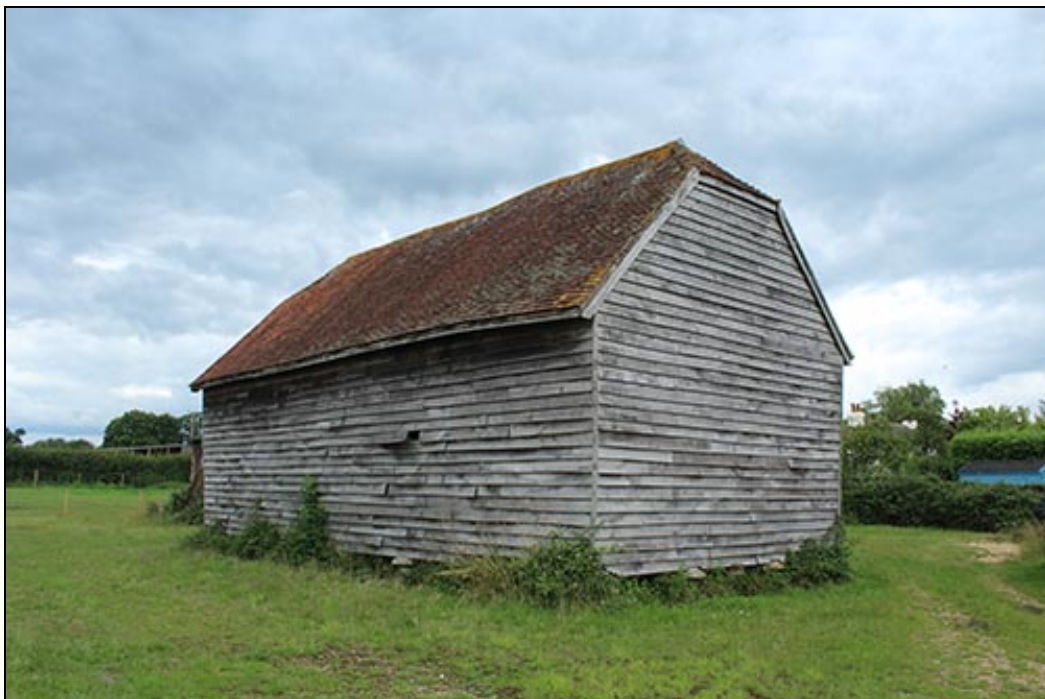
**Figure 12** The Threshing Barn looking north-west

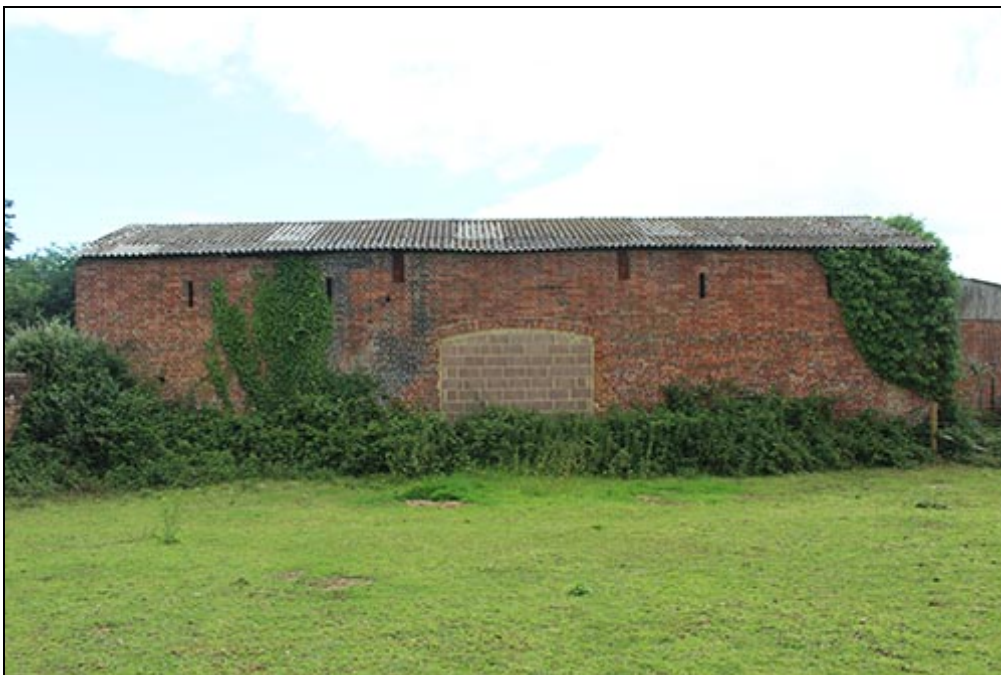
2. This new brick barn is of five bays, totalling 17.4m in length and 6.1m in width, with opposing doorways in the central bay; the western of these being infilled with blockwork in the later 20<sup>th</sup> century. Both doors exhibit signs of vehicle damage, with their lower jambs broken away and only then repaired on the southern jamb of the western door. The external walls, which include four high-level ventilation slots in the east and west elevations, are largely of Flemish Garden wall bond, while the internal walls are in irregular bond.

**Figure 18** The west elevation of the Brick Barn

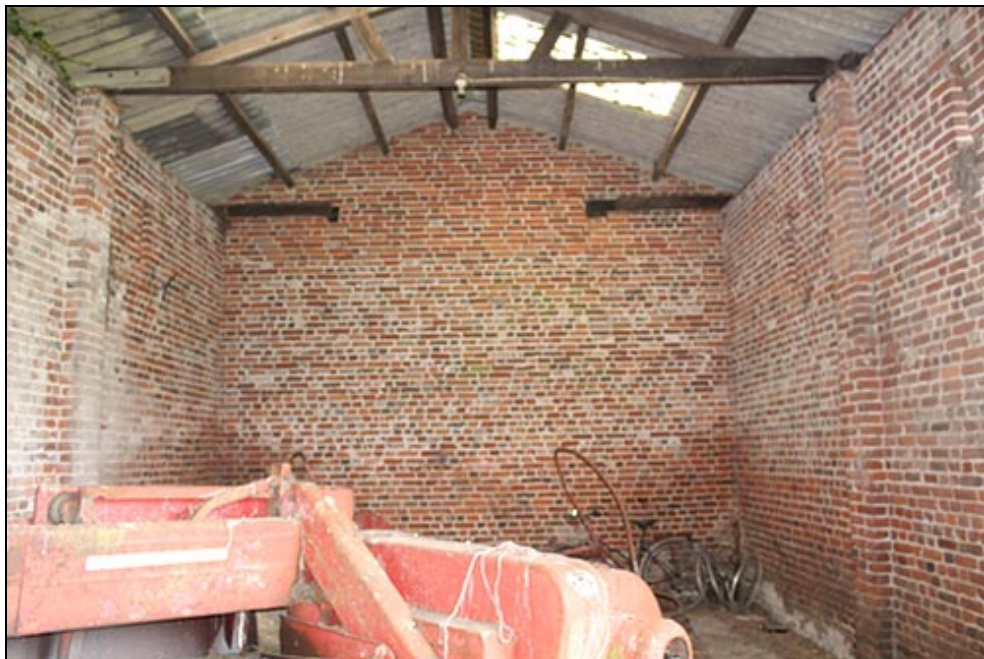
3. The original roof of the Brick Barn is now lost, apparently as a result of a fire in the late 20<sup>th</sup> century, but it was reputedly thatched with a steeper pitch than its replacement, which is of corrugated sheets supported by softwood roof trusses and purlins. Modern anchor plates with tubular tie rods have also been inserted under the two central pairs of modern trusses to provide support to the walls. The earlier roof trusses were supported on brick pilasters projecting from the internal side walls. Charred timbers set high in the gable ends may also be related to this earlier roof structure, although it is not clear as to how.

**Figure 20** The interior of the Brick Barn, looking north

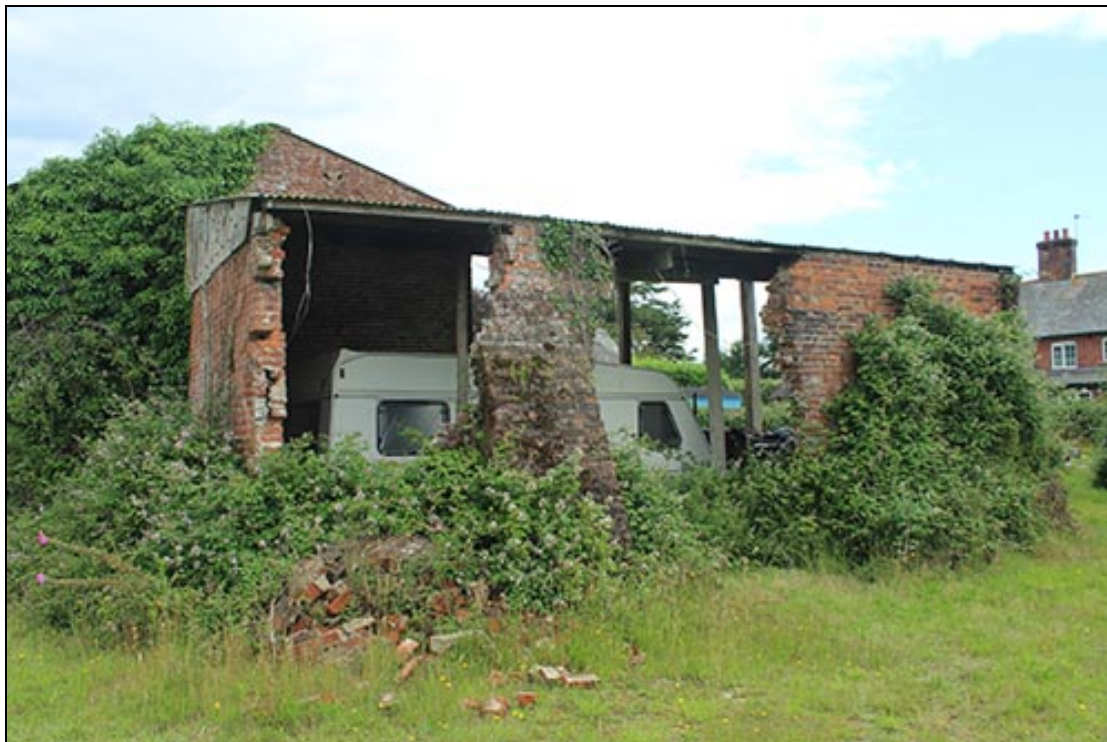
1. Attached to the south end of the Brick Barn is a lean-to composed of two brick walls on the western and southern sides, the latter partially collapsed, and open to the east and part of the north. It is covered by a low-pitched corrugated sheet roof. The roof and timber supporting posts are modern, however the brick walls are clearly older.

**Figure 23** The Lean-to looking north-east

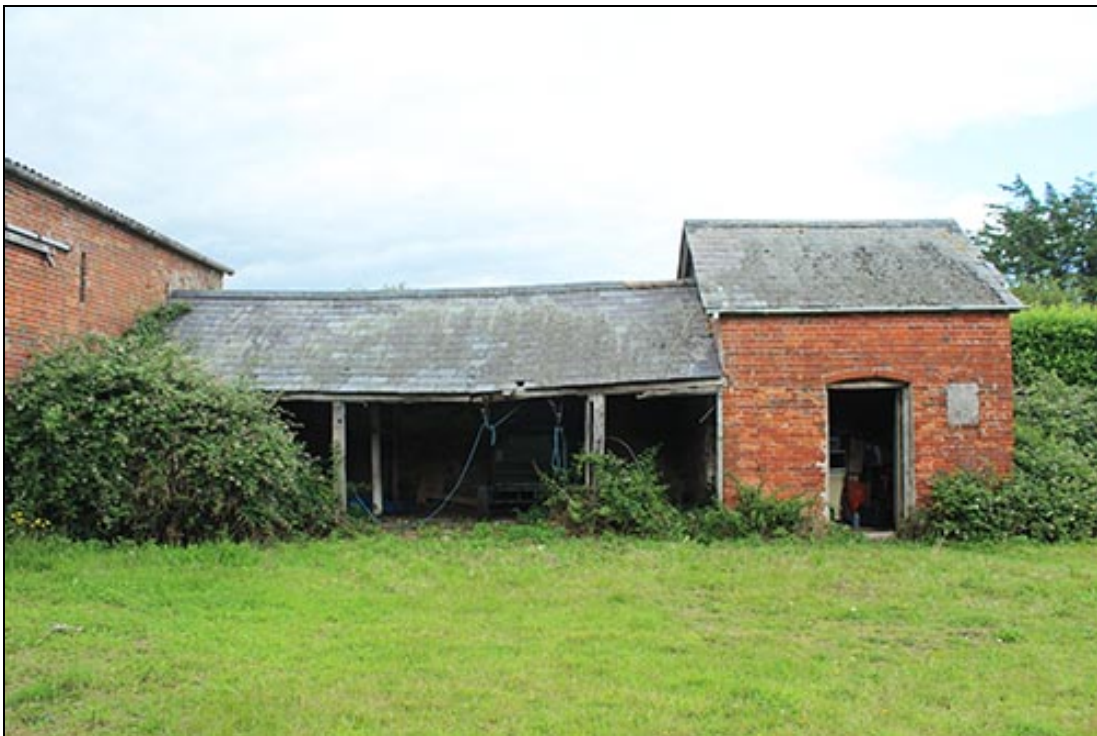
**Figure 25** The Shelter Shed and adjoining Small Store, looking north

1. Between 1839 and 1871-2 a three-bay shelter shed for cattle was added to the growing farm, attached to the north-east side of the Brick Barn. Its rear wall, and possibly its original eastern end, were of brick laid externally in a rough Flemish garden wall bond, and internally in irregular bond, with an open front, with the wall-plate, rafters, purlins and ridge-board all of homegrown softwood. Its span was 4.3m, with a roof pitch of about 36°.

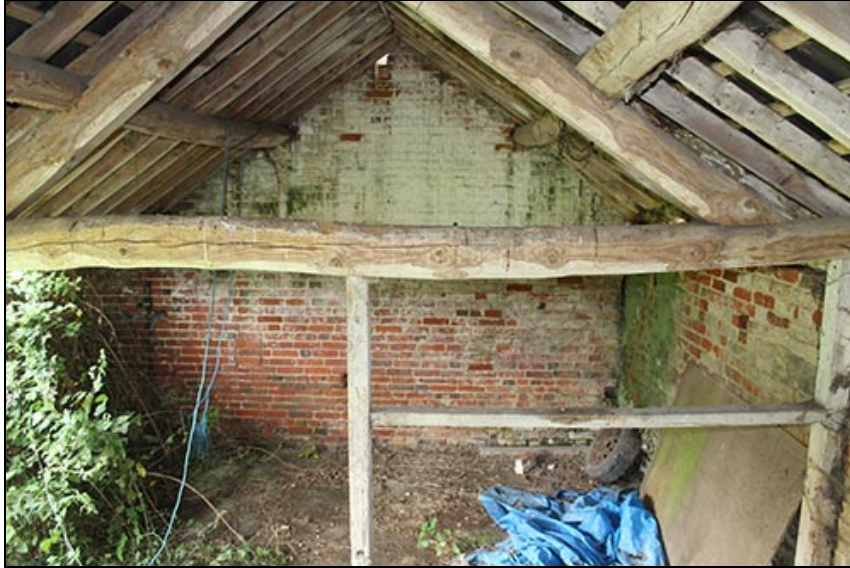
**Figure 26** The interior of the Shelter Shed, looking west at the east wall of the Brick Barn

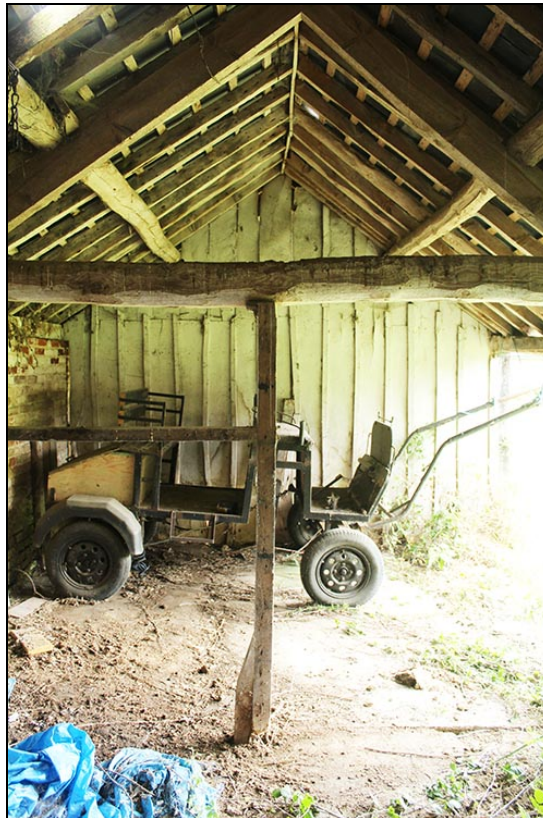
**Figure 27** The interior of the Shelter Shed, looking east at the later partition inserted after the addition of the Small Store

2. Sometime in the later 19<sup>th</sup> century its eastern bay was partially demolished, extended and re-built to form the Small Store, with the remainder of the eastern bay to the west partitioned off and floored with brick. In the mid-20<sup>th</sup> century the western part of the front wall-plate was repaired with a new section of timber, together with some of the rafters on the south elevation, with the overlying roof re-slatted. In the early 21<sup>st</sup> century further repairs were undertaken, again to the western part of the front wall-plate, although this time the adjoining stretch directly abutting the Brick Barn, and using a piece of former railway sleeper fixed to the earlier repair with a metal angle iron strap. A new western post was also added, again utilising a timber sleeper. The existing concrete floor may well have been added at this time.

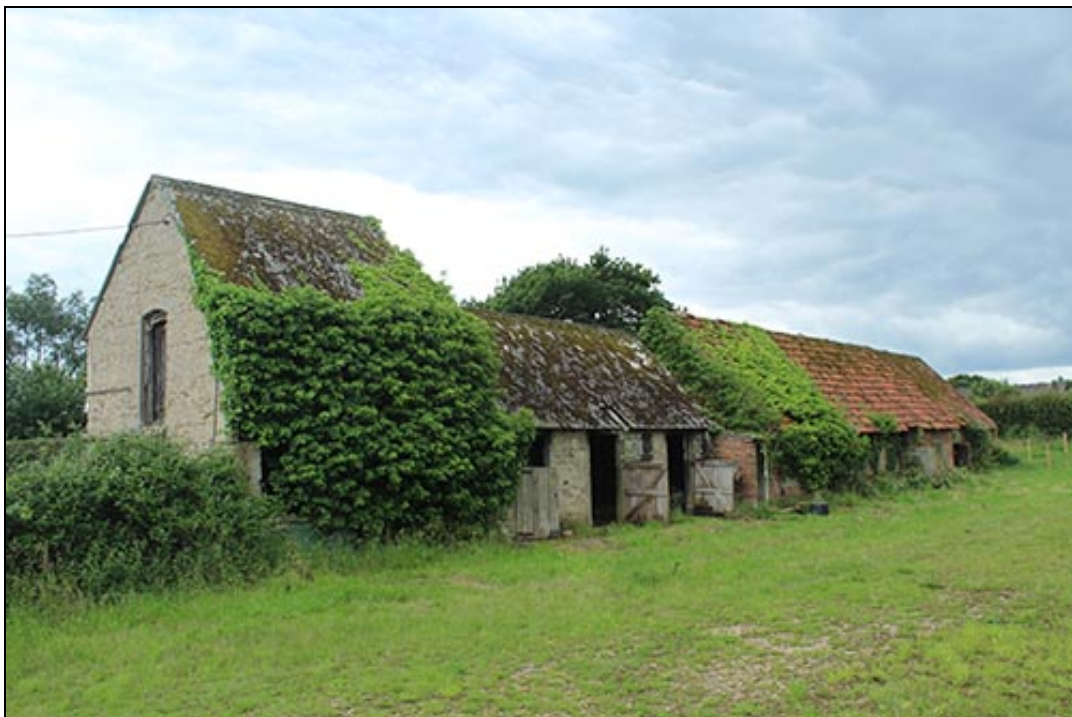
**Figure 30** The Stables and Large Store looking south-west

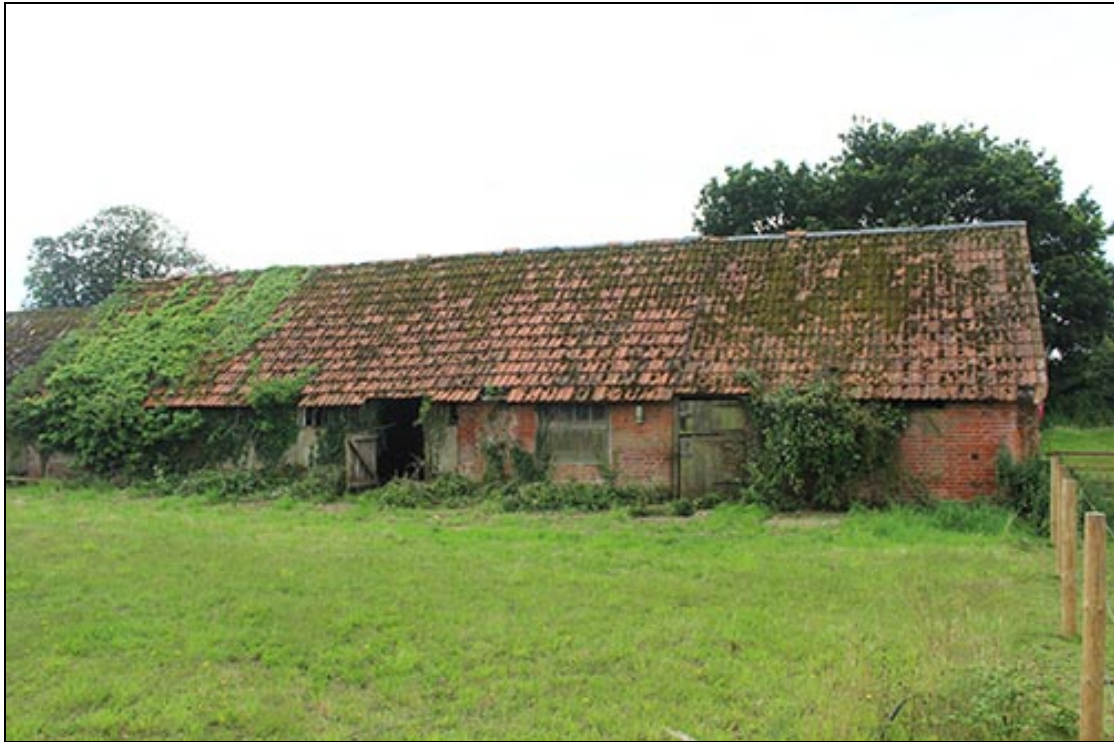
**Figure 31** The western end of the Stables, showing the earliest block (to the left) and the western extension of 1897–1907 (to the right)

3. At the western end of the original shelter shed, a second extension was added between 1897 and 1907, this time of three bays and entirely walled in brick using a rough Flemish garden wall bond. It had softwood kingbolt roof trusses, again covered with pantiles, with a large doorway (with window above) in its west end and a stable door and window on its north elevation. A low brick wall was built between the oak posts on the north elevation, possibly in response to the flooding to which the neighbouring yard is prone.

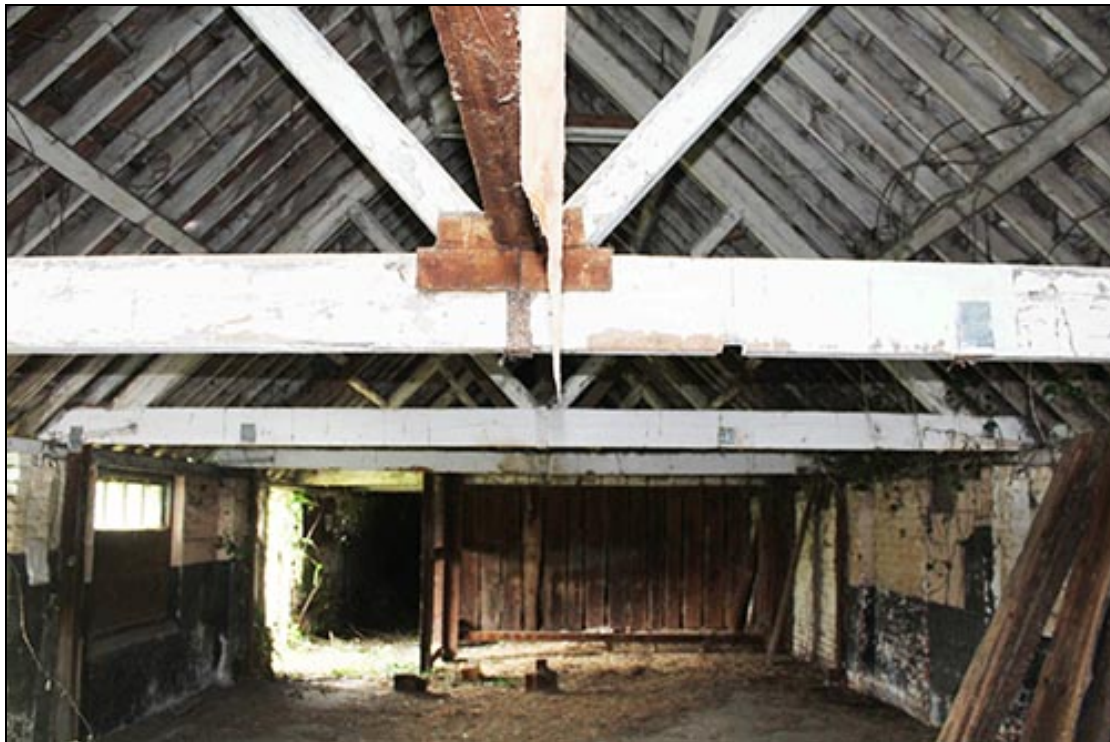
4. In the mid-20<sup>th</sup> century the eastern extension was demolished and replaced on the same footprint with a mass concrete-walled three-bay stable, with span of 5.25m and a corrugated sheet roof supported by softwood kingbolt trusses. At the other end, in the late 20<sup>th</sup> century, the roof truss at the junction between the original shelter shed and its western extension was replaced by a similar timber kingpost truss.

**Figure 32** The central and western blocks of the Stables, looking east
