Arboricultural Consultancy for Lloyds Bank

Insured	Mr Charles Southern	Address	3 Woodlands Avenue, Shrewsbury, SY5 8NG		
Client	Subsidence Management Services	Contact	Kyza Derby	Claim No.	IFS-LBG-SUB-20-0085780
ES Ref	SA-246106	Consultant	Giles Mercer	Contact No.	0330 380 1036
Report Date	05/08/2020

GEOTECHNICAL

Drainage Investigation Report

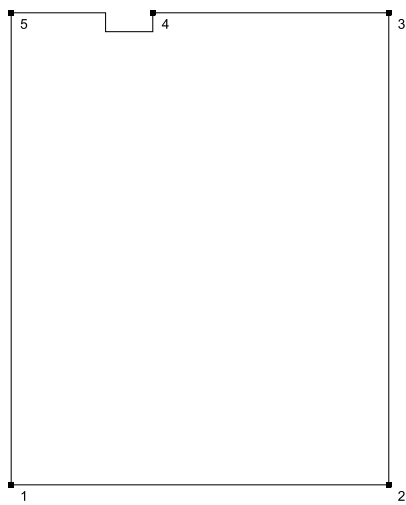
FRONT

The following image shows an isometric representation of the movement of the property, based on the Level Monitoring Stations that were installed.
