BS5837:2012 Tree Survey
Land adjacent to Crown Business Park
Old Dalby
Leicestershire
NGR SK686 138

Survey by
Christopher Barker CEnv dipHort AIEEM

Report prepared by: C Barker	Date Issued: January 2013
	Reviewed by: KB	Report Version: V1
	Report ref: P413 / 0113- 02	C B E Consulting Highbank, 5 Grantham Road, Navenby Lincoln. LN5 0JJ. Telephone (01522) 810086. www.cbeconsulting.co.uk

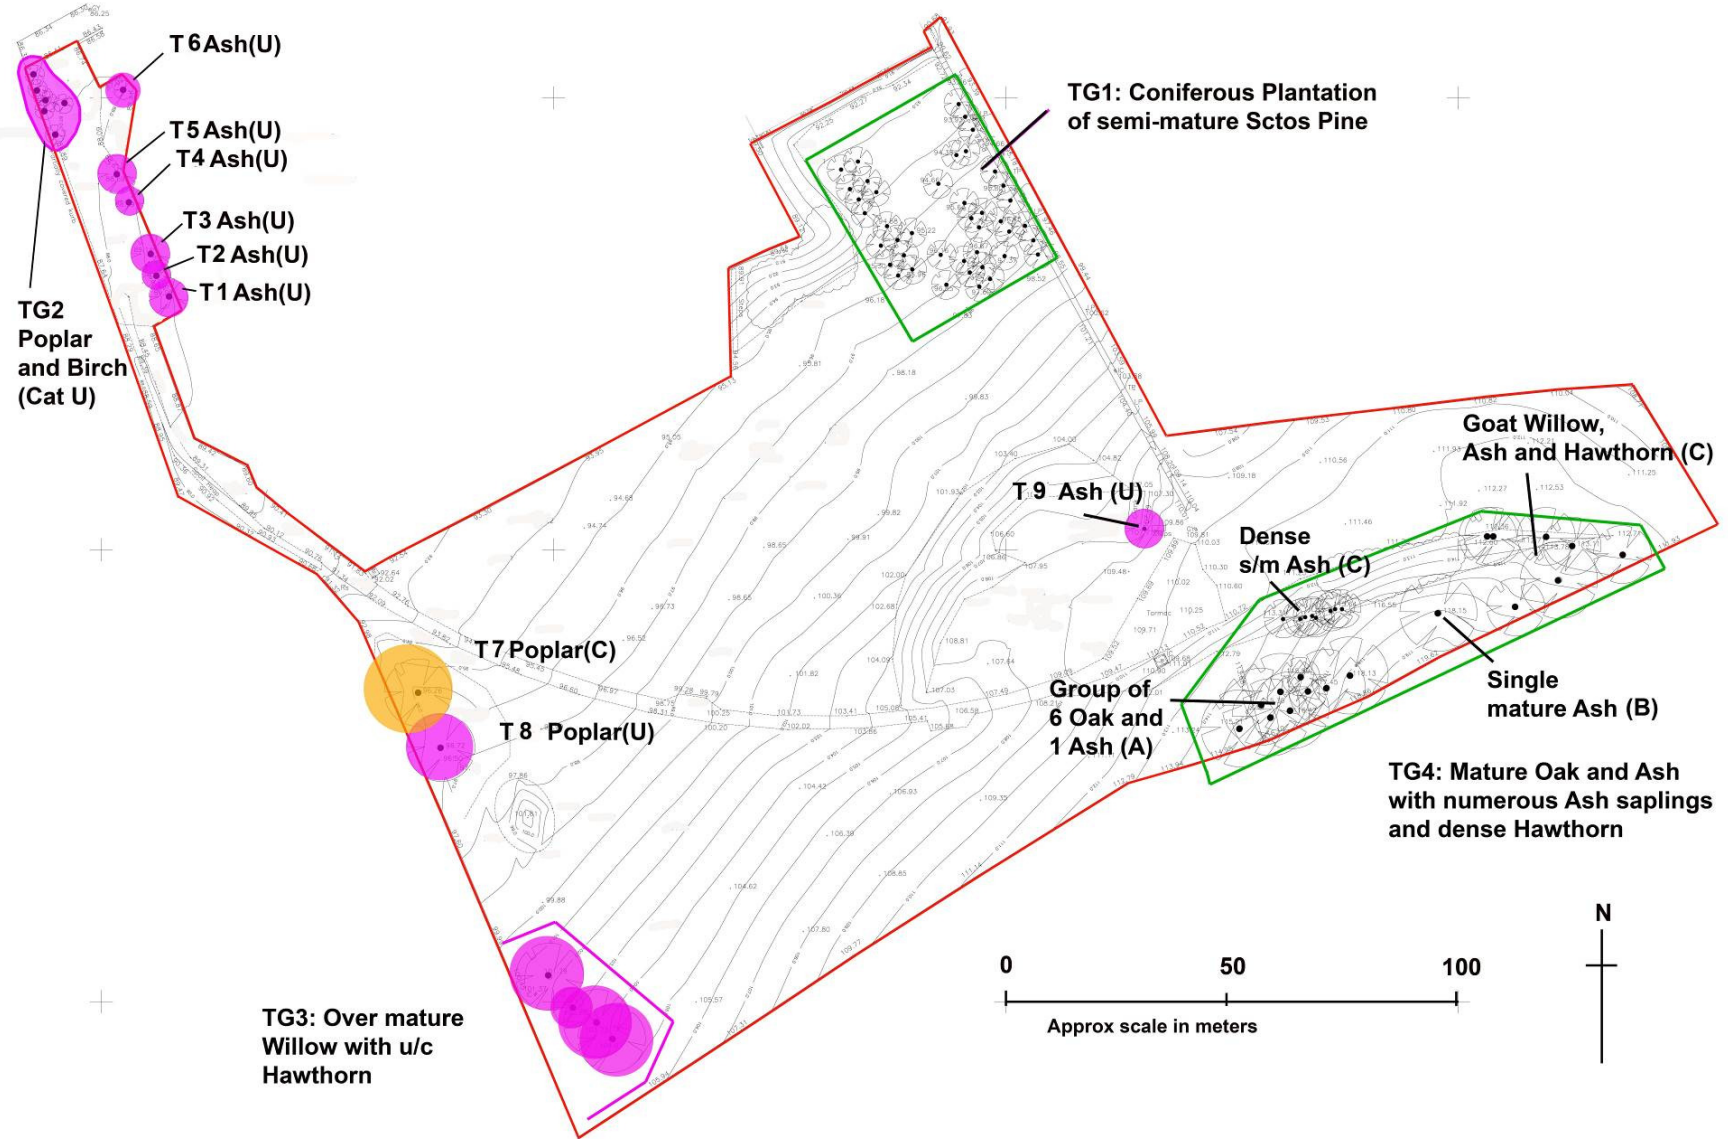
Tree T9 (centre)

Tree T9 is a small multi-stemmed Ash, probably coppiced and regenerating from this. This is a small tree that is not visually significant and not of high quality. This tree is placed within Category U.
