# Remedial design Interventions to The Old Chapel Residence

Date : 21/02/2022

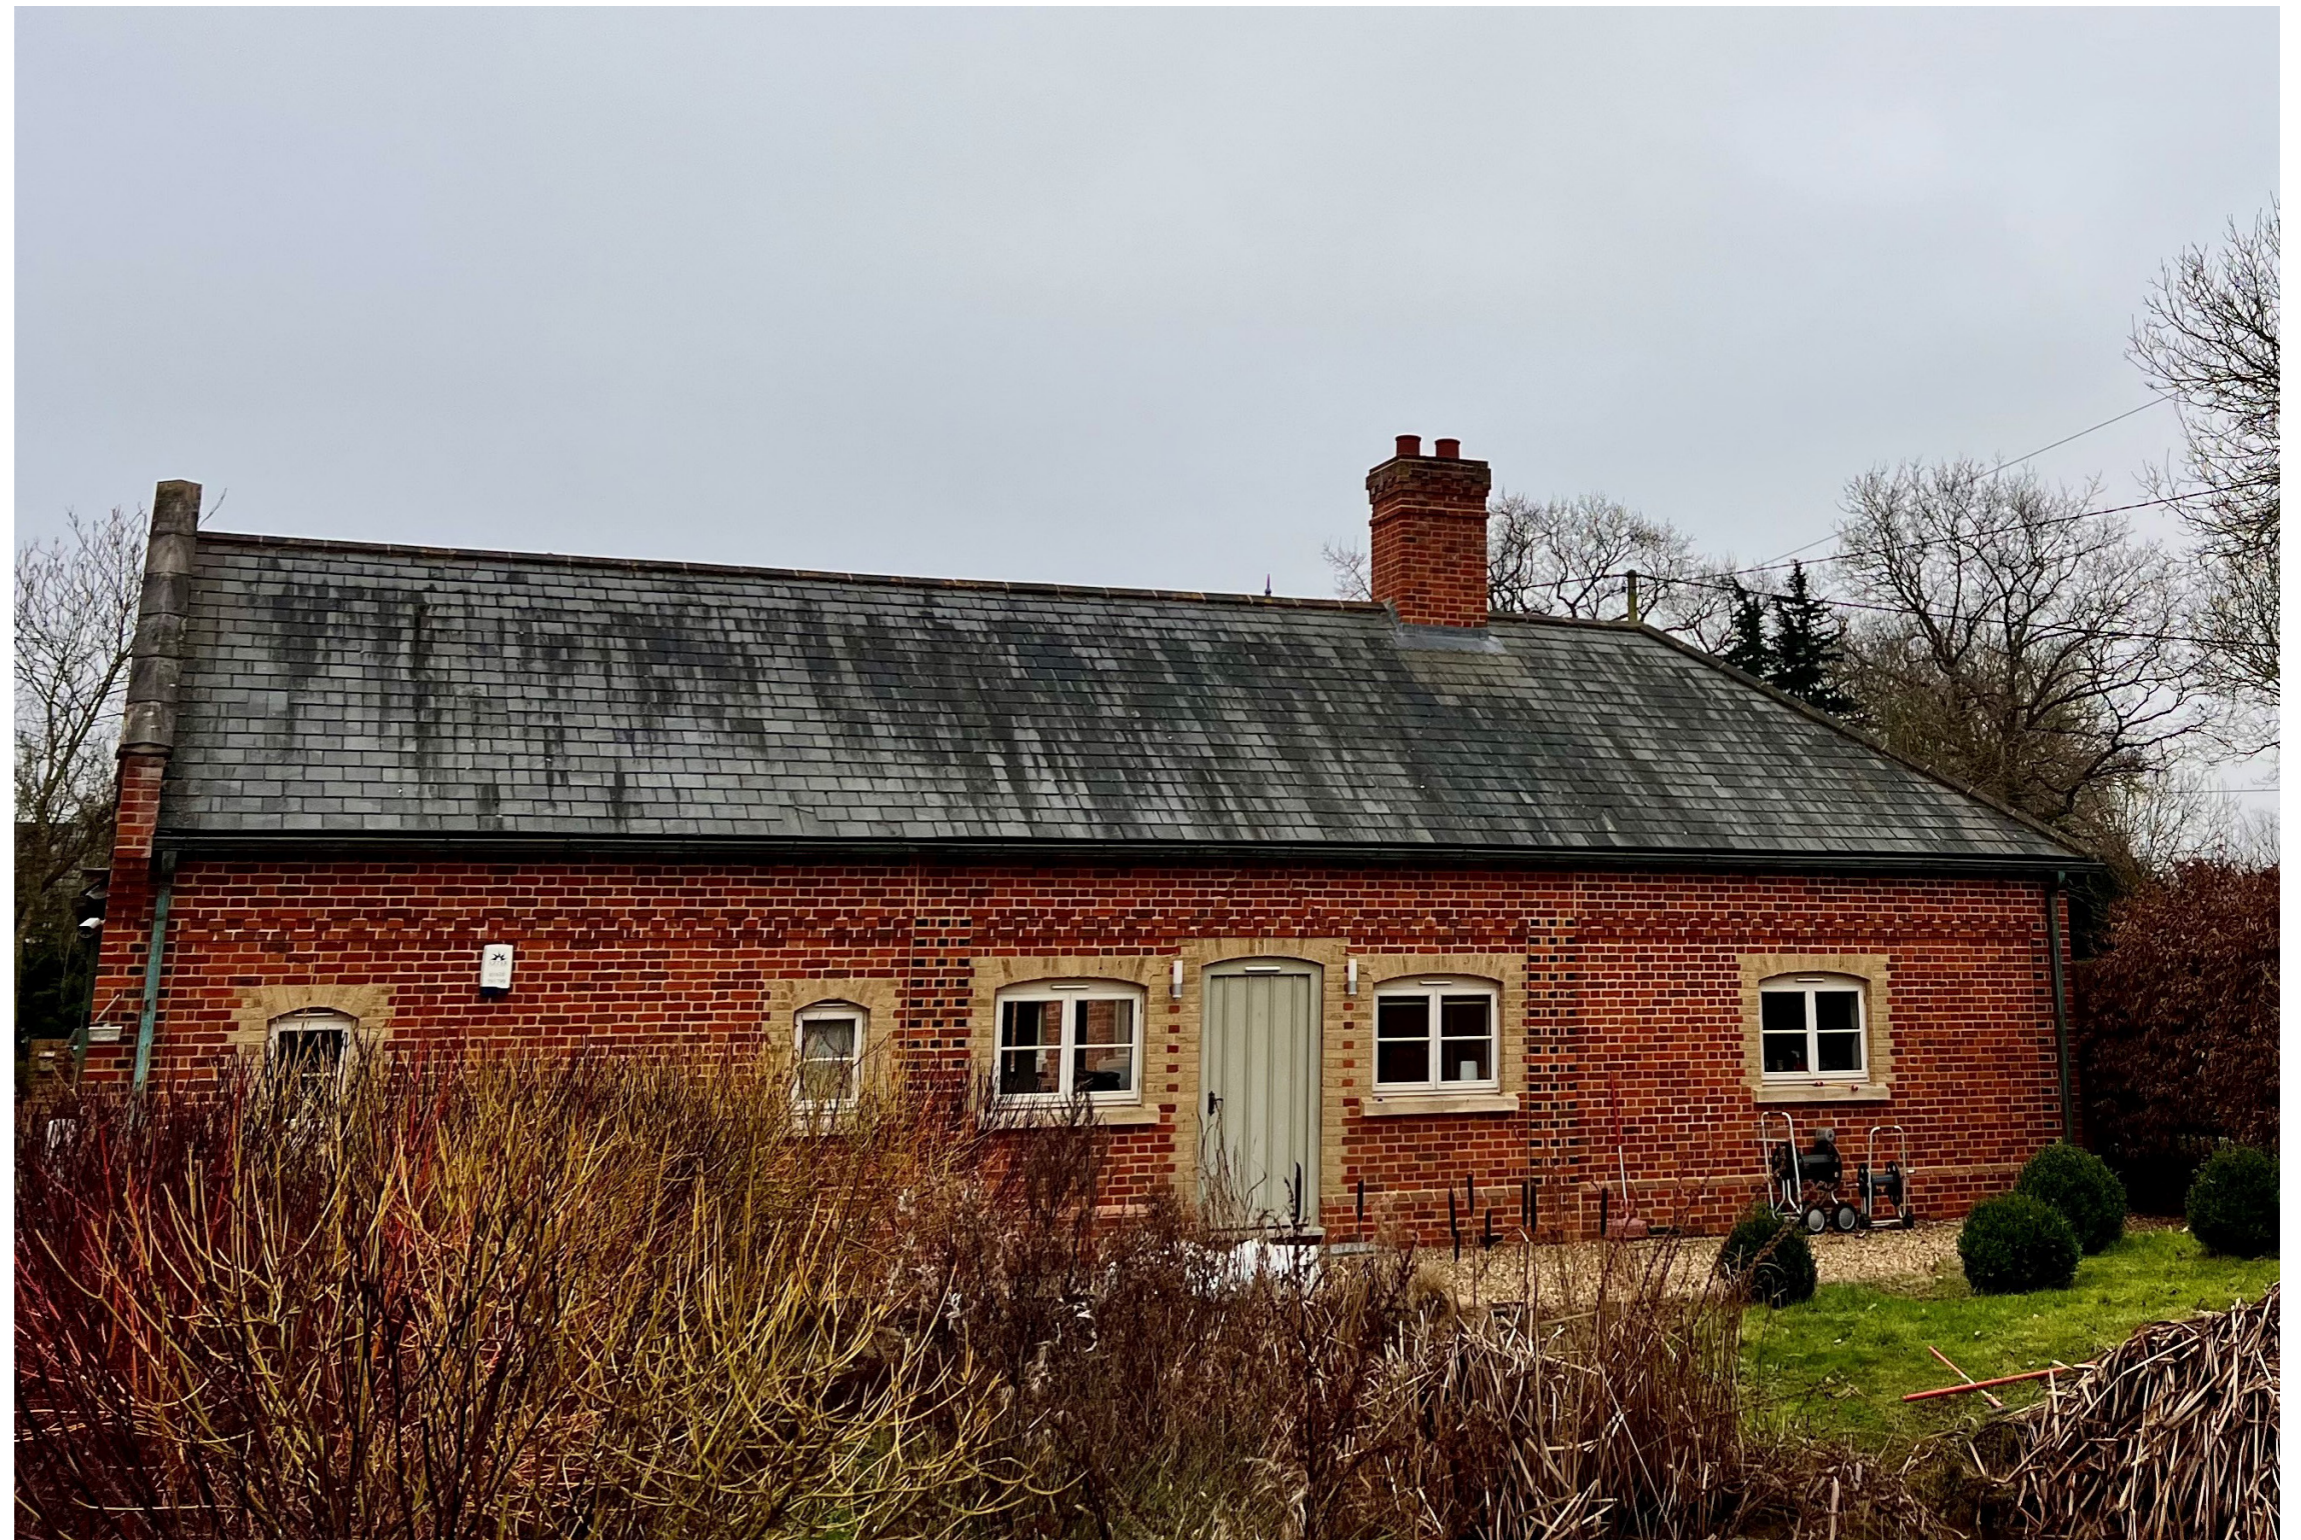
Front elevation

**South facing Glazed gable end**

The existing south facing Glazed gable end is formed of an Oak timber frame with fixed glass that is of inadequate construction quality. There are visible gaps that allow the ingress of water. Daylight gaps are visible at some junctions of mullions / posts.

In addition to the defects above, being south facing, this element is prone to high solar gain and discomfort in the central core of the home on both the ground and first floor zones.

The design interventions proposed are aimed to :

- Minimise solar gain within the home
- Improve ventilation within this area
- Install a superior quality more dependable glazing system that is structurally sound and secure against water ingress while also being airtight.
