### 1335 Swindon NEV

Technical Note No.38 Rv3: Condition 40 Flood Mitigation Strategy 3rd March 2022

Technical Note 40: Site Visit; Flood Risk Assessment 10<sup>th</sup> January 2022

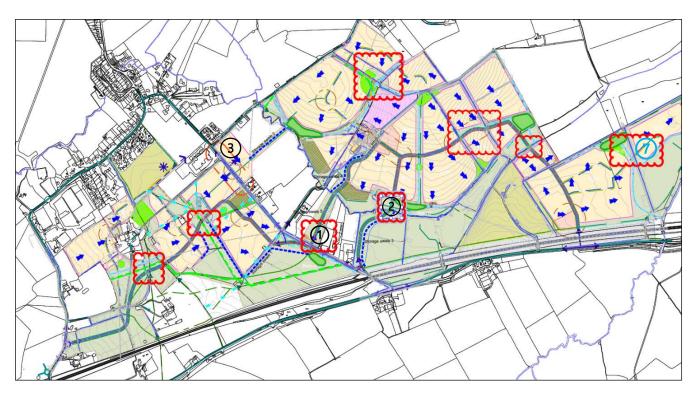
Figure 1 - Drainage Layout

- Revision clouds indicate areas that needed to be assessed.
- Numbers indicate location photo references.
