PHASE I GEO-ENVIRONMENTAL SITE ASSESSMENT

Land at Haverton Hill Road,
Billingham,
TS23 1PZ

Report Ref: 21-1063-r01
Date Issued: November 2021

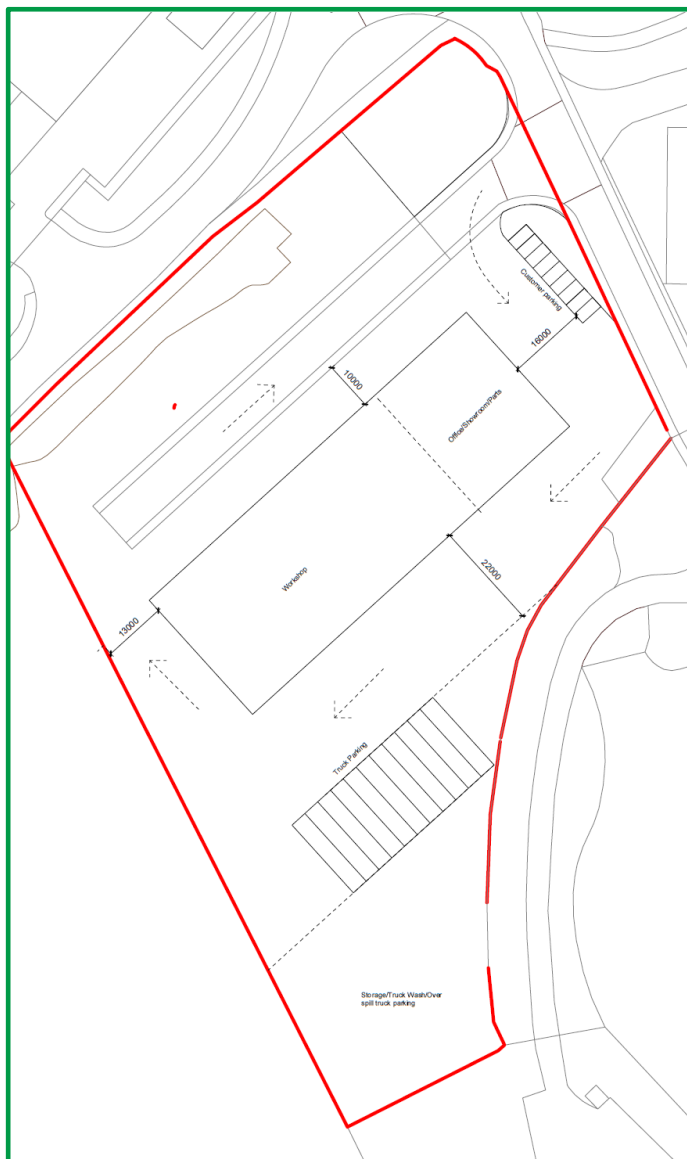
Figure 1.1 Snapshot of Proposed Development

ERGO understands that the client is considering redevelopment for the subject site for commercial use comprising vehicle workshop with office and showroom area, hardstanding yard areas for parking, storage and washing and buried service utilities infrastructure.

Drawing 21-1063-002 (Appendix III) identifies the proposed development layout. A snapshot of the proposed development is shown within figure 1.1 below.

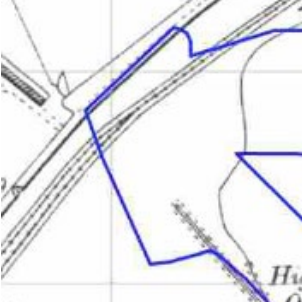
| MAP EDITION | HISTORICAL LAND USE | HISTORICAL MAP EXCERPT |
|---|--|---|
| <p>Pre 1897- Pre 1916</p> | <p>The site appears to have been reclaimed with from the River Tees. A tramway is noted to cross the northern site boundary A watercourse bisects the site and appears to have been partially culverted through the northern site area.</p> | |

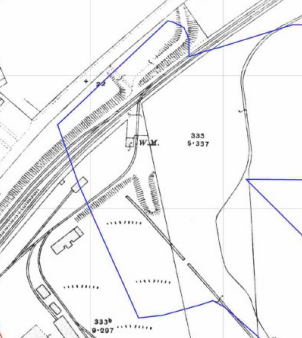
| MAP EDITION | HISTORICAL LAND USE | HISTORICAL MAP EXCERPT |
|---|--|---|
| <p>Pre 1916 – Pre 1939</p> | <p>Several areas of earthworks are now recorded in the northern and central site areas appearing to be associated with the expanding tramway network onsite. A weigh bridge structure is recorded in the central site area with a further unnamed structure noted on the western site boundary.</p> | |

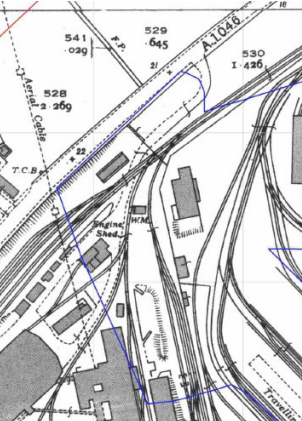
| MAP EDITION | HISTORICAL LAND USE | HISTORICAL MAP EXCERPT |
|---|--|---|
| <p>Pre 1939 – Pre 1975</p> | <p>The site appears to have been heavily developed, with numerous tramways and structures now recorded across the site. The structure formerly located on the western site boundary has expanded and is now noted to comprise an Engine Shed. A large structure is recorded in the south-western site area and is understood to comprise the ICI Chemical works Several additional structures of varying size are noted to be present onsite including an engine shed, overhead platform, tank and chimney.</p> | |

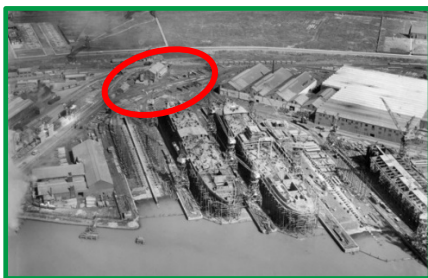
- The ICI Chemical Works previously processed Sulphuric acid which caused significant air pollution. Additionally, the site is understood to have produced phosphorus lights, Ammonium Nitrate, ammonium-based munitions and Uranium Hexafluoride products;
- It is understood the site may have undergone remediation via Phytoremediation under Teeside University;
- The site is shown below in 1950, showing the Furness shipyard; and,

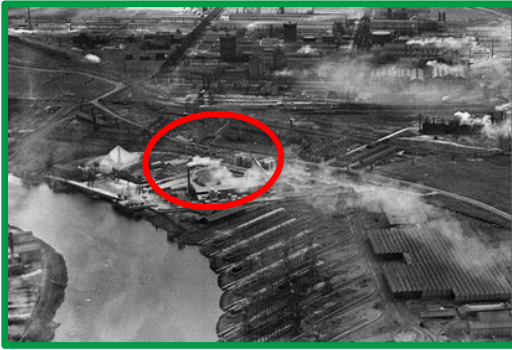
- The site is shown below in 1932, showing the ICI factory and shipyard.
