STRUCTURAL APPRAISAL

**Outbuildings
The Chequers Inn
Braintree Road
Felsted
Dunmow
Essex CM6 3DL**

Hawthorn Leisure

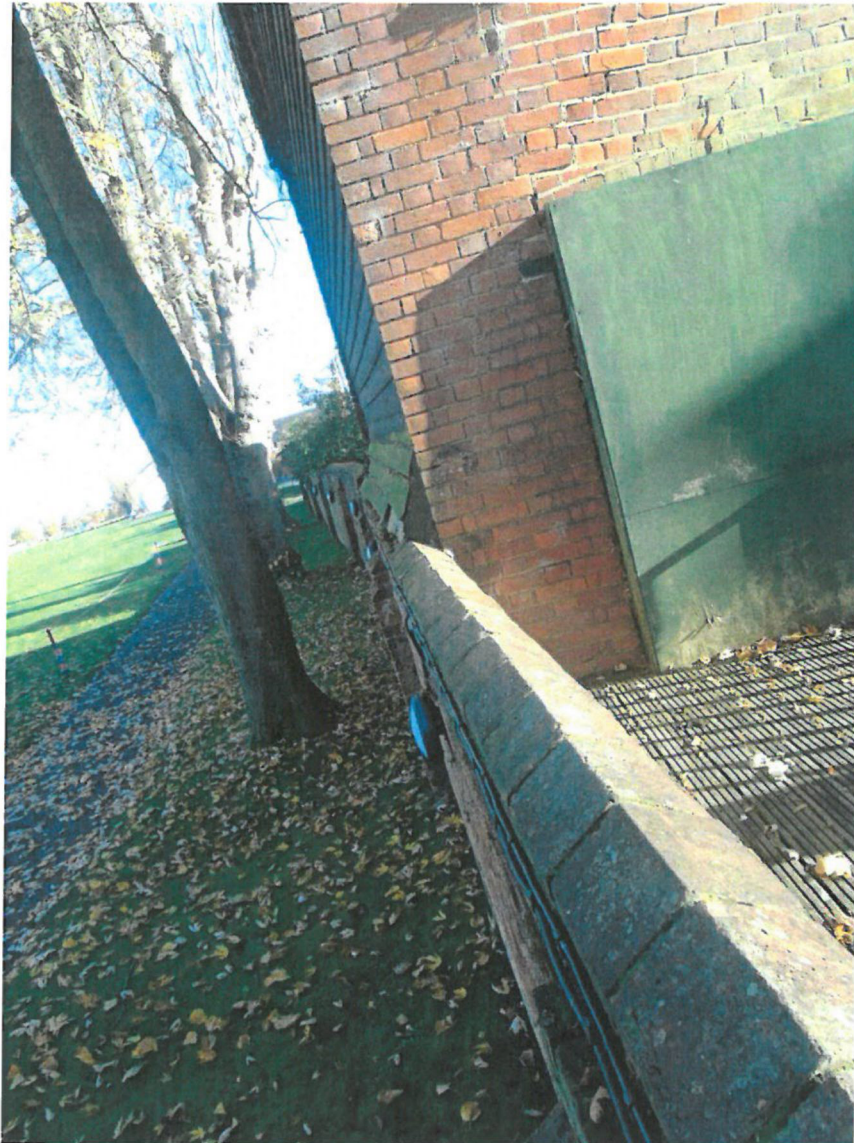
There is a row of mature trees on the edge of the sports field in close proximity to the left hand flank wall of the stables building.

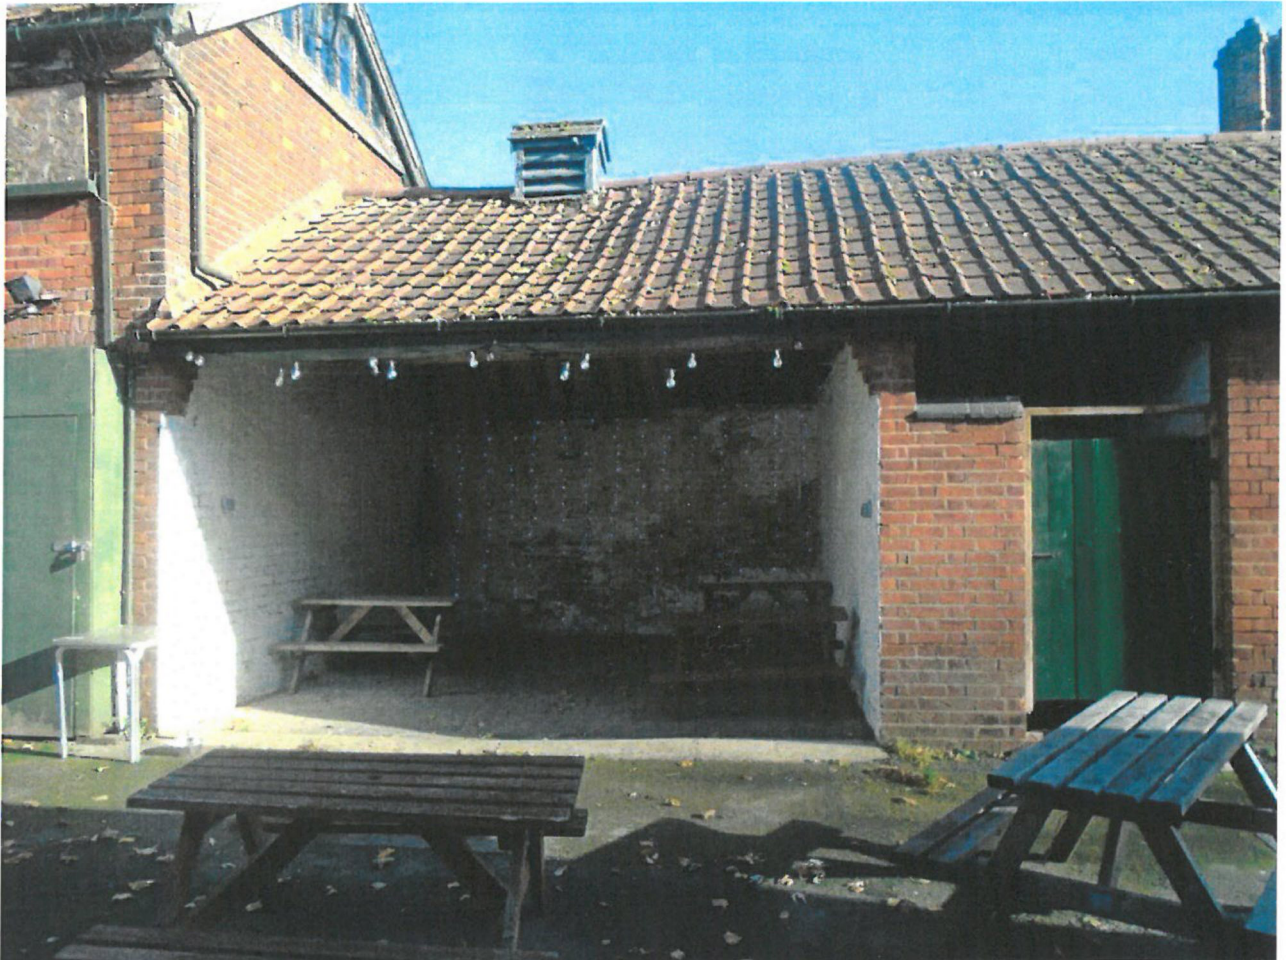
The roof pitches of the cart lodge have deflected as has the front beam over the opening. A study of the roof structure reveals that the original roof to consist of common rafters, purlins and collars. The purlins have deflected significantly

The roof structure has been strengthened with additional rafters placed alongside the originals to the rear pitch, replacement timber boarding, some strengthening of the front pitch rafters and two fabricated timber trusses / beams propping the ridge

With regard to the cart lodge, this shares a wall with the stables building. The roof requires replacement which will only leave a relatively small element of the building remaining. We consider that the cart lodge should also therefore be demolished.
