LDN Architects

Mains of Crommey - Planning Submission

March 2022

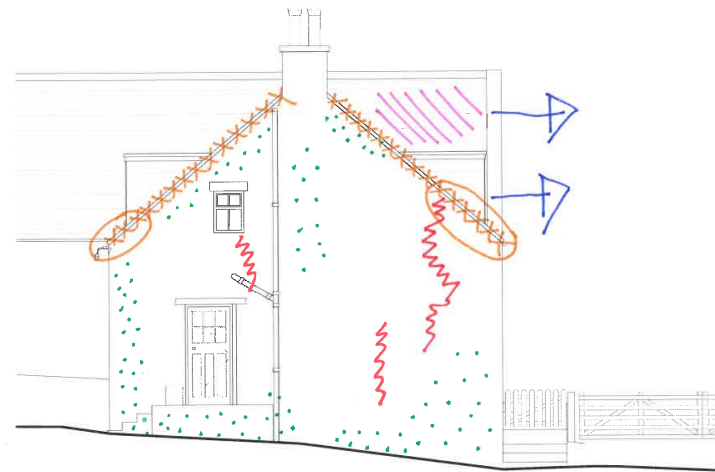
South Elevation

The walls are a mix of heavy 'stuck' cement pointing, numerous periods of cement repairs and some areas of original lime. In places the cement is heavily coated in biological growths which is an indication as to the level of moisture that is being retained within the walls.

There is extensive cracking running down through each of the elevations - an indication of movement and the level of deterioration (due to the high level of retained moisture within the fabric, a result of the level of deterioration).

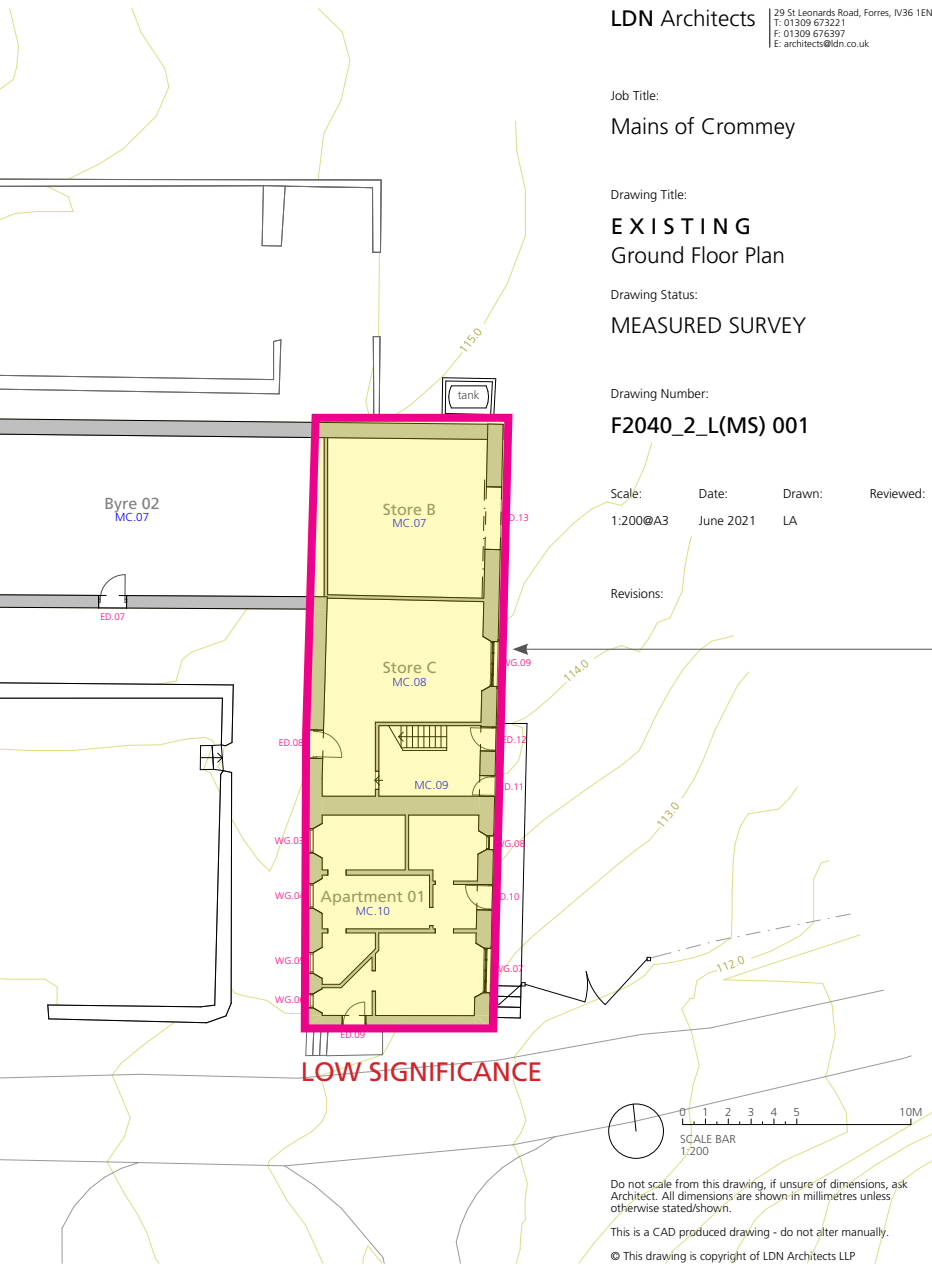
← Extent of proposed demolition
