# Inspection Report

Property address	8 Drummond Place
Membership No	412 785
Date of inspection	22/02/2022
Date of report	22/02/2022
Report prepared by	T Simmons

### 6.1 ROF1 Main roof

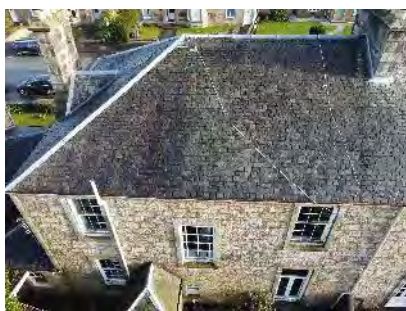
3

Ref	Element	Condition, defects present & recommended repair priority
6.1.1	<b>ROF 1 Pitched Surface</b>	<p>The pitched surfaces of the roof (ROF1 R1 – R5) are covered in Scot’s slate laid in diminishing courses.</p> <p><b>The condition of the Pitched Surfaces appears to be poor and these components are likely to require repair.</b></p> <ul style="list-style-type: none"> <li>• Slates have cracked and sections of slate are loose or have fallen away. Cracked slates reduce cover and can make the roof vulnerable to water ingress. IMG: 3, 6, 7, 13, 17</li> <li>• A number of slates upon the roof have fallen or slipped indicating that nail sickness may be an issue. Nail sickness or failure of the slate fixings can reduce cover and lead to water ingress. Falling slates also present a hazard to building users. IMG: 3, 6, 7, 13, 18</li> </ul> <p><i>Recommended Action</i>  <i>Replace cracked slates with units to match existing type and style. A comprehensive overhaul of the roof is required including the complete removal, redressing and reaffixing of the slate. Supplement existing slate with units of a matching type.</i></p>

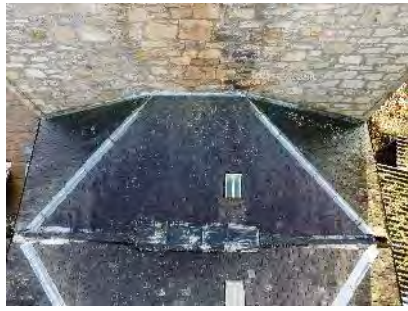
36

6.2.5	<b>ROF 2 Roof Lights</b>	<p>The roof light (RL2) is an original cast iron unit.</p> <p><b>The condition of the Roof Light varies and this component may require some maintenance or repair to avoid further deterioration.</b></p> <ul style="list-style-type: none"> <li>• The surface of the cast Iron has corroded. Corroded cast iron will ultimately fail leading to potential leakage. IMG: 36</li> <li>• The roof light has been repaired with flashing tape. Flashing tape is a temporary repair medium and has a limited lifespan, failure of the repair could mean leakage and associated decay. IMG: 36</li> </ul> <p><i>Recommended Action</i>  Remove rust from the cast iron rooflight and repaint to protect against future corrosion.  remove the flashing tape and make good the underlying condition of the roof light.</p>	2

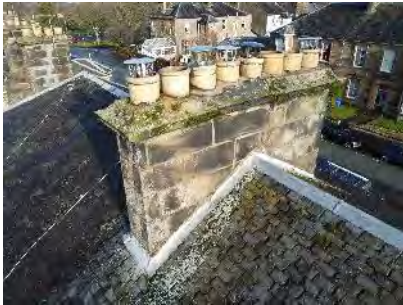
<p>23</p>

<p><b>The condition of the Chimney Stack varies and this component may require some maintenance or repair to avoid further deterioration.</b></p> <ul style="list-style-type: none"> <li>• Vegetation is growing upon the masonry of the chimney stack. Vegetation retains moisture which can accelerate decay. IMG: 23</li> <li>• Joints appear to have been repointed in an impermeable mortar. Impermeable pointing limits vapour transfer and can cause accelerated decay in adjacent masonry units. IMG: 23</li> <li>• The mortar within the joint has cracked and there are gaps between the pointing. Cracked mortar can make joints vulnerable to water ingress potentially leading to internal dampness and accelerated decay. IMG: 20</li> </ul> <p><i>Recommended Action</i>  Remove vegetation and treat with an appropriate herbicide to avoid future regrowth.  Monitor adjacent units for evidence of decay, if stone decay is occurring rake out impermeable mortar and repoint using a lime mortar.  Rake out cracked pointing from between masonry units within chimney stack and repoint using a lime mortar.</p>
