EXISTING

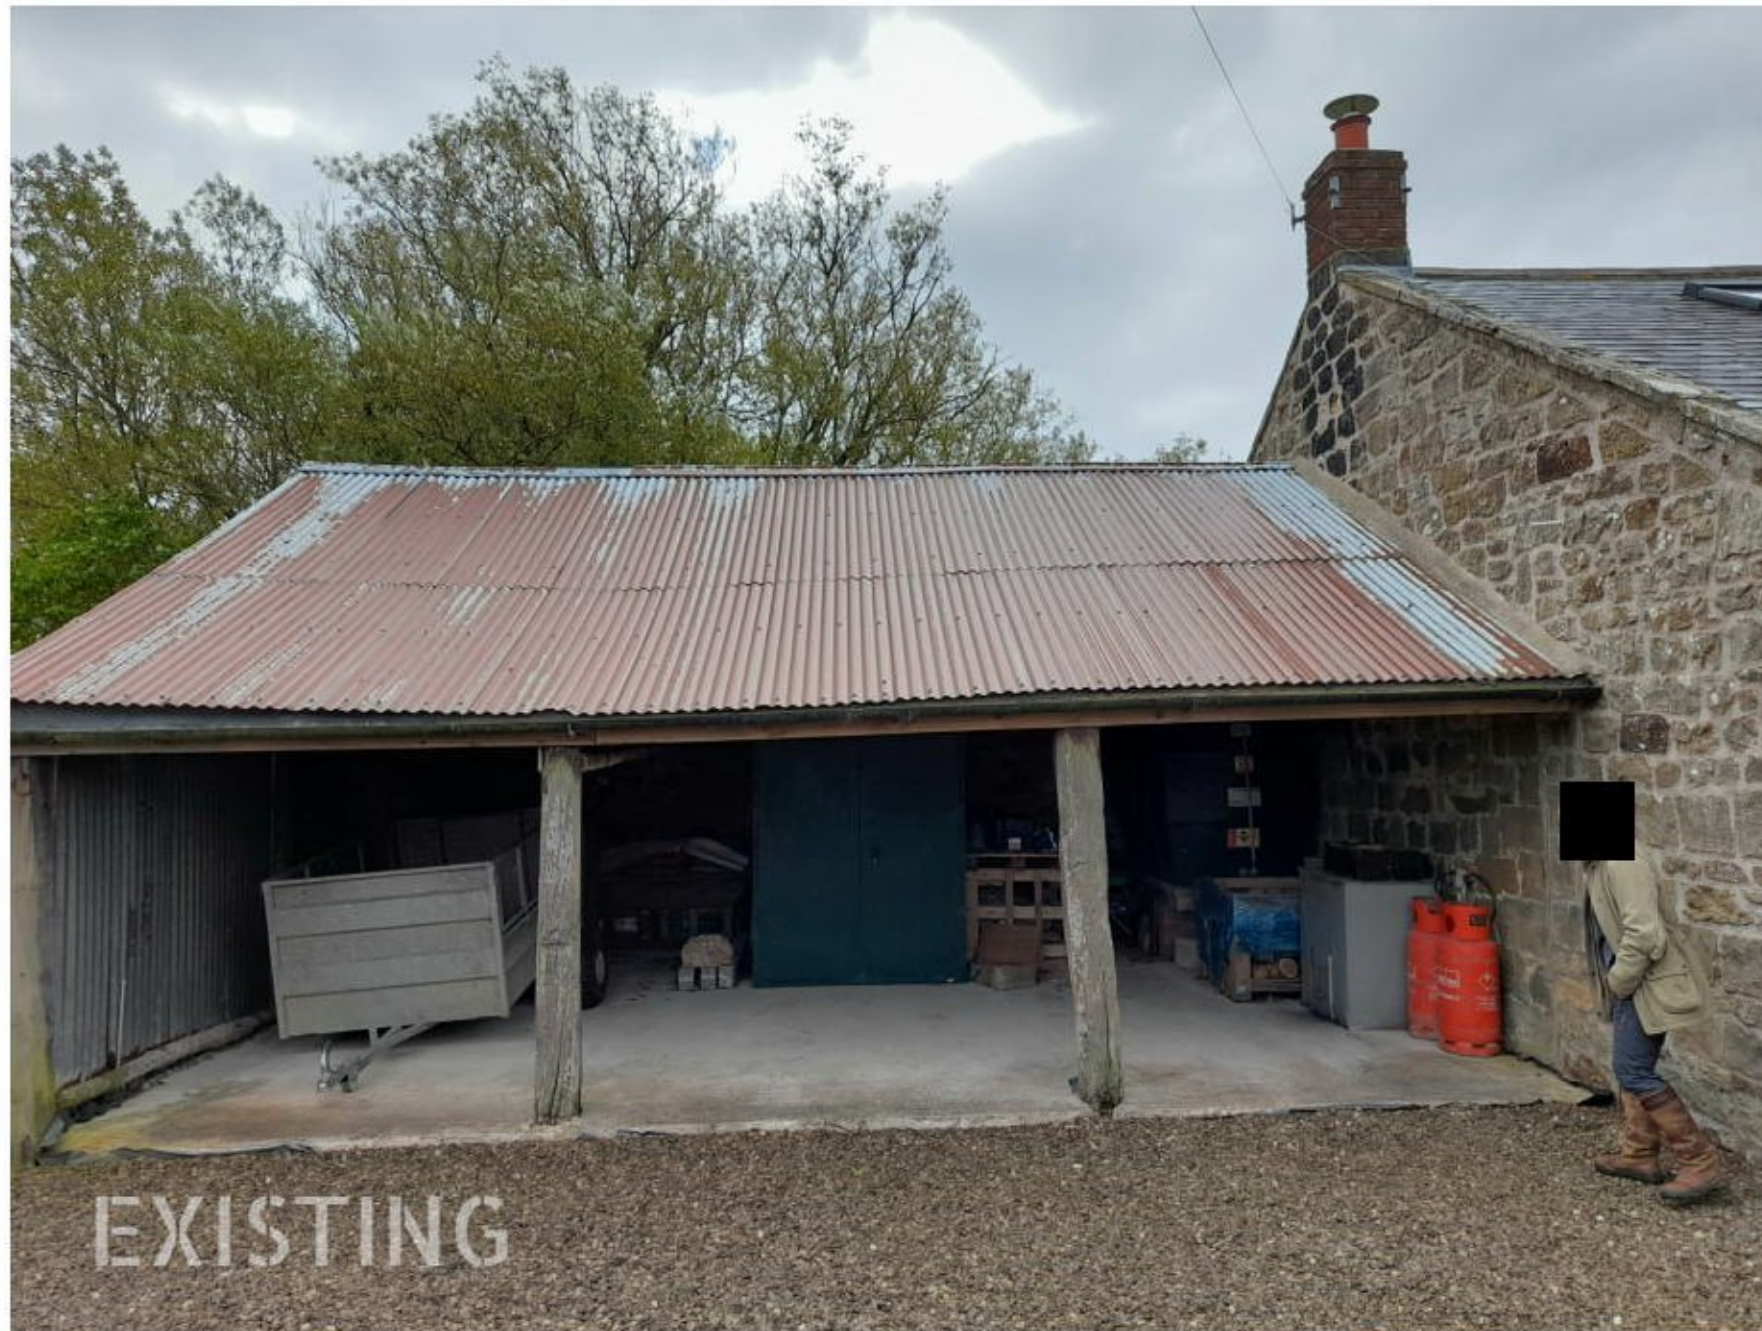
EXISTING TRACTOR LODGE HAS A CONCRETE FLOOR ON A PLASTIC DPM. STONEMWORK SHOWS STRUCTURAL CRACKS TO BACK WALL. ROOF BOWING AND SHOWING CORROSION TO METAL CORRUGATED SHEET. TIMBER COLUMNS CRACKED AND WITH EVIDENCE OF ROTTING AT GROUND LEVEL.
