The Old Cottages, Thrandeston.

Having completed the first phase of works during June 2022 we removed the final sections of render to clarify the extent of the remaining works. These are numbered 2, 4, 5, 6, 7 & 8 below.

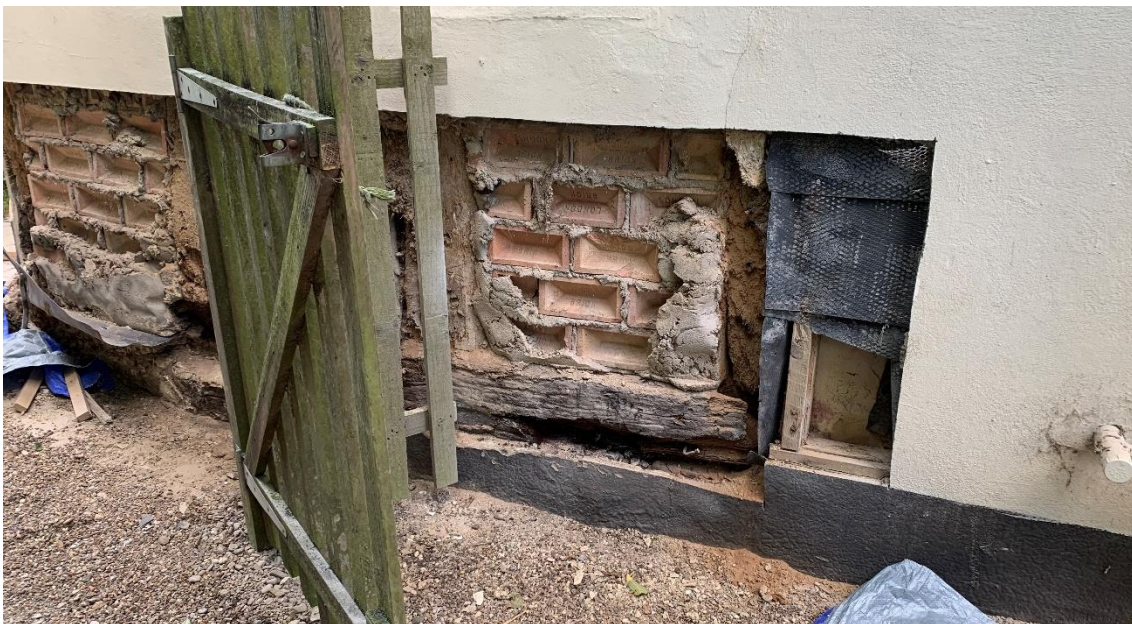
7 & 8. We propose to fit an entirely new length of oak sole plate from the SE corner post (6) through 7 and up to point 8. We had hoped to retain the section shown at 8 but it is in poor condition and replacement will give a stronger end result, assisting the critical corner point. It will be approx. 3m x 200mm x 150mm copying the existing timber and for it to be packed up underneath with a coarse mortar mix. Two of the three studs are to be repaired with simple patches to the outer face using air-dried oak. We will also trim the modern DPC so that it isn't in contact with any historic timbers.
