Arboricultural Report

Principle Formal Arboricultural Report/Survey
(in accordance with BS 5837:2012 Trees in Relation to Design,
Demolition and Construction)

Location: Coleby Lodge Farm, Heath Road,
Coleby, Lincoln LN5 0AR

Date: 22nd August 2019

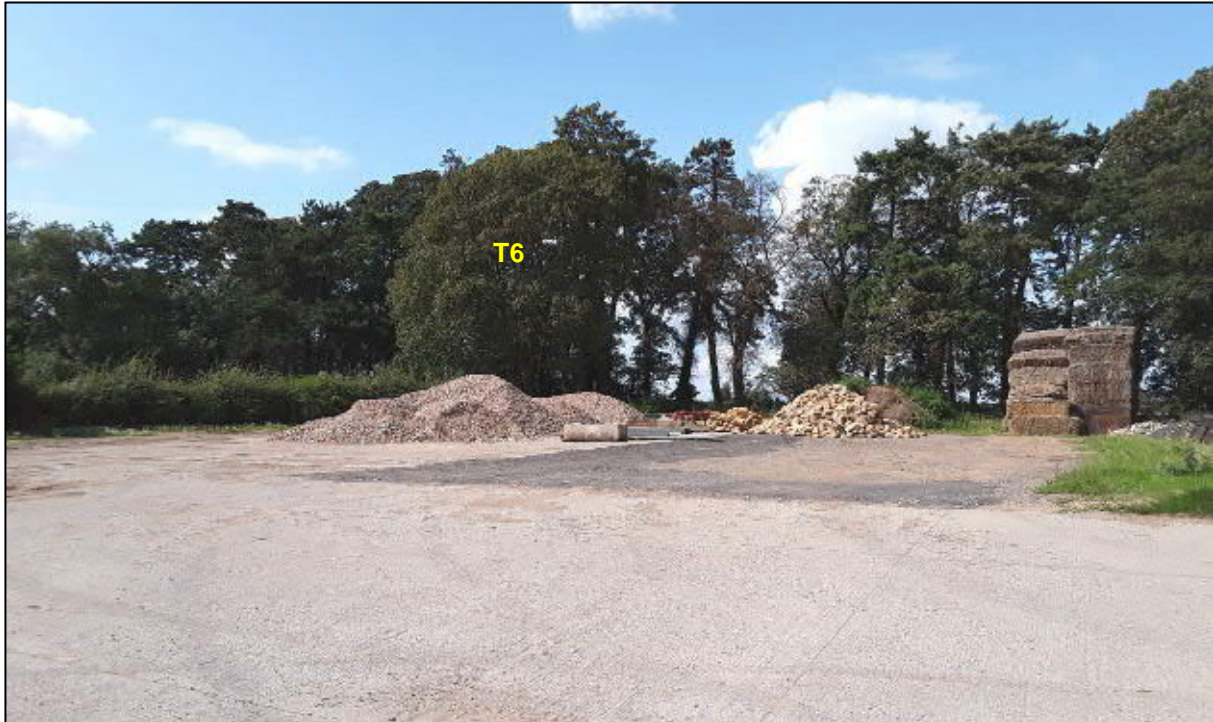
7.3 Photos

A shelter belt of mature trees wrap around the existing farm yard site on the north side and part of the west side

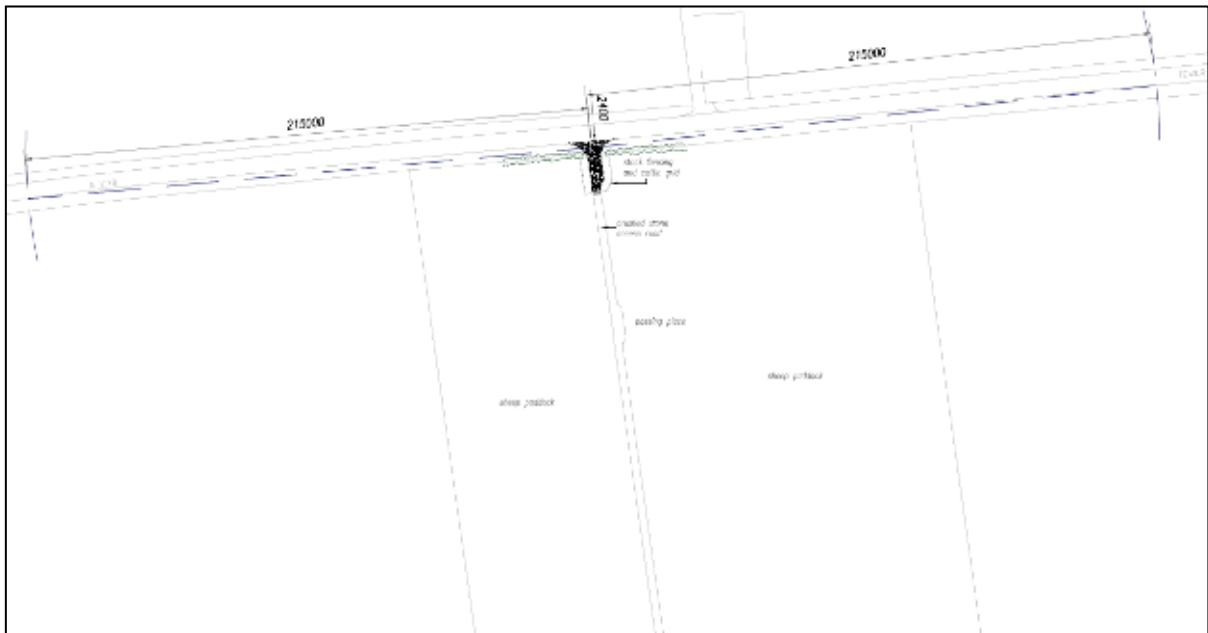
Image source: © Flare Visual Ltd. (2019) - Proposed development at Coleby – Visibility splays – Dwg. No. F2913-01

8.7 In accordance with the proposed access arrangement a short section of hedgerow, H2, will require removal. The maximum length proposed for removal to facilitate the access and visibility splays is 20m. Two sections of hedgerow, approx. 60m and 112m respectively, are proposed to be retained along the northern field boundary.

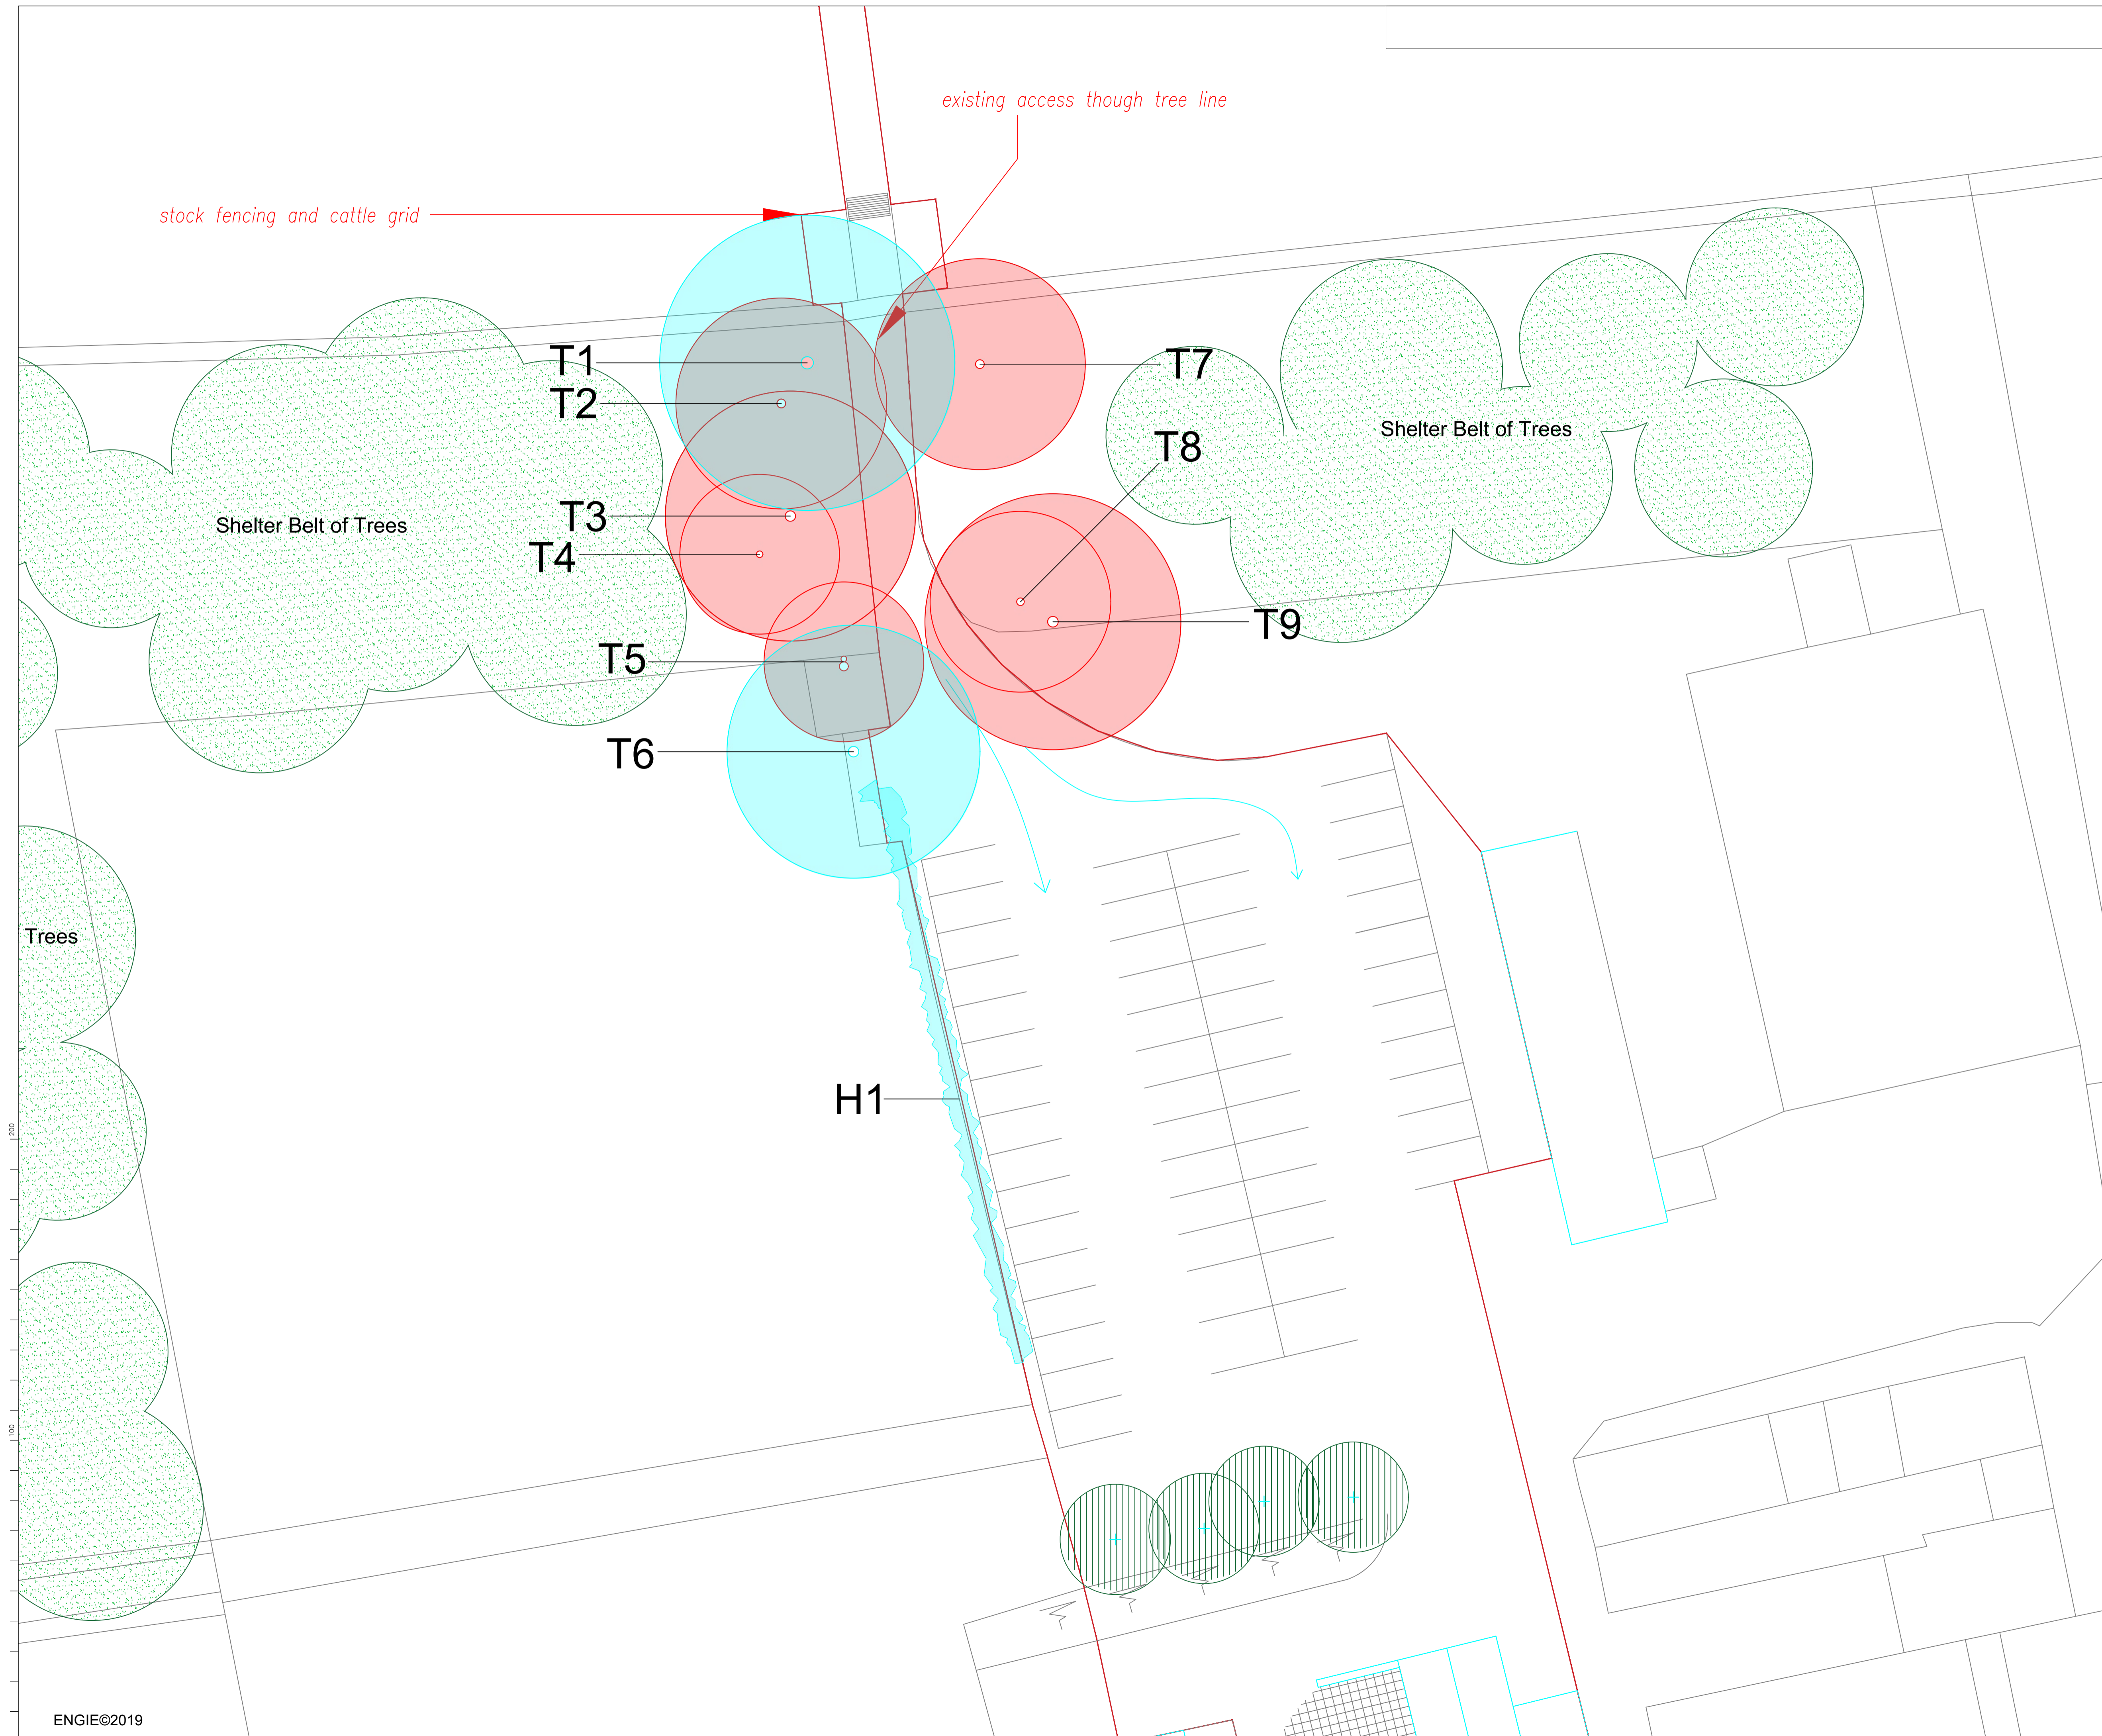
CLIENT	C A Mottram & Sons	
PROJECT	Coleby Lodge Farm, Heath Road, Coleby, Lincoln LN5 0AR	
TITLE	Tree/Hedge Retention & Removal Plan (South)	
DRAWN	DJM	CHECKED AH
DATE	22nd August 2019	APPROVED AH
FILE REF	AH-ENGIE	SCALE 1:200
	DRAWING NO. TRRP-06-220819	REVISION NO.

7 individual to be removed in order to facilitate development and in accordance with good arboricultural practice

H2 - 20m section to be removed

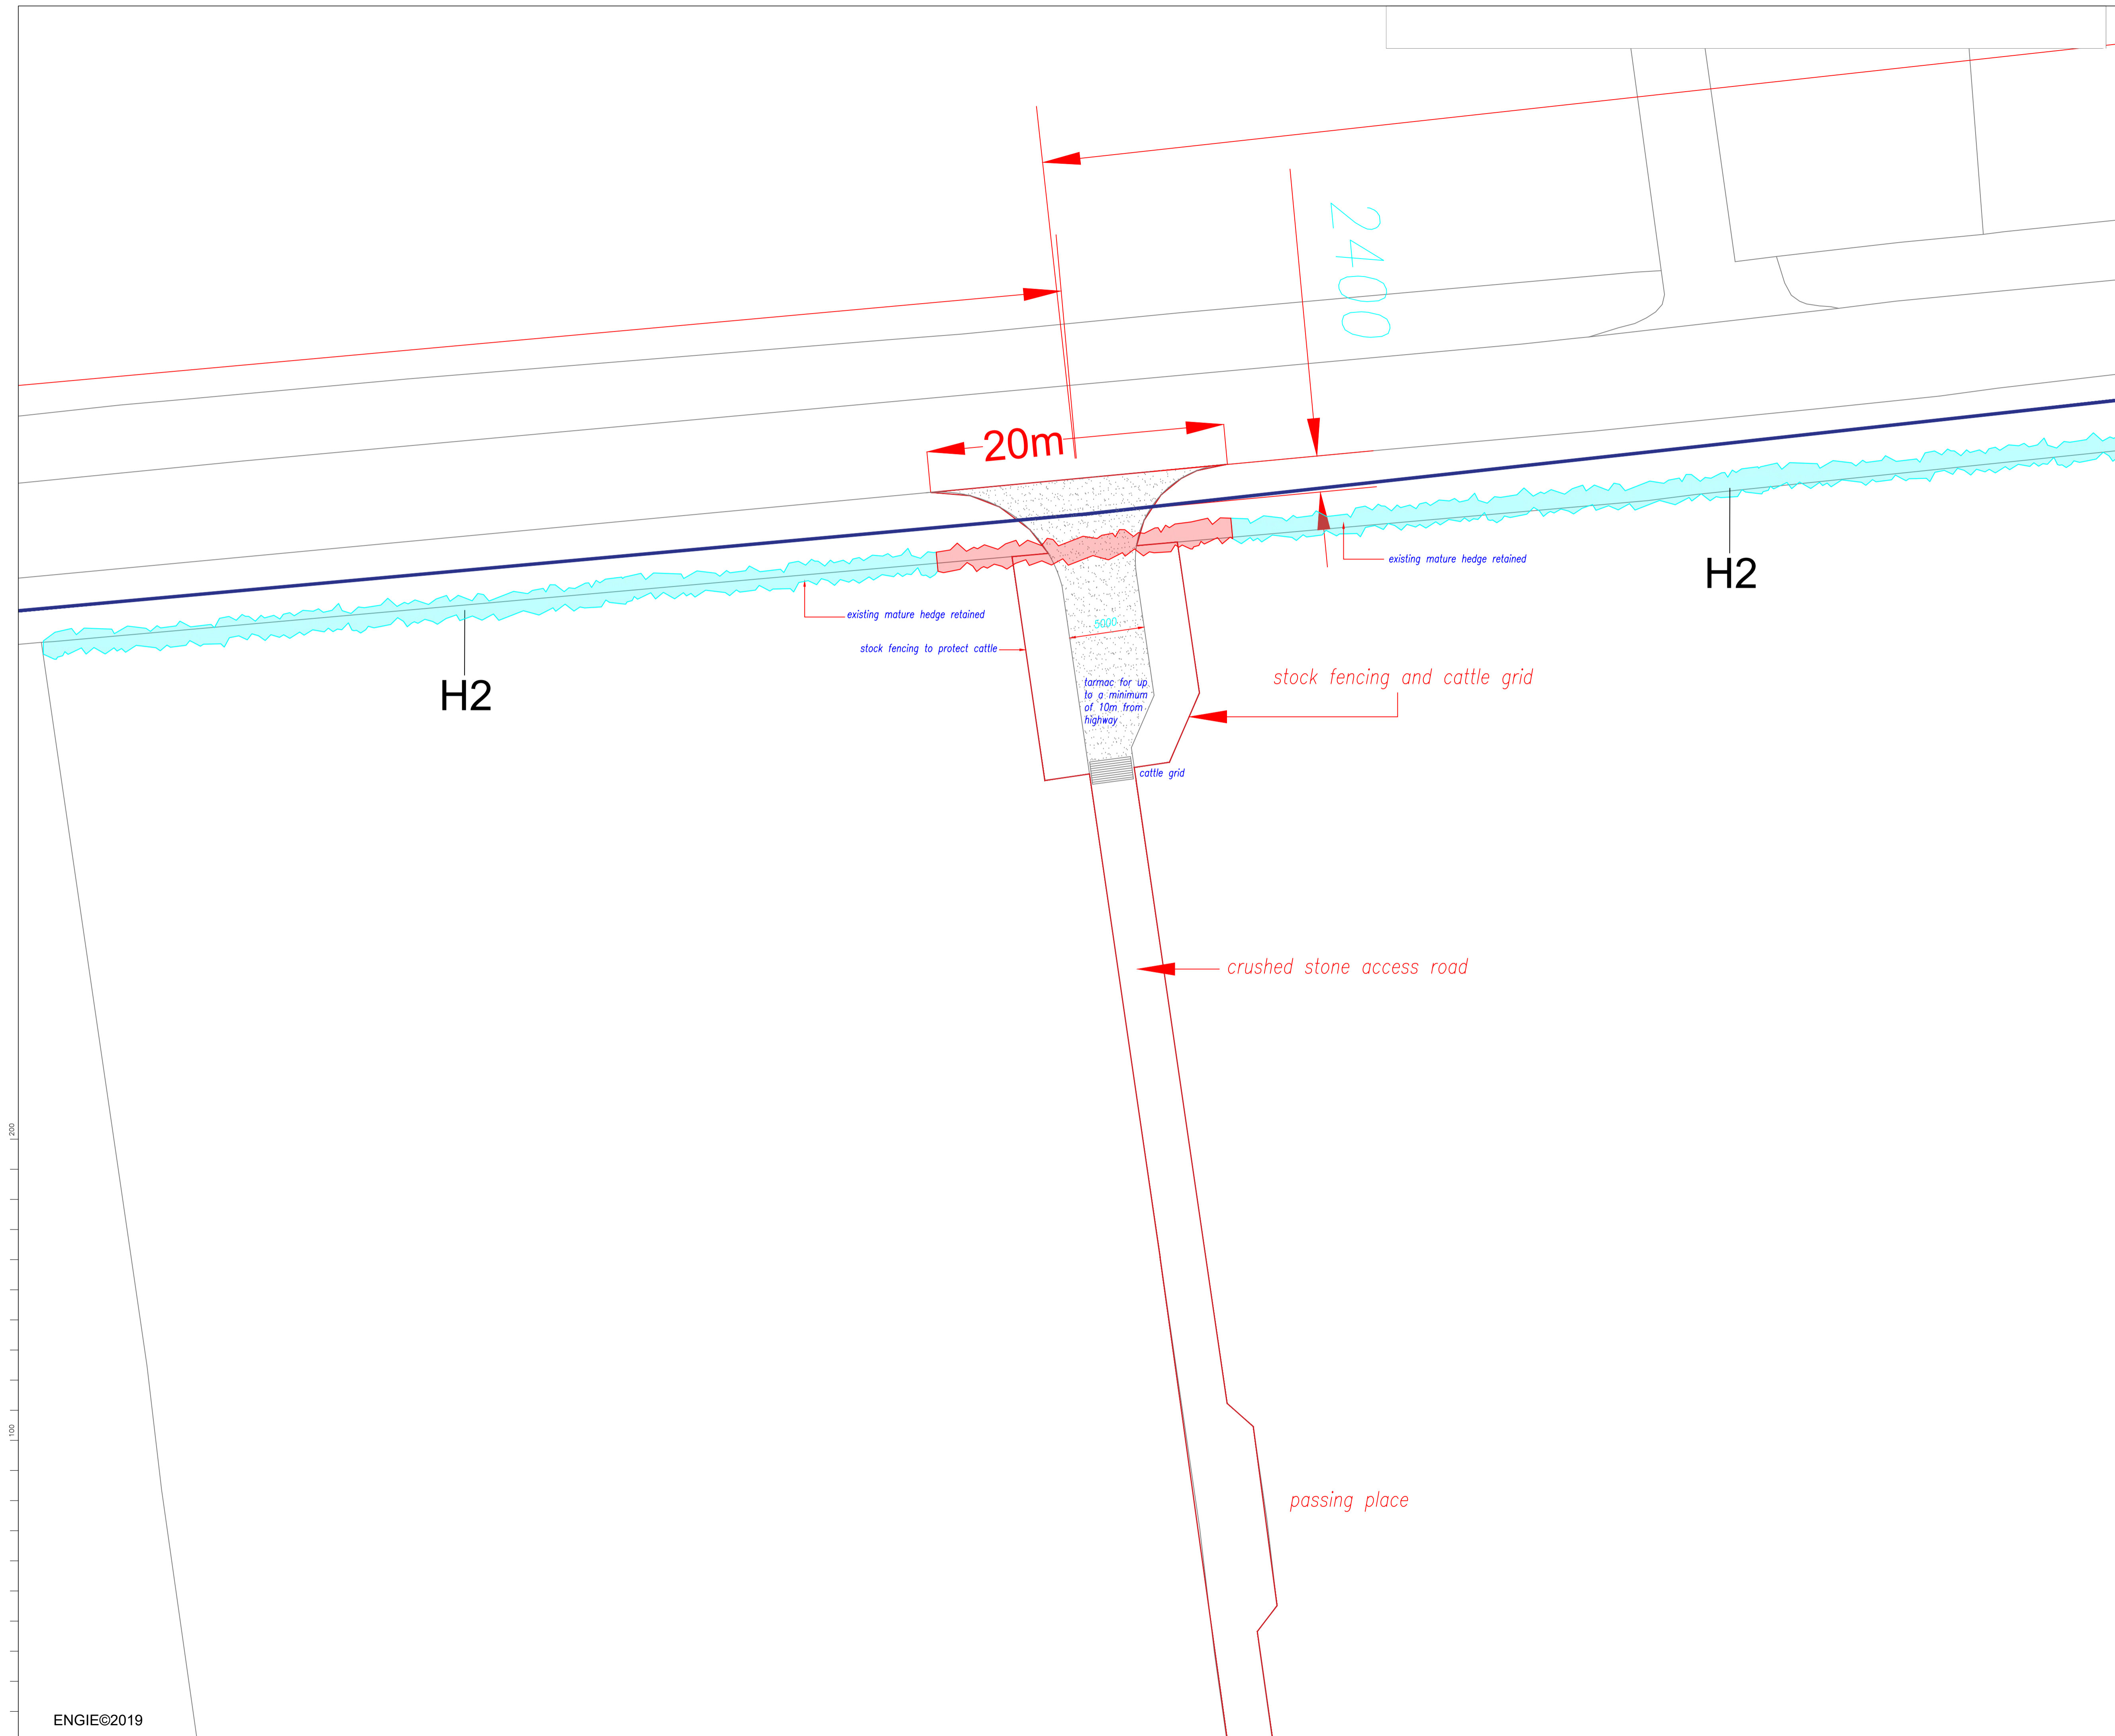
CLIENT	C A Mottram & Sons	
PROJECT	Coleby Lodge Farm, Heath Road, Coleby, Lincoln LN5 0AR	
TITLE	Tree/Hedge Retention & Removal Plan (North)	
DRAWN	CHECKED	APPROVED
DJM	AH	AH
DATE	ORIGINAL SIZE	SCALE
22nd August 2019	A1 (594 x 841)	1:200
FILE REF	DRAWING No.	REVISION NO
AH-ENGIE	TRRP-07-220819

7 individual to be removed in order to facilitate development and in accordance with good arboricultural practice

H2 - 20m section to be removed

T1 - Pine - Sever ivy at base and remove first 6m. Re-inspect. Clean out any dead, diseased, crossing, duplicating branches.

T6 - Sycamore - Sever ivy at base and remove first 6m. Re-inspect. Clean out any dead, diseased, crossing, duplicating branches. Remove lowest branch north at 2.5m and lift canopy east and south up to 6m above ground level.
