## PHASE I GEO-ENVIRONMENTAL SITE ASSESSMENT

Land North West of Tollgate House,  
Barrington Road,  
Bedlington,  
NE22 7AP

Report Ref: 21-1085-r01  
Date Issued: April 2022

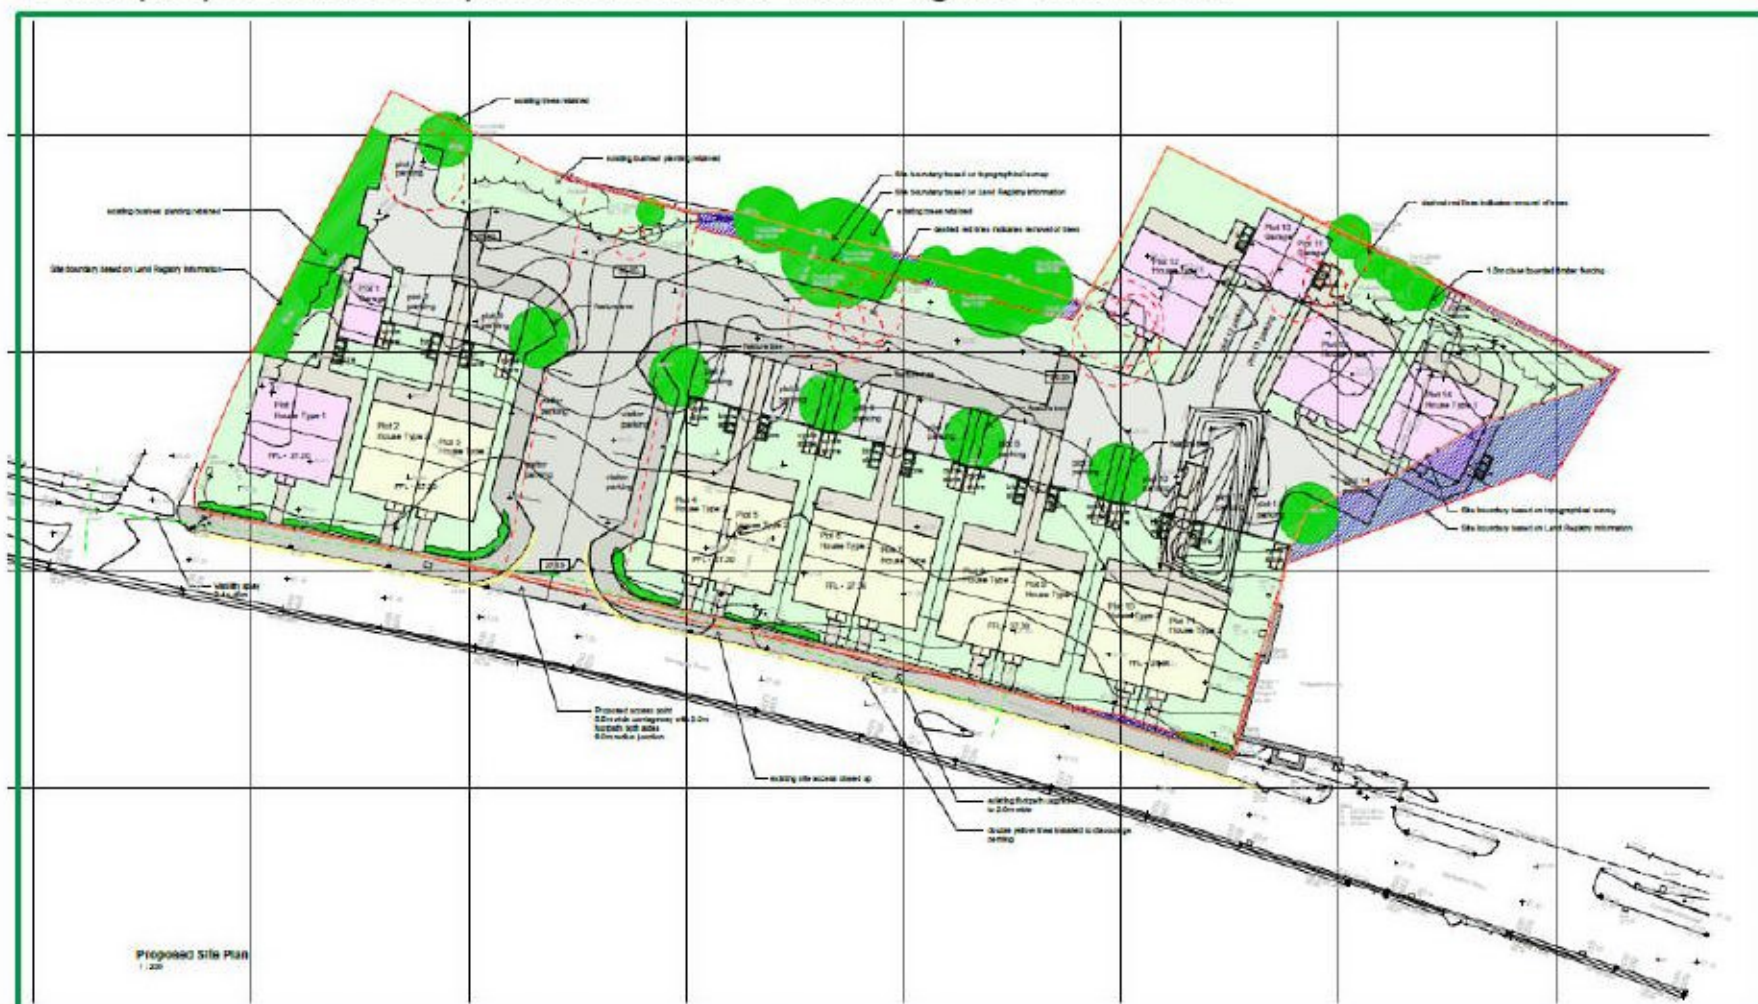
Figure 1.1 Snapshot of Proposed Development

ERGO understands that your Client intends to develop the subject site for a low rise residential end use. The proposed development is understood to comprise up to 16no. detached and semi-detached houses with associated estate roads, driveways, gardens and infrastructure.

Drawing 21-1085-002 (Appendix III) identifies the proposed development layout. A snapshot of the proposed development is shown within figure 1.1 below.

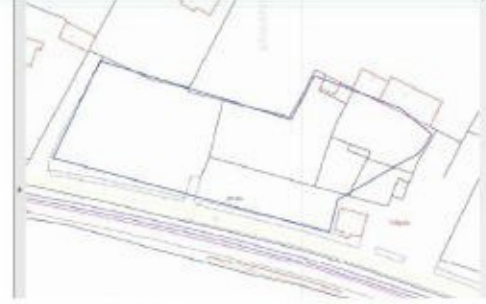
| MAP EDITION | HISTORICAL LAND USE | HISTORICAL MAP EXCERPT |
|---|---|--|
| Pre 2003-<br>Pre 2010 | Further reconfiguration of fence lines has occurred separating the west and eastern areas of the site.<br>The western area of the site now comprised multiple fence lines and 2No. structures partially straddling the northern boundary. | |

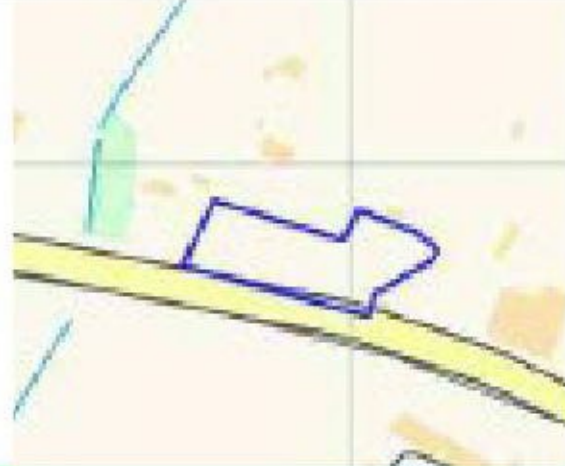
| MAP EDITION | HISTORICAL LAND USE | HISTORICAL MAP EXCERPT |
|---|---|--|
| Pre 2010-<br>Present | Fence lines are no longer depicted within the site boundary. Buildings are no longer present on the northern boundary. | |

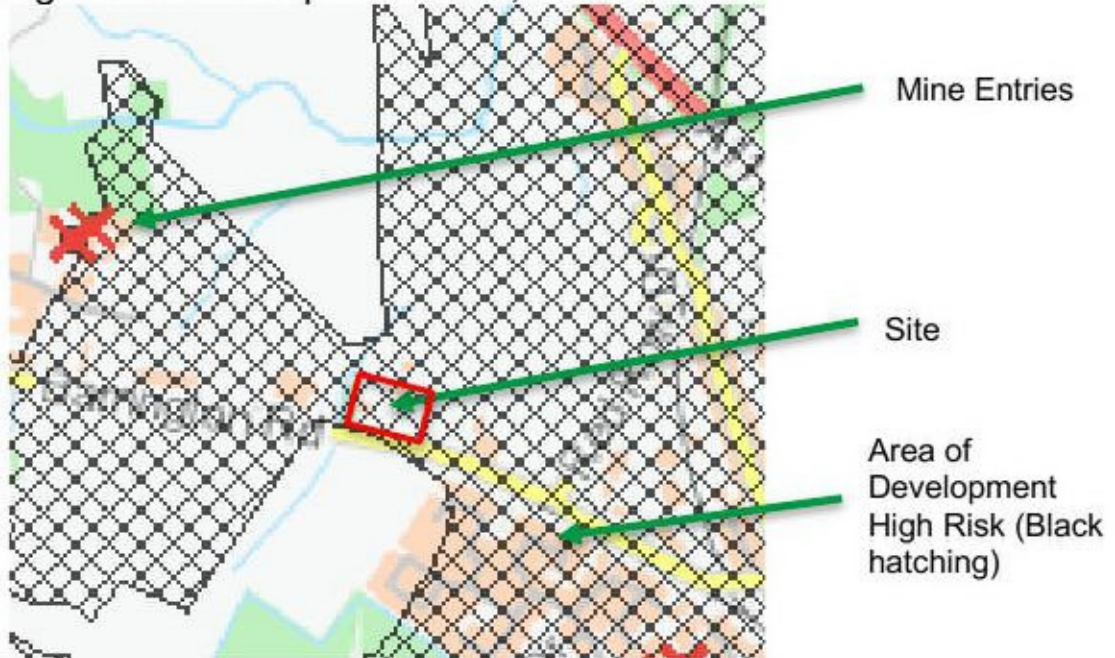
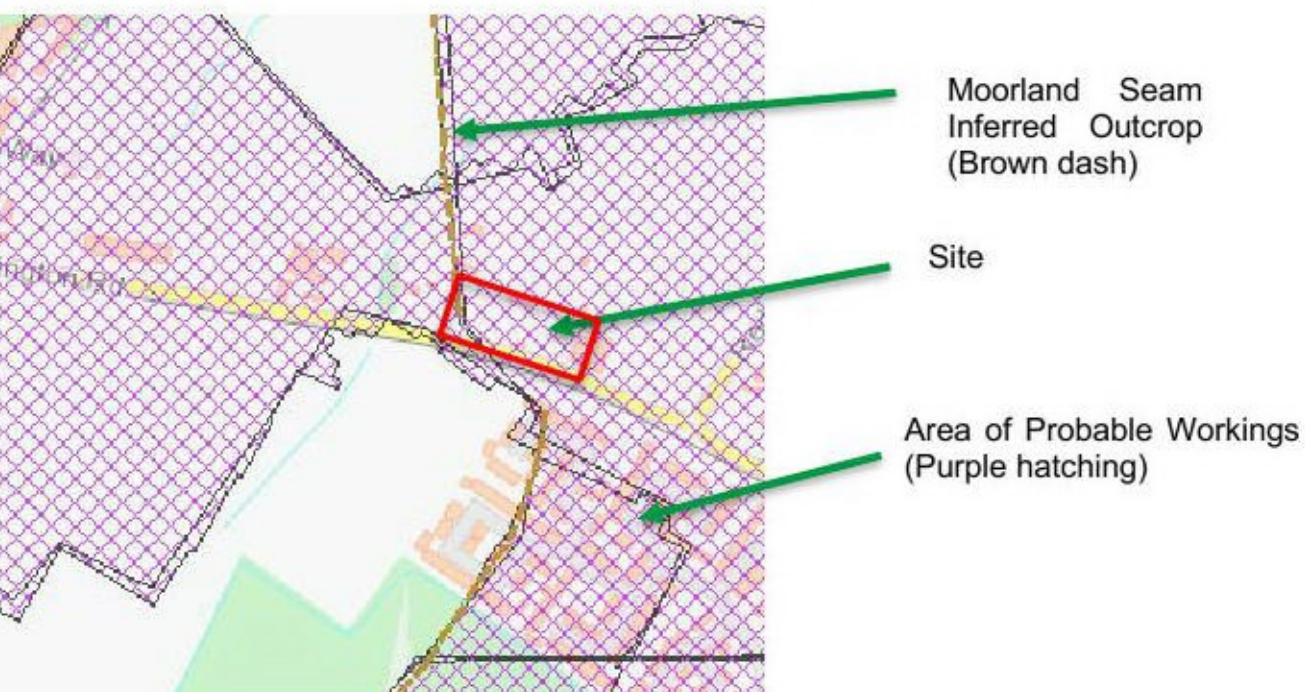
| SOURCES OF INFORMATION | SUMMARY |
|--|---|
| <p><b>Coal Authority Interactive Map</b></p> | <p>The Coal Authority Interactive Map shows that the site is located within in a High Risk Development Area;</p> <p>The site is located within an area of probable shallow workings;<br/> The Moorland Seam is shown to outcrop on site.</p> <p>No opencast workings are noted within the vicinity of the site.</p> |
