Bellister Castle

Window Condition Report

Martin Johnson & Co (York) Ltd

April 2021

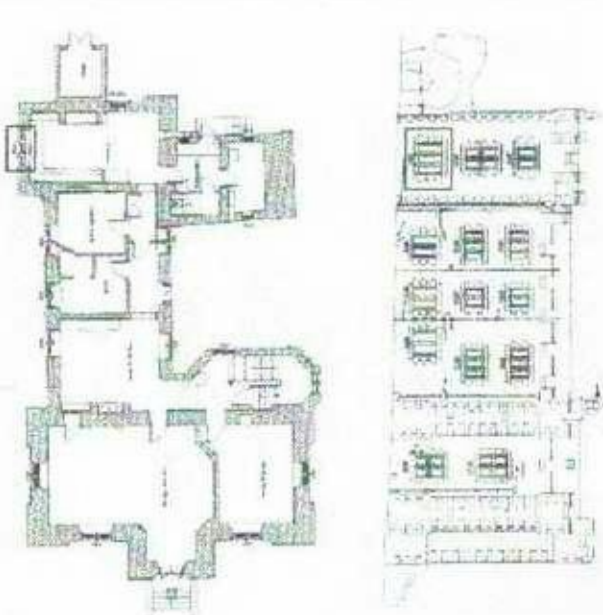
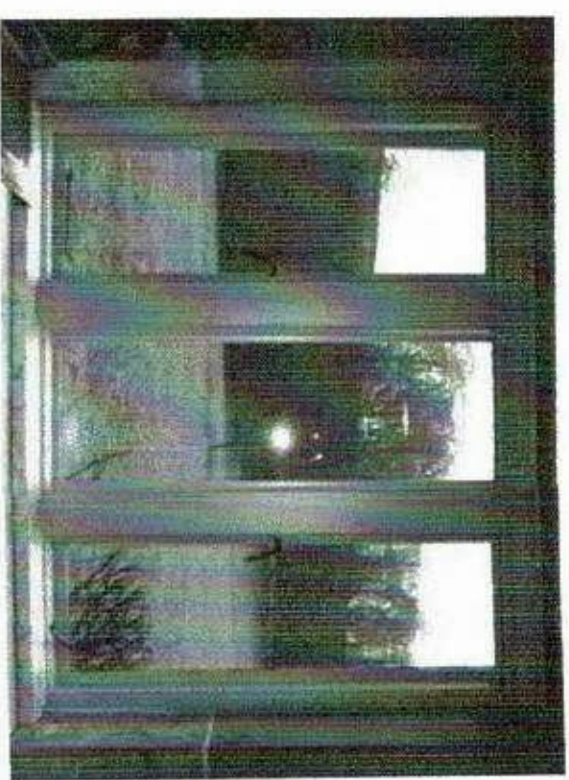
4.1 Window WG1

Location	South elevation, west-most Ground floor kitchen window

Description	3 lights: <i>a</i> and <i>c</i> lights are openers, <i>b</i> light is fixed		
Dimensions	All lights 430 x 1300mm		
Condition	Both opening lights are operable		
Proposed works	Refurbish all lights in-situ

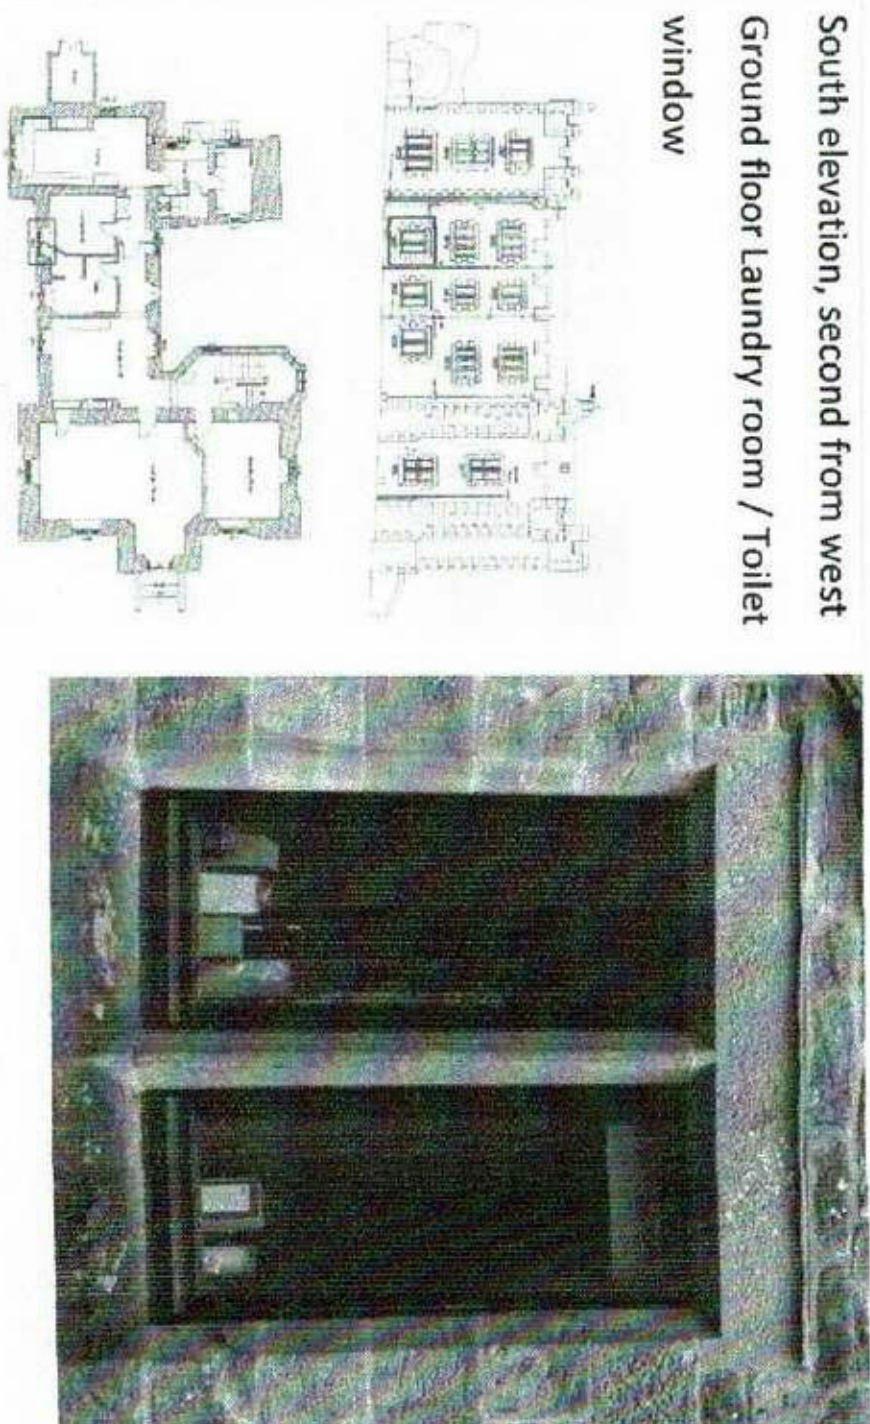
4.2 Window WG2

Location	South elevation, second from west Ground floor laundry room / Toilet window
Installation	Timber frames Window is separated into 2 rooms
Description	2 lights, both openers The timber framed windows are not assessed as part of this report

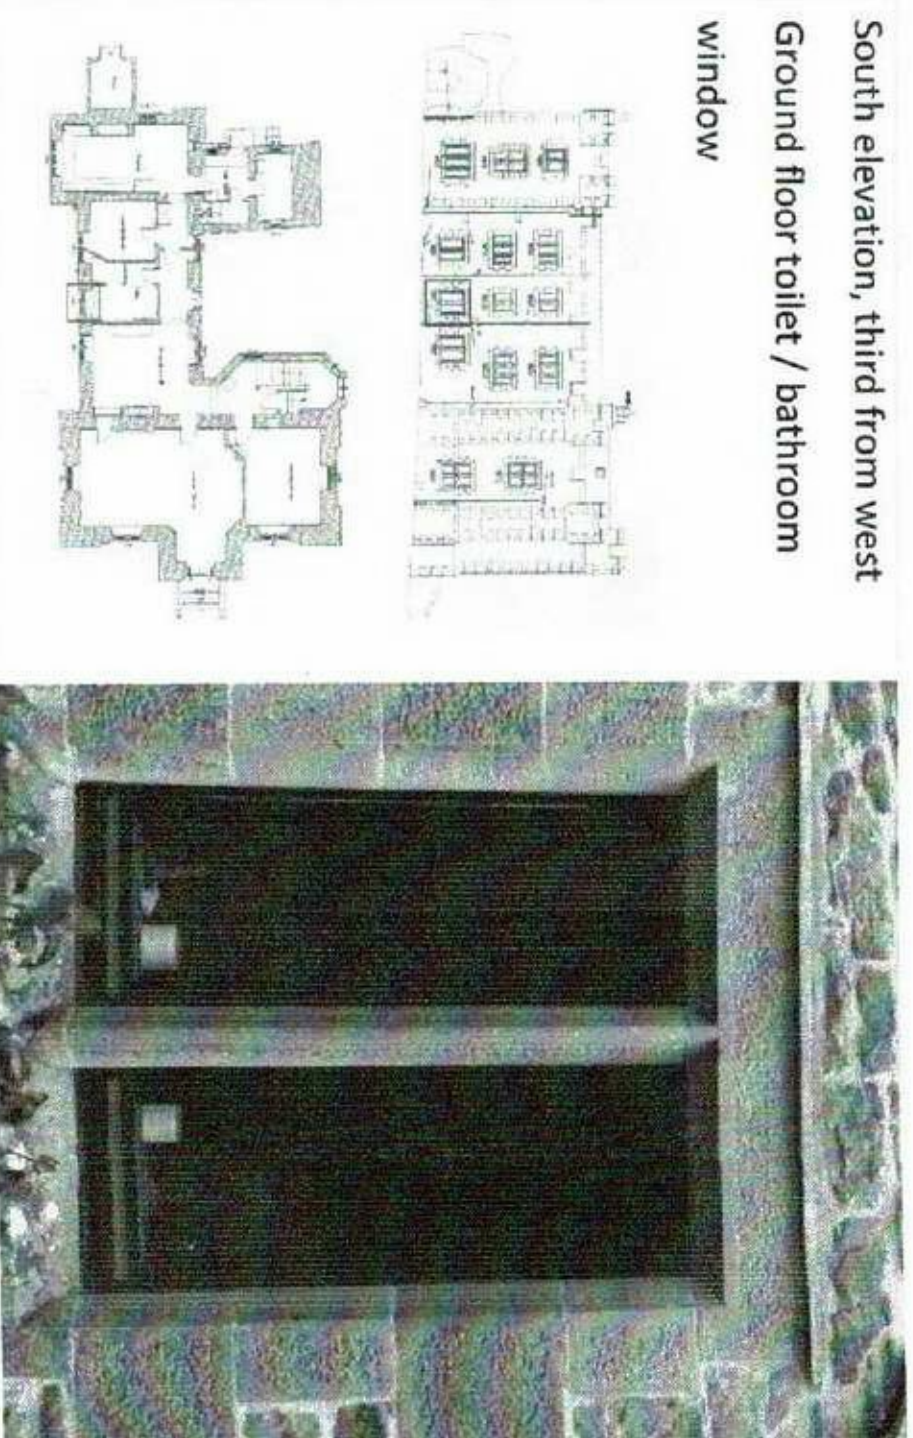
4.3 Window WG3

Location	South elevation, third from west Ground floor toilet / bathroom window
Installation	Timber frames
Description	2 lights, both openers The timber framed windows are not assessed as part of this report

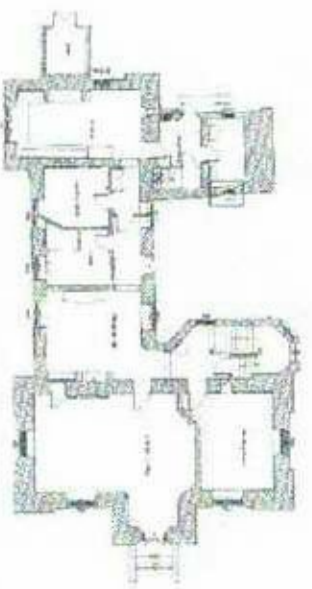
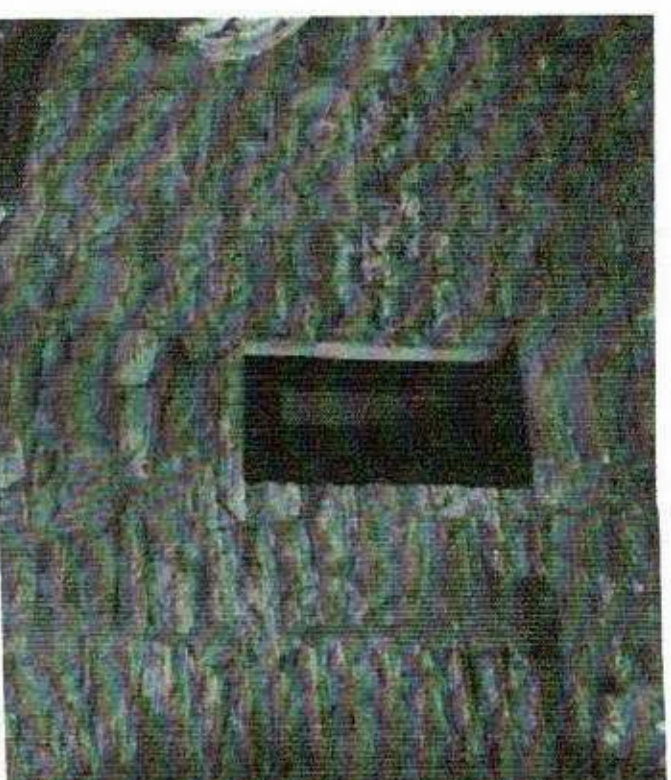
4.12 Window WG12

Location North elevation, ground floor east-facing wall of boiler room

Description Single light window

The timber framed windows are not assessed as part of this report

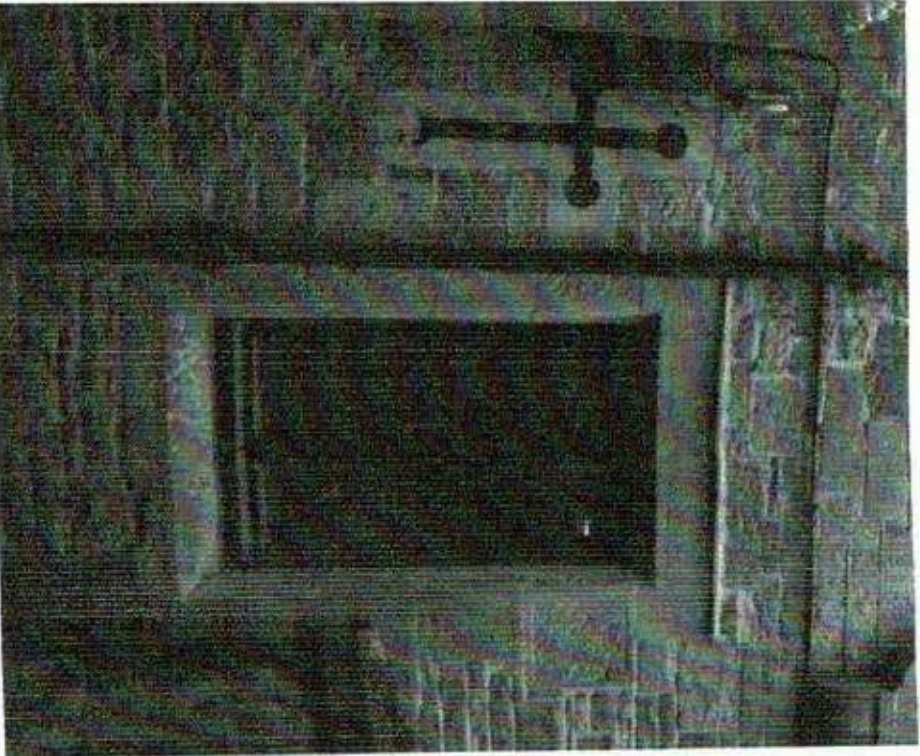
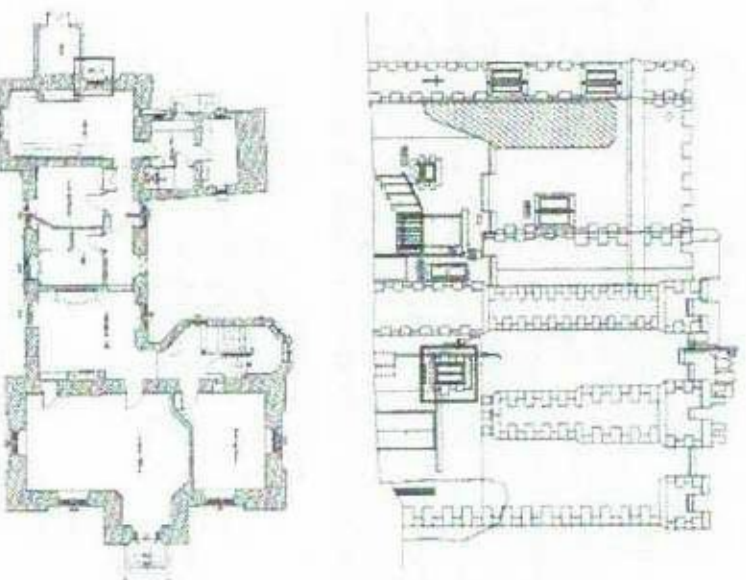
4.15 Window WG15

Location	Ground floor north elevation, entrance hall window

Installation	Timber frame	
Description	2 light window	
The timber framed windows are not assessed as part of this report

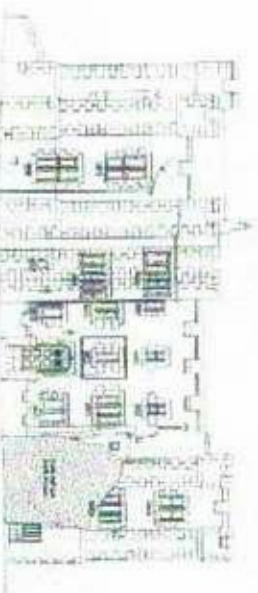
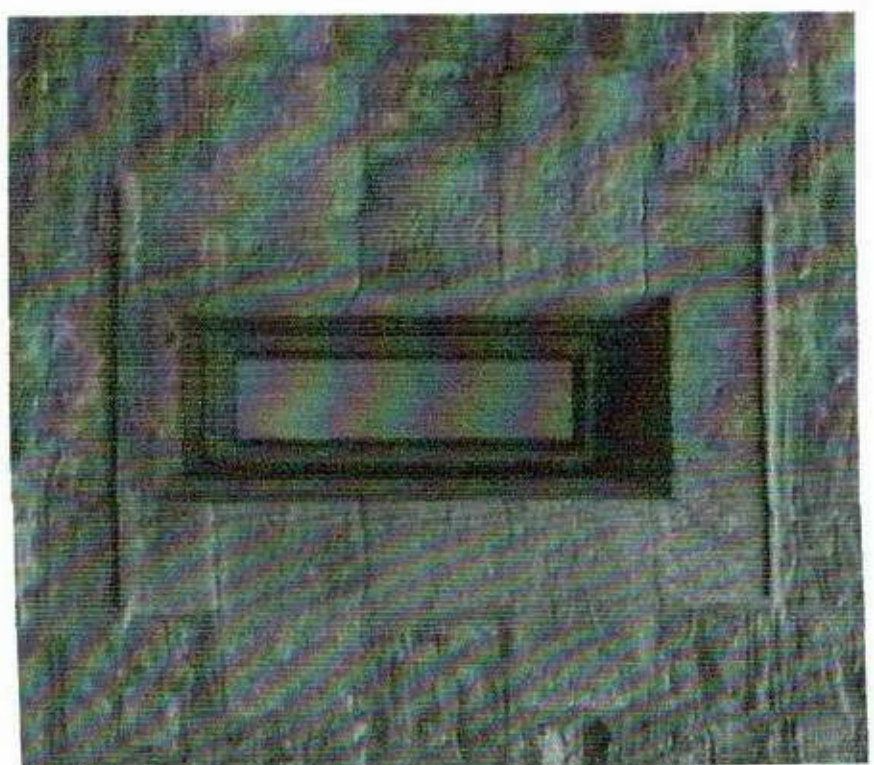
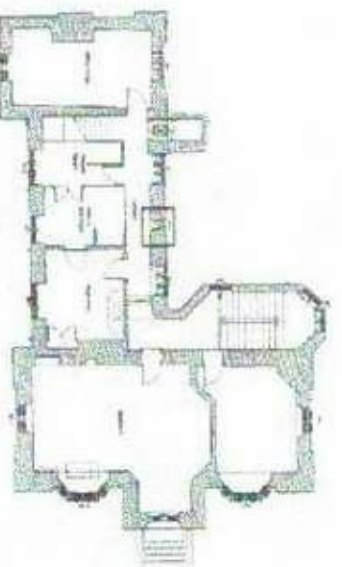
4.18 Window WF3

Location North elevation, first floor corridor window

Description Single light window

The timber framed windows are not assessed as part of this report

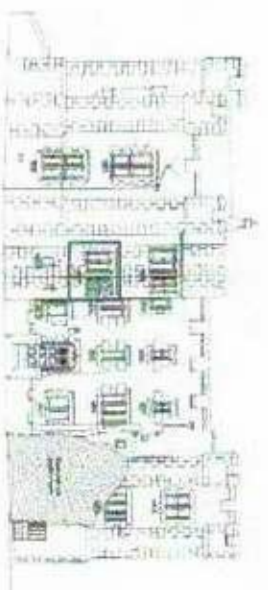
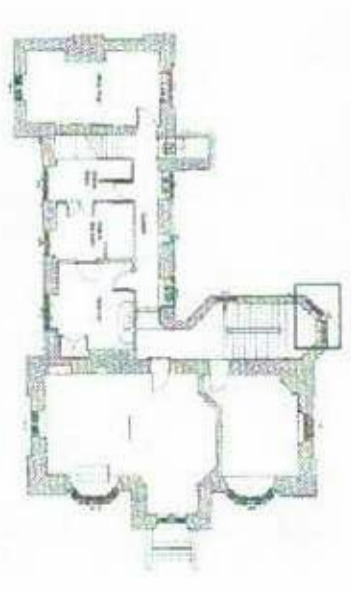
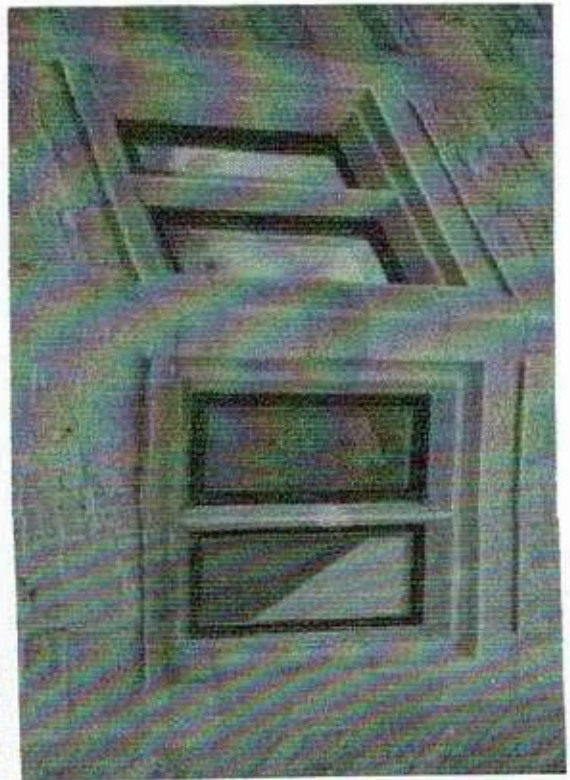
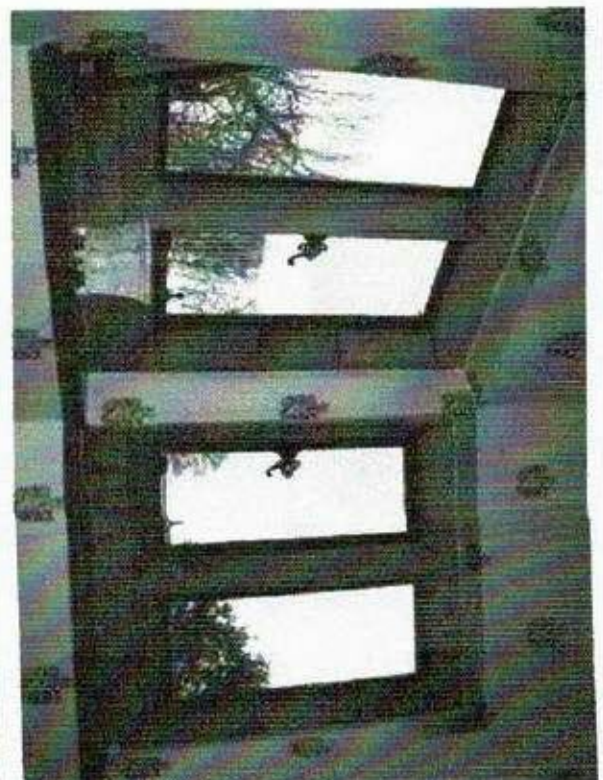
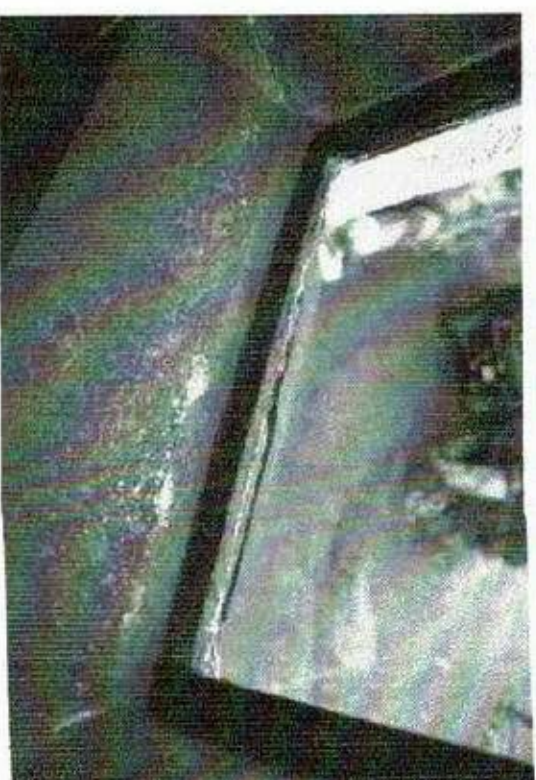
4.21 Window WF6

Location	North west corner, first floor stairwell window	
Installation	Cast iron frames	
Description	4 light window:	
	<i>a</i> light	Fixed
	<i>b</i> light	Opener
	<i>c</i> light	Opener
Dimensions	All lights 380 x 910mm	
	<i>a</i> light	Has been reglazed
	<i>b</i> light	Opener inoperable
	<i>c</i> light	Opener inoperable
Proposed works	<i>d</i> light	Has been reglazed
	Remove both opening lights for refurbishment

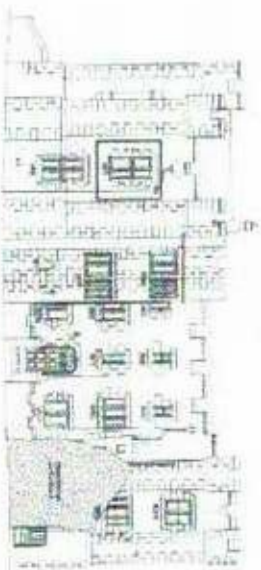
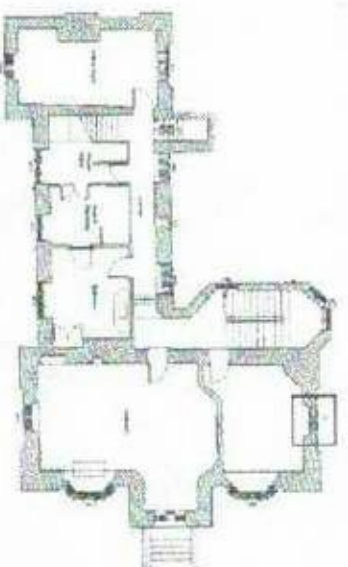
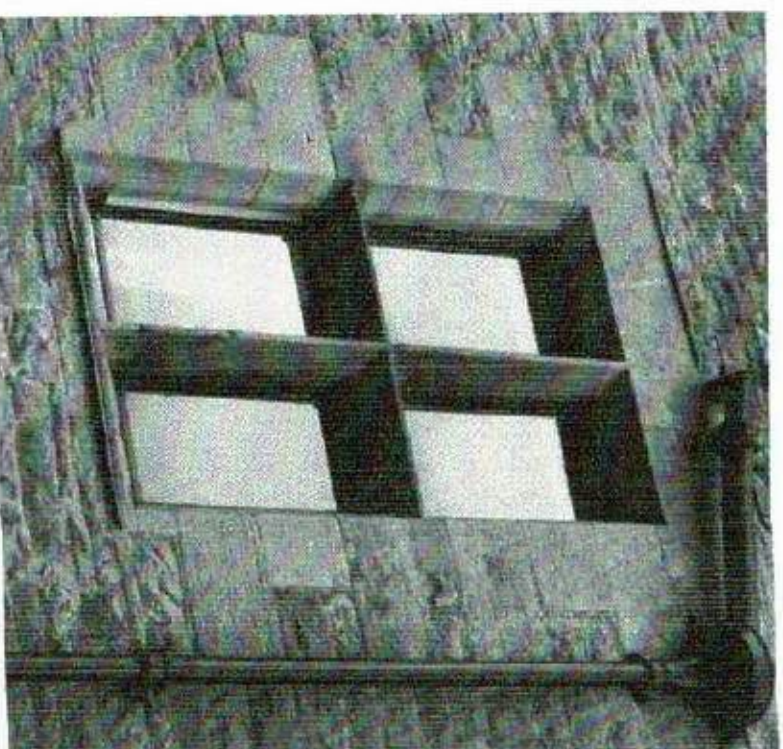
4.22 Window WF7

Location North elevation, first floor
bedroom window

Condition	<i>a</i> light	Sound
	<i>b</i> light	Trial panel
	<i>c</i> light	Sound
	<i>d</i> light	Sound

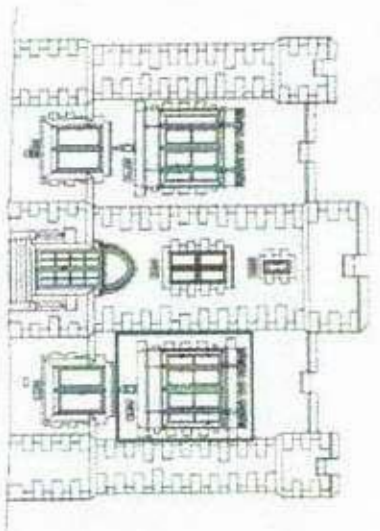
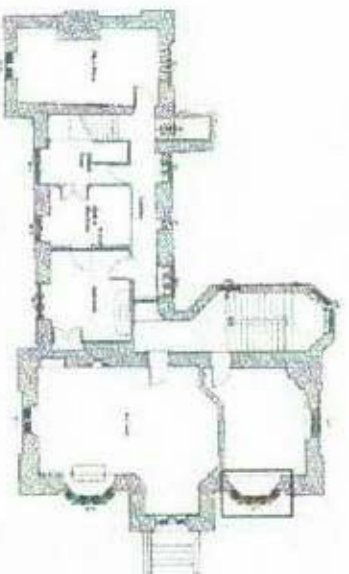
4.23 Window WF8

Location East elevation, first floor bedroom window, north-most

Condition *a* light Inoperable, thumb turn missing

b light Inoperable, stay missing

d light Inoperable, thumb turn missing

e light Rusting at base

Proposed works Remove *a, b, c, d & e* for refurbishment & replace furniture
 Refurbish *f, g & h* in-situ

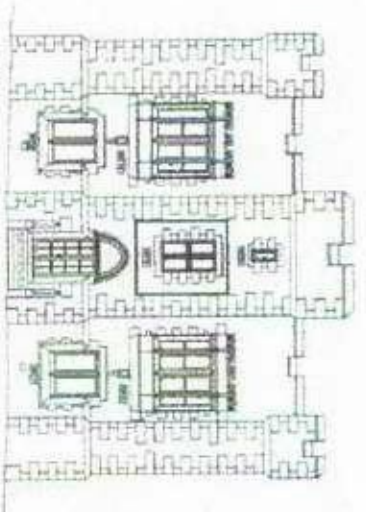
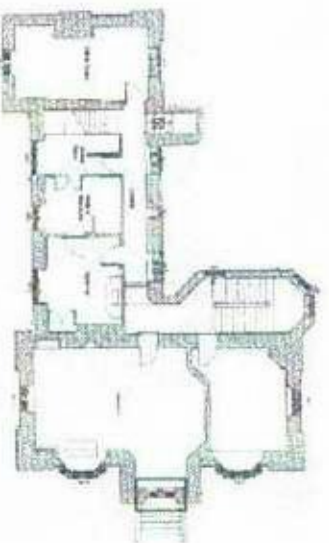
4.24 Window WF9

Location Central bedroom window, first floor

Condition *a* & *d* are sound, *b* & *c* are inoperable

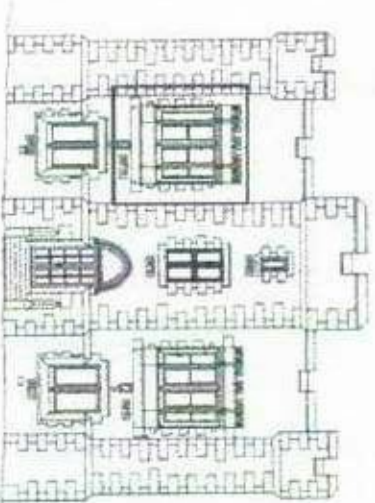
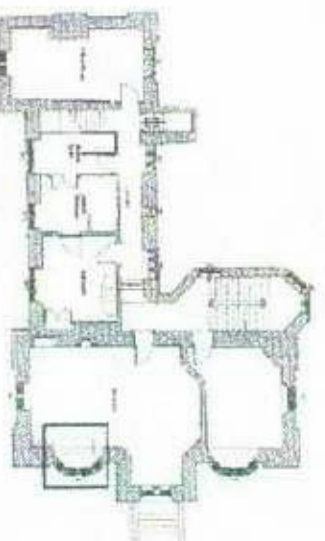
4.25 Window WF10

Location East elevation, first floor bedroom window, south-most

Condition *a* light Inoperable

b light Inoperable, thumb turn missing

<i>g</i> light	Sound, though previous glass replacement not correctly installed.
	<i>h</i> light	Sound
Proposed works	Remove and refurbish <i>a</i> , <i>b</i> , <i>c</i> & <i>d</i> . Refurbish <i>e</i> , <i>f</i> , <i>g</i> & <i>h</i> in-situ. Consider re-fitting of glass in <i>g</i> light

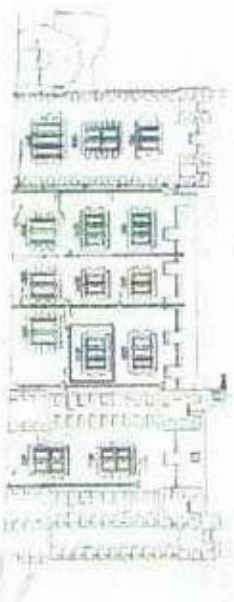
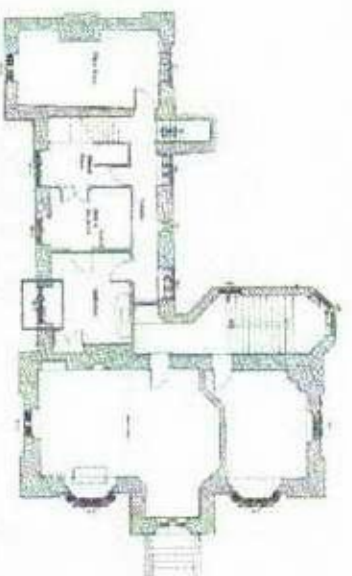
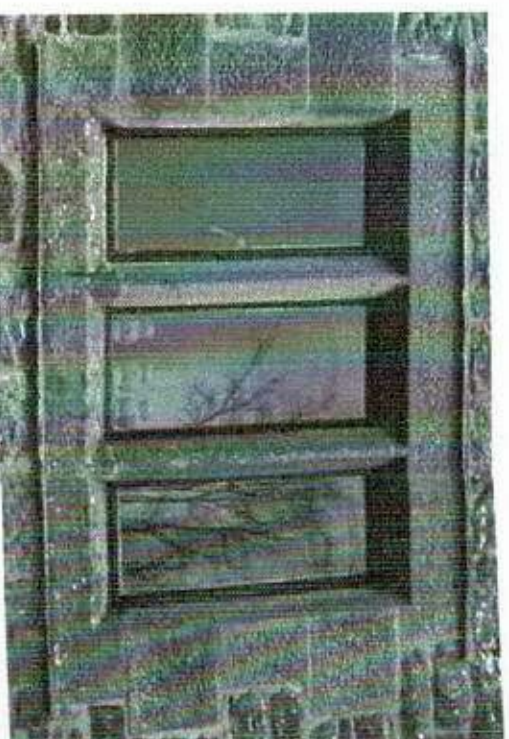
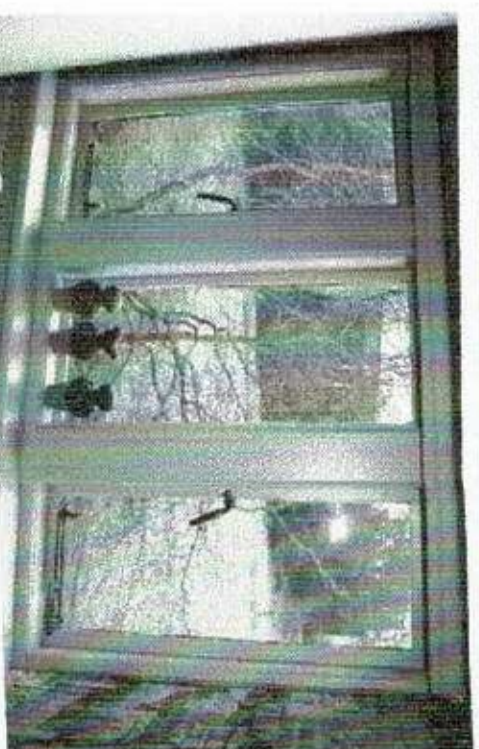
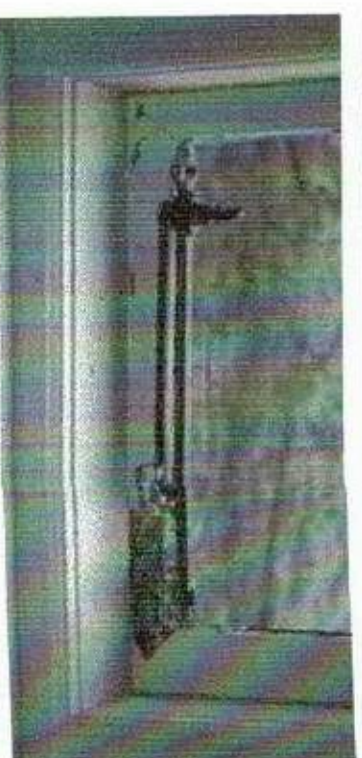
4.27 Window WF12

Location South elevation, first floor bathroom window

Condition *a* light Sound

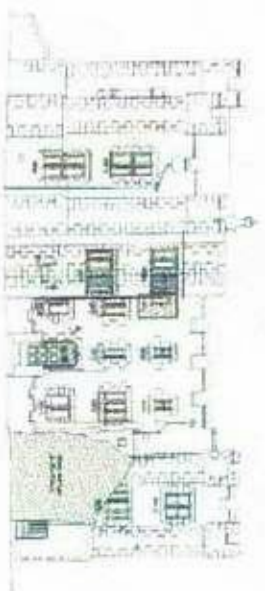
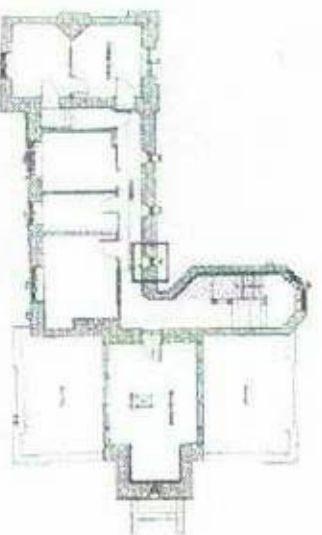
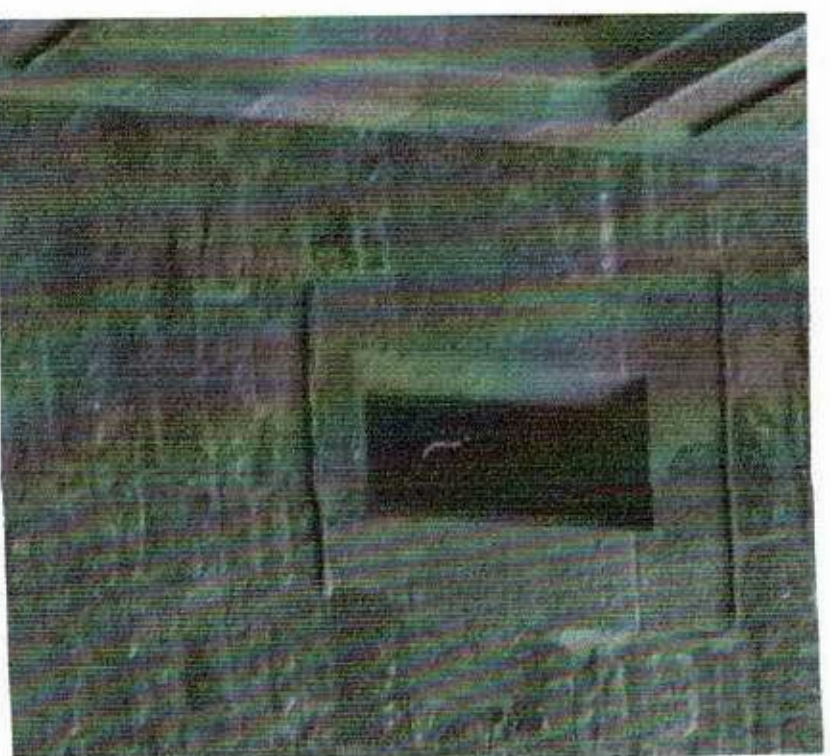
4.37 Window WS7

Location North elevation, second floor
corridor window

Installation Timber frames

Description Operer

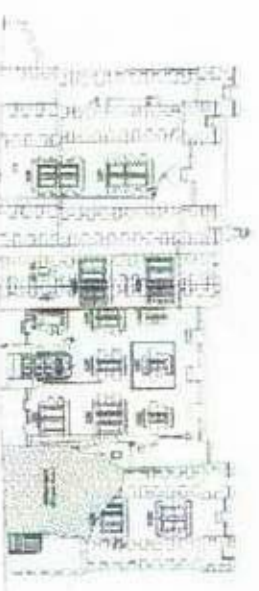
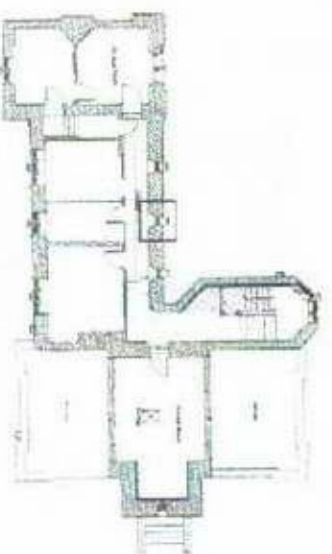
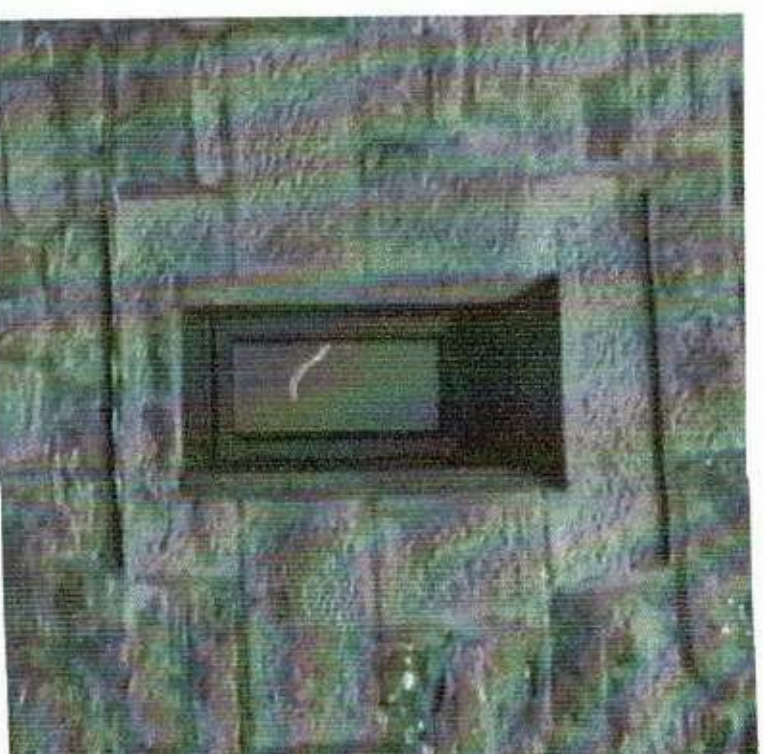
4.38 Window WS8

Location North elevation, second floor
corridor window

Installation Timber frames

Description Operer

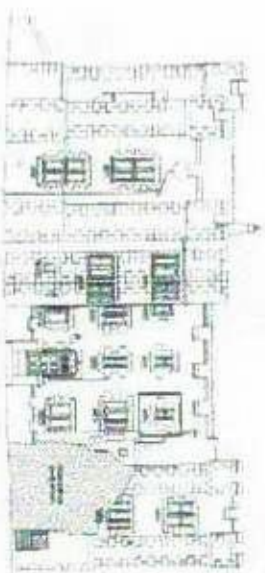
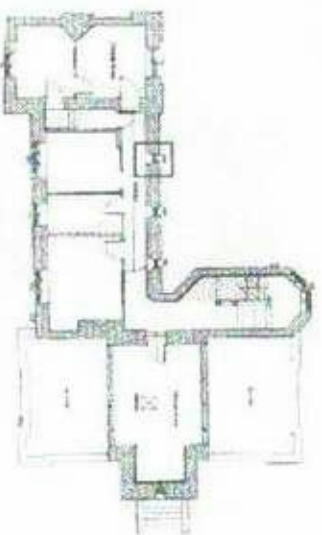
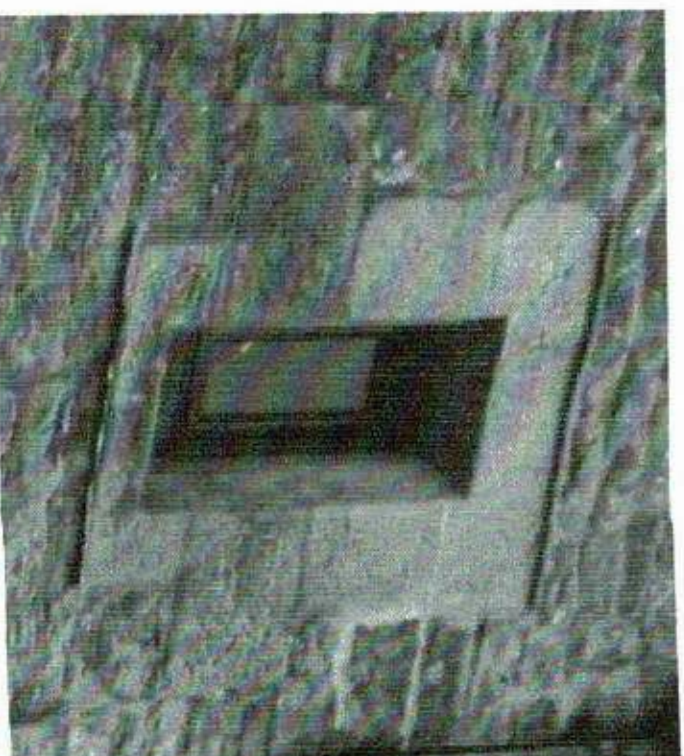
4.39 Window WS9

Location North elevation, second floor
corridor window

Installation Timber frames

Description Single light window, opener

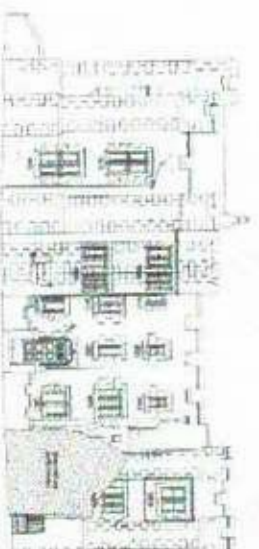
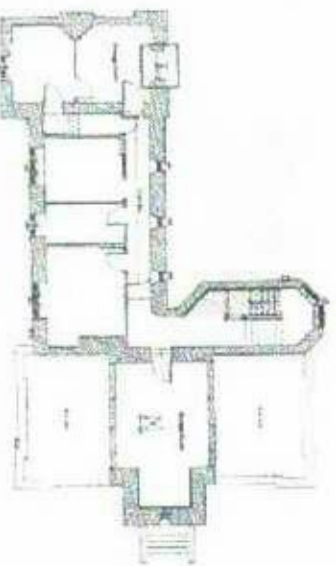
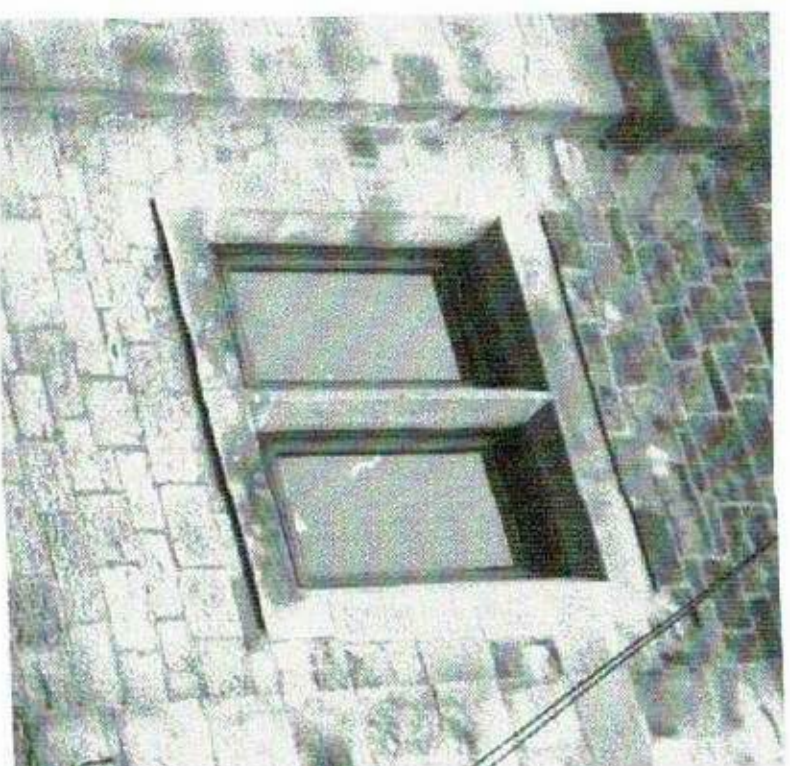
4.40 Window WS10

Location North elevation, second floor
storage room window

Installation Timber frames

Description Two-light window
