**KDK Archaeology Ltd**

**Gun Hill House & Outbuildings**

**Historic Building Appraisal**

**Report Reference: 242/BOS/1**

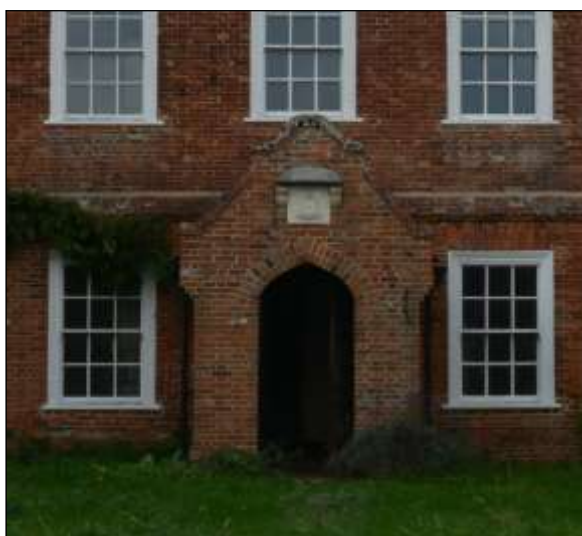
Plate 2: South elevation: porch detail

Project No/code: 226/BOS	Project: Gun Hill Burnham Overy Staithe	Elevation: South
<p><b>Doors:</b> Main entrance within centrally located porch. French doors in extension to the east.</p>		
<p><b>Windows GF:</b> Three 6 over 6 timber sash windows to either side of the door. Deep frames and narrow glazing bars. Some have queen closers but others do not. All under flat segmental arch</p>		
<p><b>Windows FF:</b> Seven window in the same style as on the ground floor</p>		
<p><b>Walling material:</b> Brick built with offset plat band largely obscured by wisteria. Various rebuilding/repair events evident in the change in brick use, loss of queen closers to openings and the use of cement mortar to repoint. Bricks measure 23x10.5x5cm and are well puddled with few stone inclusions. Horizontal skintling apparent on one of two of them.</p>		
<p><b>Other Architectural Features:</b> Brick built porch with stone heraldic device over opening and stepped gable. This is a later addition but utilising bricks with diagonal skintlings to match those on the west elevation. Bricks of similar size to main wall.</p>

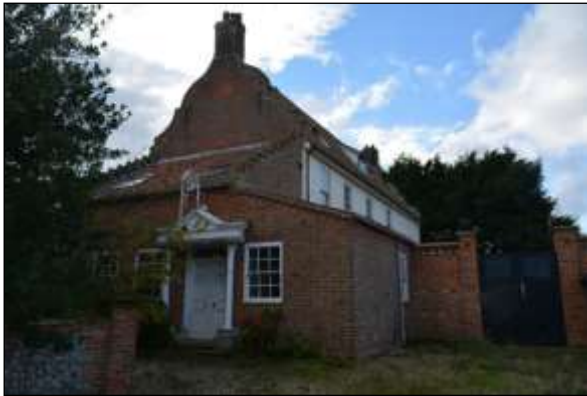
**Plate 6:** East elevation from the northeast

<b>Project No/code:</b> 226/BOS	<b>Project:</b> Gun Hill Burnham Overy Staithe	<b>Elevation:</b> East
<b>Doors:</b> Double doors with 3 panels apiece beneath pediment supported on posts based on Egyptian palm columns		
<b>Windows GF:</b> Three 6 over 6 timber sash windows in extension		
<b>Windows FF:</b> -		
<b>Walling material:</b> Extension of modern bricks. Gable end of main house Dutch gable with T C for Thomas Coke in iron		
<b>Other Architectural Features:</b> Ornate iron light over the entrance. Clay tiled roof with two skylights		
<b>Recorder:</b> KK	<b>Survey date:</b> 22.10.16

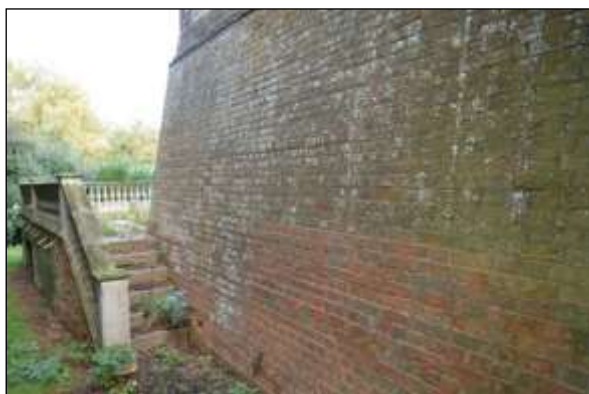
Plate 9: West elevation: angled lower section

Project No/code: 226/BOS	Project: Gun Hill Burnham Overy Staithe	Elevation: West
Doors: -		
Windows GF: --		
Windows FF: -		
<p><b>Walling material:</b> Upper and lower sections are of brick with a chalk and brick section between. Dutch gable. Lower section is splayed on both planes and acts as buttress to the wall. The bricks in the lower are set in English bond in cement mortar and measure 23x11x6cm. The bricks forming the chimney stack within the clunch have diagonal skintlings. If original this could date the chimney to the late 17<sup>th</sup> or early 18th century. The bond in the upper section appears to be Flemish.</p>		
<p><b>Other Architectural Features:</b> Square brick panels are set into the chalk wall on either side of the chimney. A brick and stone stair gives access to the north terrace.</p>		
Recorder: KK	Survey date: 22.10.16

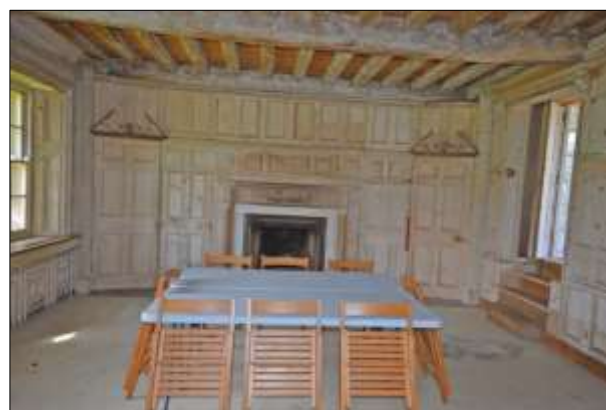
Plate 13: G1: west wall

Project No/code 226/BOS	Project: Gun Hill Farm, Burnham Overy Staithe	Room no: G1
Location: Ground floor, west end		Function: Reception
<p><b>Wall form &amp; decor:</b> East wall: Reused 4 panelled door to north and south of fireplace. Panelling above clearly modern as there are carpenter's pencil and scribe marks as well as metal pins fastening mouldings. Mixture of reused timbers such as doors and possibly panelling above the rail, but modern inserts are clearly evident in the columns with Ionic capitals, pediments over the curved doors to north and south and infill within the panelling itself.</p> <p>North wall: Modern skirting with reclaimed panelling above. Modern cornice. Panelling on west return wall of fireplace from reclaimed material below the dado and modern above. Panelling above fireplace made from reclaimed timber with modern fillers.</p> <p>East wall: Modern skirting. Panelling made from reclaimed and modern timber.</p> <p>South wall: Ditto. Panelling between the two windows is a rebuilt door.</p>

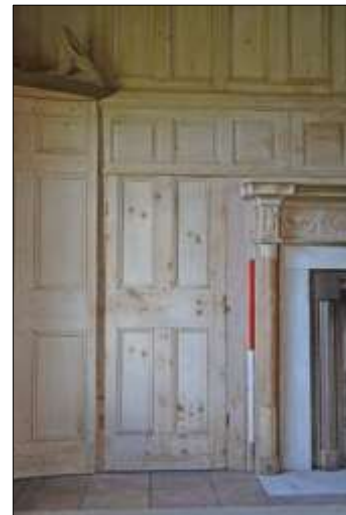
**Plate 17:** G1: re-used door as panelling in west wall

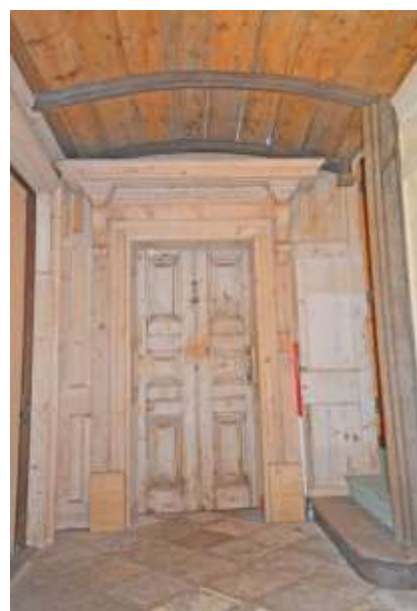
Plate 19: G2: view to west

Project No/code 226/BOS	Project: Gun Hill Farm, Burnham Overy Staithe	Room no: G2
Location: Centre of the ground flor		Function: Hall
Wall form & decor: Panelling throughout made from reclaimed and new timber, including two heavily moulded beams reused as posts on the north wall.		
Ceiling / roof structure: Timber barrel vaulting using reclaimed timbers.		
Windows: -		
Doors: Door to west reclaimed (see G1 sheet). Door to east similar but the back has been cut off and poor quality moulding added. Reclaimed door to north, cut down to fit. Good quality oak door to south; historical but unlikely to have been the original. Hood, pediment and brackets all modern additions. Half glazed timber door to staircase purpose built.		
Floor: -		
Fireplace: -		
Staircase: Closed string staircase with barley twist balusters and newel posts. Possibly 18th century but could be early 20th century addition. Historical panelling on the stair wall inserted at some unknown date, possibly with the staircase in the 1980s. Balustrade on first floor landing made from reclaimed material of good quality. Newel post on half landing has replacement upper half

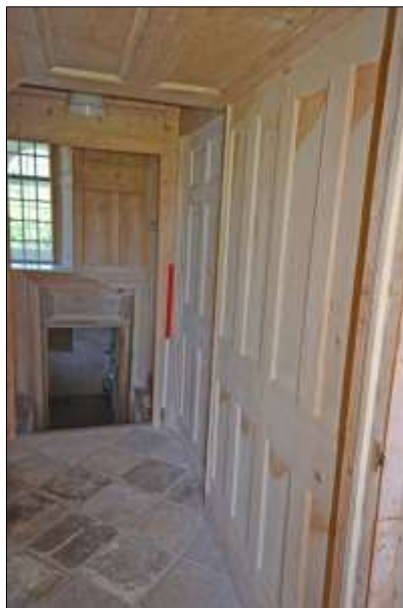
Plate 22: G3: view to north

Project No/code 226/BOS	Project: Gun Hill Farm, Burnham Overy Staithe	Room no: G3
Location: Ground floor, north of hall (G2)		Function: Passage and WC
Wall form & decor: Panelling from modern and reclaimed timbers, including a 6 panelled door in the east wall of the passage.		
Ceiling / roof structure: -		
Windows: -		
Doors: Door to WC reused. Door to passage also reused and cut to fit.		
Floor: -		
Fireplace: -		
Staircase: -		
Other architectural details:		
Recorder: KK	Survey Date: 14.07.16

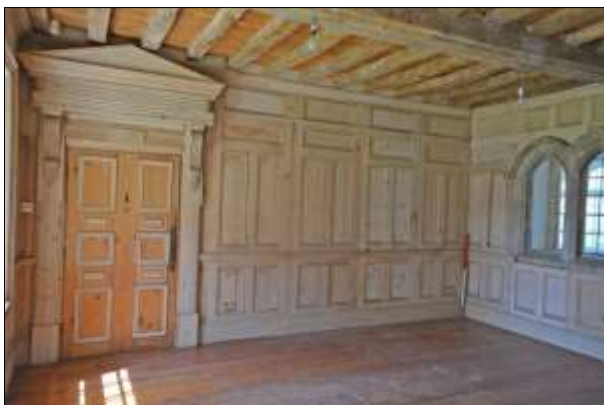
Plate 23: G4: west wall

Project No/code 226/BOS	Project: Gun Hill Farm, Burnham Overy Staithe	Room no: G4
Location: East of main entrance		Function: Reception
Wall form & decor: Panelling from modern and reclaimed timber		
Ceiling / roof structure: Original chamfered beam with plain joists.		
Windows: The windows to the south are the same as in the other ground floor rooms (6 over 6 timber sash x2 with a large gap between to form elementary double glazing). In the north wall are two 2-light gothic windows made from oolitic limestone, possibly Clipsham, and clearly imported for reuse here.		
Doors: Reclaimed 6 panelled door with the interior face cut back and rudimentary moulding applied. Double folding door to the kitchen to the east is modern. Pediments over all the doors are modern		
Floor: -		
Fireplace: Pastiche from salvaged material reassembled to form stone fire surround.		
Staircase: -		
Other architectural details: -

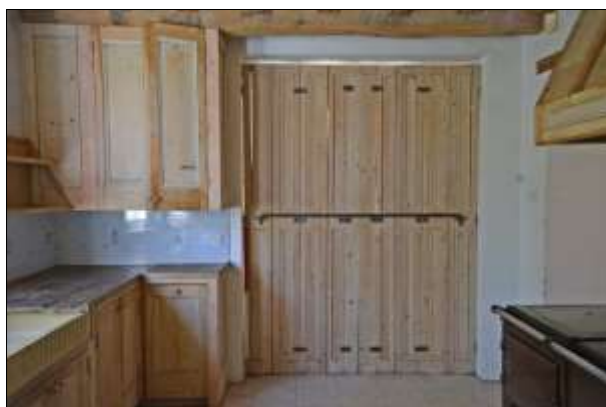
Plate 27: G5: south wall

Project No/code 226/BOS	Project: Gun Hill Farm, Burnham Overy Staithe	Room no: G5
Location: Ground floor, east end		Function: Kitchen
Wall form & decor: Tiled and painted – no panelling		
Ceiling / roof structure: Beam on different alignment. Joists to south have no moulding but appear to have been added later. Joists to north have recesses rather than chamfers and are also later installations		
Windows: Window to south has folding panels. The outer leaves are from original window shutters but the central four are modern. The iron security bar functions in the same way as original shutters but is also of modern manufacture.		
Doors: Double folding door to west		
Floor: -		
Fireplace: -		
Staircase: -		
Other architectural details: This room is a later addition with joists installed to mirror those used elsewhere on the ground floor.		
Recorder: KK		Survey Date: 14.07.16

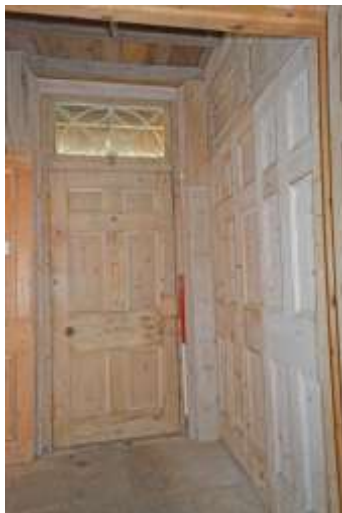
Plate 29: G6: view to east

Project No/code 226/BOS	Project: Gun Hill Farm, Burnham Overy Staithe	Room no: G6
Location: North of kitchen (G5)		Function: Side entrance
Wall form & decor: Reused panelling to north. 6 panelled door reused as panelling to south. Some modern material also interspersed. Panelling in north wall of two different types: heavy moulding below and lighter above		
Ceiling / roof structure:		
Windows:		
Doors: Reused doors to north, east and west. Half glazed door to west has large iron door lock and handle. Door to east has number 7 so visible on outer face		
Floor: -		
Fireplace: -		
Staircase: -		
Other architectural details: -		
Recorder: KK	Survey Date: 14.07.16

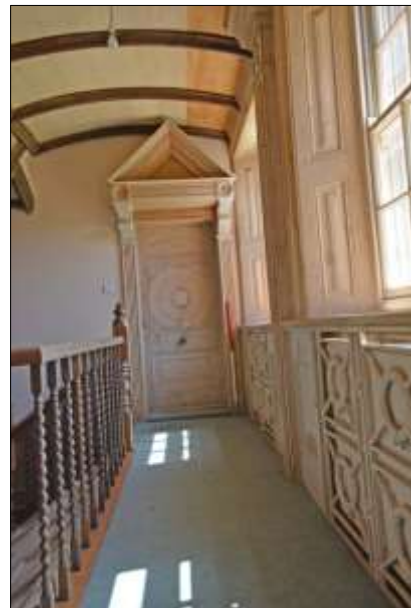
Plate 33: F1: view to east

Project No/code 226/BOS	Project: Gun Hill Farm, Burnham Overy Staithe	Room no: F1
Location: Centre of first floor		Function: Landing
Wall form & decor: Good quality historical panelling lining the stairs. Modern to south wall and above stairwell.		
Ceiling / roof structure: Timber barrel vaulting with northern side utilising same moulded timber as in the hall below (now used as posts)		
Windows: 6 over 6 timber sash x2 in each opening to form double glazing. Reveals are panelled.		
Doors: Doors made from reused timbers with unusual opening mechanism (also modern manufacture using historical materials) to east and west. Reclaimed medieval timber door to north. Frame of medieval door is partly historical and partly of new timbers. Brackets and hoods modern.		
Floor: -		
Fireplace: -		
Staircase: Closed string staircase with barley twist balusters and newel posts. Possibly 18th century but could be early 20th century. Historical panelling on the stair wall presumably added when the staircase was installed in the 1980s. Balustrade on first floor landing made from reclaimed material of good quality, worth keeping. Newel post on half landing has replacement upper half

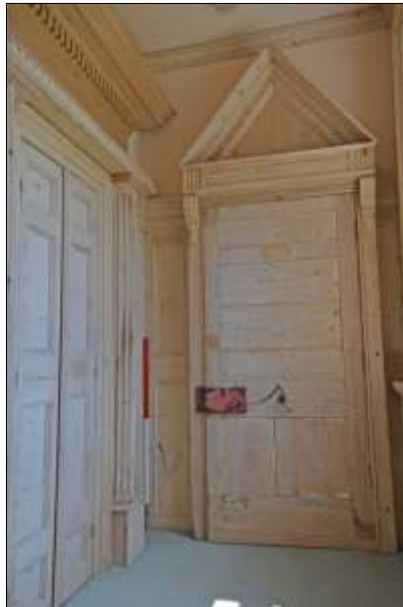
Plate 37: F2: view to northeast

Project No/code 226/BOS	Project: Gun Hill Farm, Burnham Overy Staithe	Room no: F2
Location: First floor, west of landing (F1)		Function: Anteroom
Wall form & decor: Timberwork all modern apart from double door to cupboard, which has some historic timbers		
Ceiling / roof structure: -		
Windows: As elsewhere		
Doors: Door to east from reused timbers with unusual opening mechanism (also modern manufacture using historical materials) Door to west early 19th century 2 panelled		
Floor: -		
Fireplace: -		
Staircase: -		
Other architectural details:		
Recorder: KK	Survey Date: 14.07.16

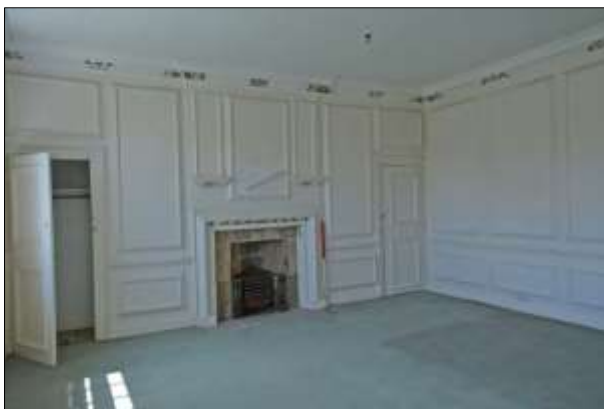
Plate 38: F3: west wall

Project No/code 226/BOS	Project: Gun Hill Farm, Burnham Overy Staithe	Room no: F3
Location: First floor, west end		Function: Bedroom
Wall form & decor: Painted full height panelling to all walls. Probably 18 <sup>th</sup> century. Deep cornice with floral motif picked out on gold paint. Large raised fields above roll moulded dado with smaller raised panels below.		
Ceiling / roof structure: -		
Windows: -		
Doors: Two panelled doors to east and west all on H hinges		
Floor: -		
Fireplace: Timber surround is almost certainly coeval with the panelling that it matches. However, the interior has been rebuilt in stone using cement mortar and probably replaces an earlier design. Marble hearth.		
Staircase: -		
Other architectural details:		
Recorder: KK	Survey Date: 14.07.16

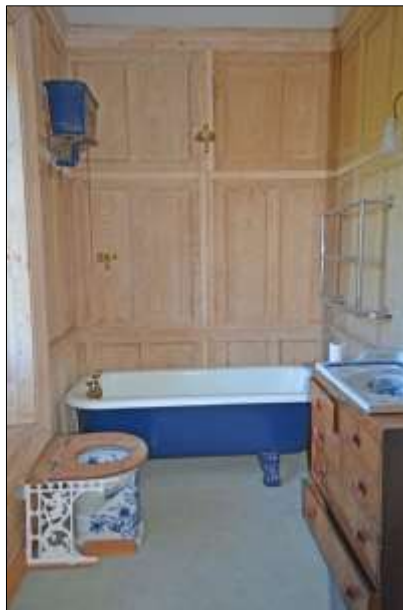
Plate 41: F4: view to east

Project No/code 226/BOS	Project: Gun Hill Farm, Burnham Overy Staithe	Room no: F4
Location: First floor, north of anteroom (F2)		Function: En suite
Wall form & decor: Reused panelling with modern timbers as infill. Modern timber coving and skirting		
Ceiling / roof structure: -		
Windows: -		
Doors: Reused 4 panelled door		
Floor: -		
Fireplace: -		
Staircase: -		
Other architectural details: Reused sanitary fittings		
Recorder: KK	Survey Date: 14.07.16

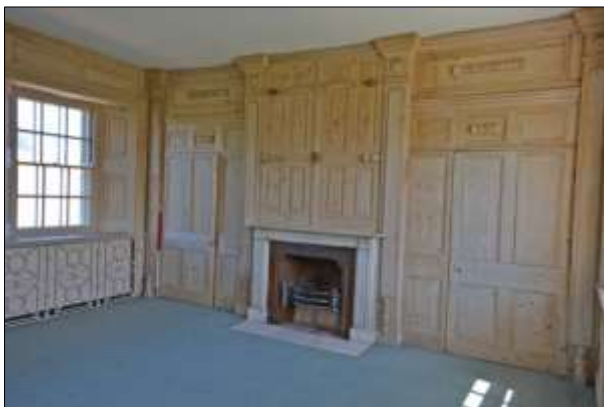
Plate 42: F5: view to northwest

Project No/code 226/BOS	Project: Gun Hill Farm, Burnham Overy Staithe	Room no: F5
Location: First floor, east of landing (F1)		Function: Bedroom
Wall form & decor: Good quality softwood panelling, stripped of paint. Modern and historical panels used. The long panels, which are historical, have been spliced and have a pedestal base applied below the panels. Decorative features on east wall modern.		
Ceiling / roof structure: -		
Windows: -		
Doors: Reused and cut to fit to east. Door to west made from reused timbers with unusual opening mechanism (also modern manufacture using historical materials). Pediment above well made and also has paint remnants on frieze.		
Floor: -		
Fireplace: Regency style marble surround		
Staircase: -		
Other architectural details:		
Recorder: KK	Survey Date: 14.07.16

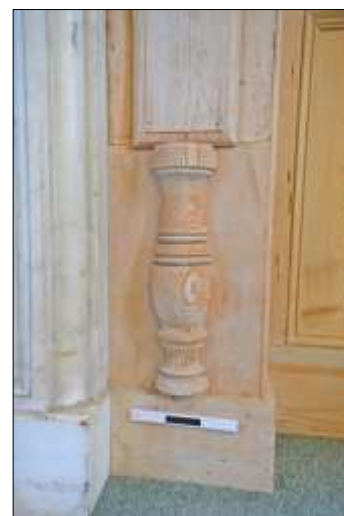
Plate 45: F5: modern detail below reused panel

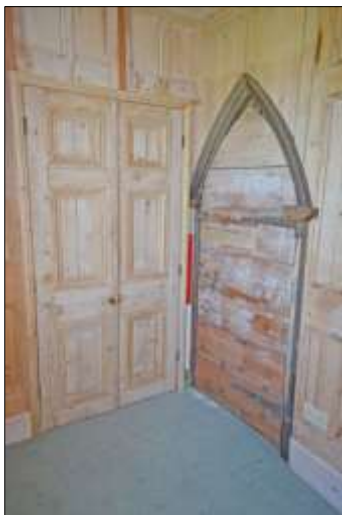
Plate 46: F6: view to southeast

Project No/code 226/BOS	Project: Gun Hill Farm, Burnham Overy Staithe	Room no: F6
Location: First floor, north of landing (F1)		Function: Anteroom
Wall form & decor: Reused and modern panelling with additional modern features (eg. pillar & bracket)		
Ceiling / roof structure: -		
Windows: -		
Doors: Reused double door backed onto panelling in east wall. Medieval door to south. Plain strap hinges added later and on opposite side to the original. The timber frame is cobbled together. Door made up of three sections, horizontal planks to north, vertical planks to south and vertical planked section between		
Floor: -		
Fireplace: -		
Staircase: -		
Other architectural details:		
Recorder: KK	Survey Date: 14.07.16
