PROPERTY ADDRESS, LOCATION

July 2022
MS/6830

1.0 Introduction

This statement has been prepared in support of a Listed Building Application for repairs to 2 no. outbuildings at White House Farm. This is a retrospective application for works undertaken by the applicant in 2017.

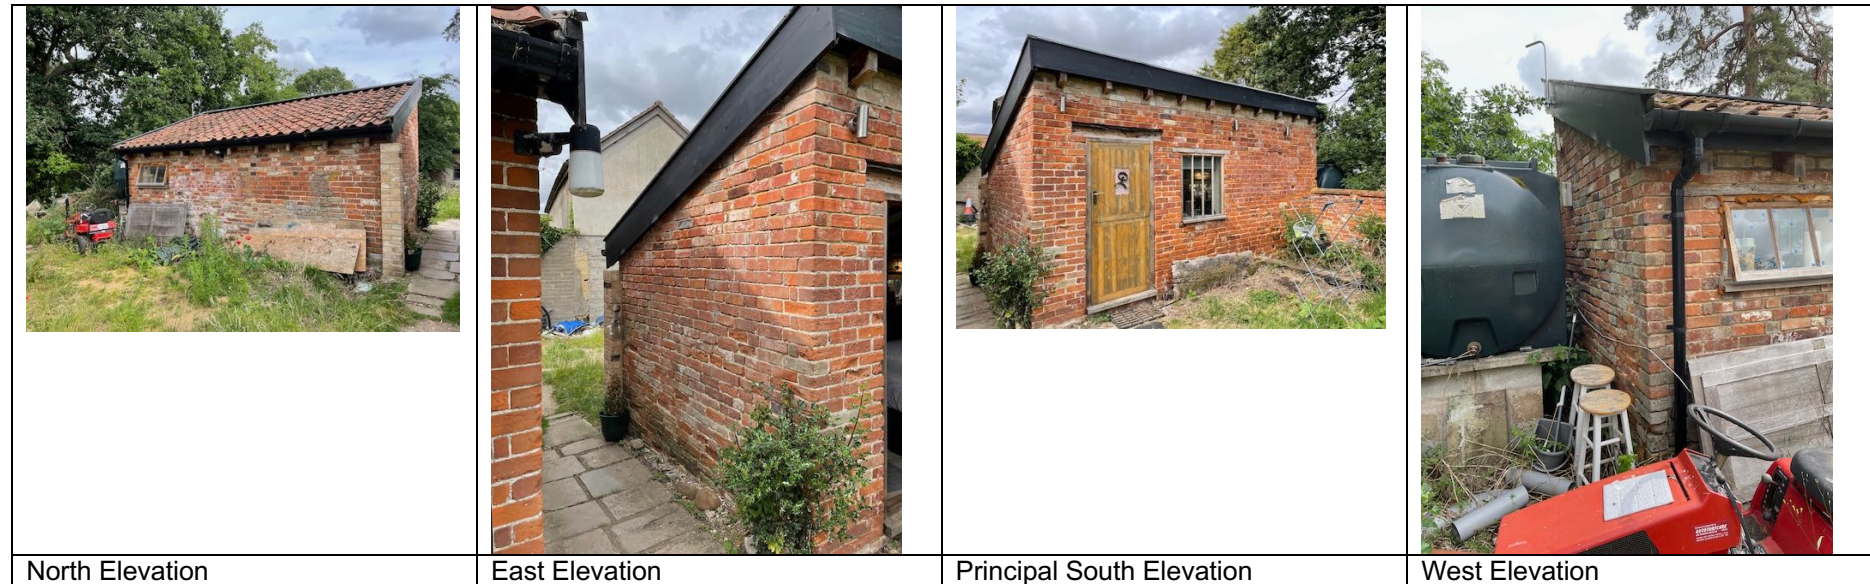
Both outbuildings (referred to as Barn 1 and Barn 2) are of brick construction with clay tiled roofs. Both outbuildings had the roof coverings replaced in the late C20 with corrugated iron by a previous owner. In 2017 these roofs were torn off by Storm Doris <https://www.metoffice.gov.uk/weather/warnings-and-advice/uk-storm-centre/storm-doris> prompting the need for urgent repairs to be undertaken.

i	 	<p>Roof – This had collapsed following storm damage and the rafters were severely decayed as shown in the photo of one of the original rafters. New oak rafters were installed. The corrugated iron roof covering was disposed of and a clay tile roof re instated with clay pantiles being a mix of the original tiles found within the building made up with re claimed tiles to match.</p>
---	--	---

Entrance door – The lintel above the door was decayed and starting to collapse, this was replaced with a new oak lintel and a new softwood door installed.

Windows – The windows were decayed and have ben replaced with new softwood windows to match the window in the kitchen of the farmhouse which was the former dairy of the property.
