Tree Structural Integrity Report

6 Eastfield Road
Redland
Bristol
BS6 6AA

JH.210690.R

16th December 2021

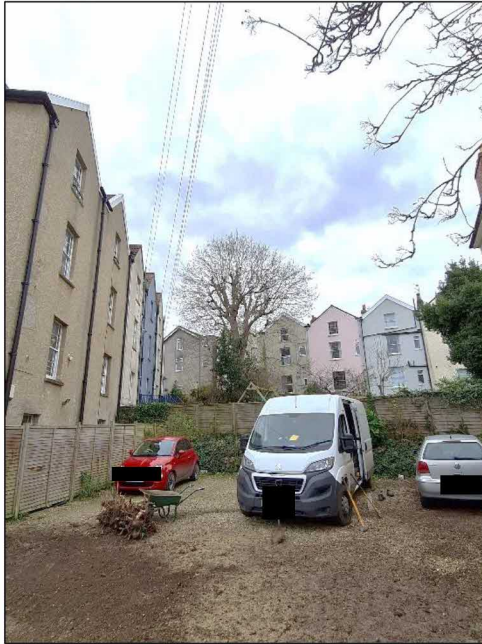
Main Stem	<ol style="list-style-type: none"> 1. Old wound on northern side of stem from ground level to approx. 2.0 metres height 2. Wound approx. 30 centimetres in width with exposed, desiccated decayed heartwood 3. Good wound-wood formation 4. Area of loose and sunken bark on southern side of the stem w/exposed and decaying sap wood from ground level to 60 centimetres height above ground level 5. Variations in tone when sounding eastern & western aspects of stem adj. these features 6. Cavity at approx. 3.0 metres height northwest side of stem, probed to depth of 25 centimetres 7. Co-dominant leaders at approx. 4.5 metres height w/partially included bark union 			
Crown	<ol style="list-style-type: none"> 1. x2 old pruning wounds eastern side of co-dominant leader approx. 15 cm diameter 2. Wounds partially occluded with loose and flaking bark around them (sapwood dysfunction possible when viewed through binoculars) 3. x4 dead primary limbs on the eastern side of crown approx. 20-25 centimetre diameter 4. Cavity visible on western co-dominant leader approx. 60 x 20 centimetres 5. Fruiting body at approx. 14 metres height western side of primary scaffold limb 6. Small diameter dead branches throughout crown 7. Small dead stubs at old reduction pruning wounds 8. Poorly attached re-growth at old reduction pruning wounds w/little adaptive growth visible 9. No signs / evidence of Ash Dieback

Figure 4: Image Showing Ash in Landscape from North
