Full Bat Survey Report

Orchard Cottage

Radnage Common Road
Radnage
High Wycombe
Buckinghamshire
HP14 4DH

Dr Stacey Dawn Waring
21-024-FBSR
March 2022

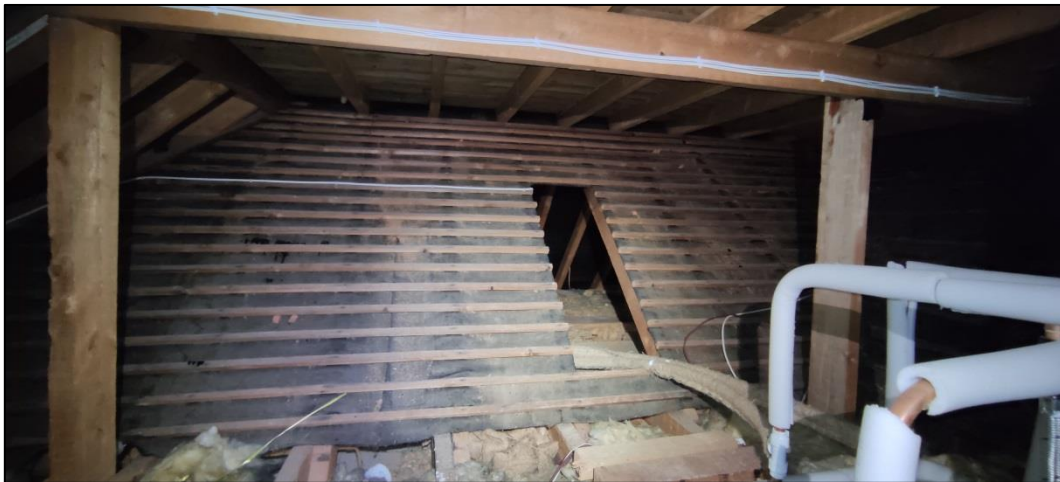
Roof Void 1 was located at the eastern end of the house (Figure 14). The roof was of moderate size, with the void approx. 1.5m high at the ridge throughout the two areas (Figure 15). The central portion of the roof void had an area of flat roof, which was boarded on the underside (Figure 16), this was well sealed, with no gaps between the boards. The old section of roof was still present in void 1, which will increase the number of different microclimates found within the roof; providing bats with more options for roosting throughout the seasons.

The modern timber rafters and trusses were in good condition, with no gaps or joints that could be utilised by bats (Figures 14 and 15). The underlay beneath the primary roof covering (Figures 15 and 17) consisted of a Type 1F bitumen felt, which was in fair condition. However, there were some areas where the overlaps were sagging (Figure 17) and light could be seen entering around parts of the eaves.

Widely scattered bat droppings consistent with brown long-eared bats were present throughout the entirety of the void, though there were no concentrated collections. There was also evidence of large rodent and mouse droppings, particularly under the flat-roof section.

Figure 15 – showing roof void 1, with previous section of roof and boarded section

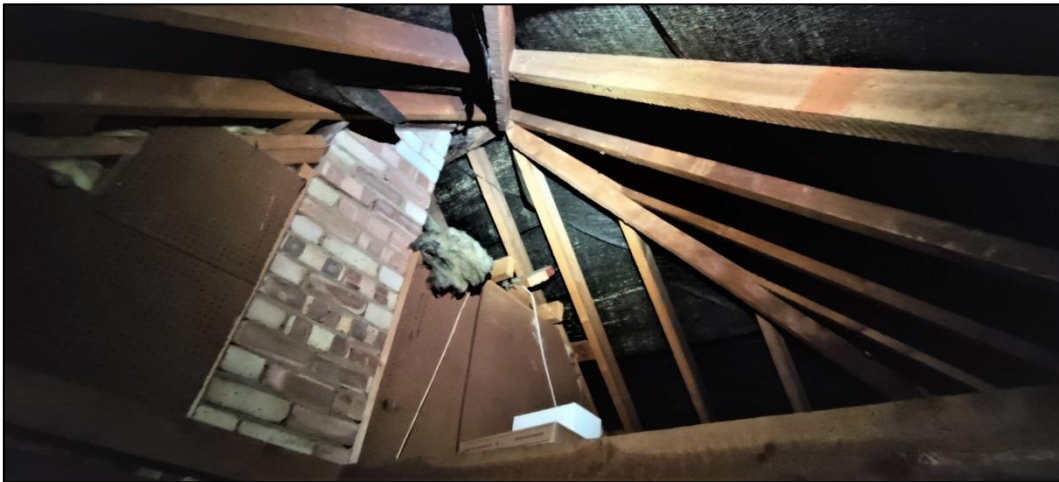
The section closest to void 1 was approx. 2.5m high at the ridge (Figure 18). This area was partitioned off due to the dormer that occupied part of the roof void. This area had a chimney stack present. The brickwork and mortar was in good condition with no sections missing. Previous hipped sections of roof, were also visible throughout this section of the roof (Figure 19).

Figure 18 – showing hipped section, chimney and bitumen underlay

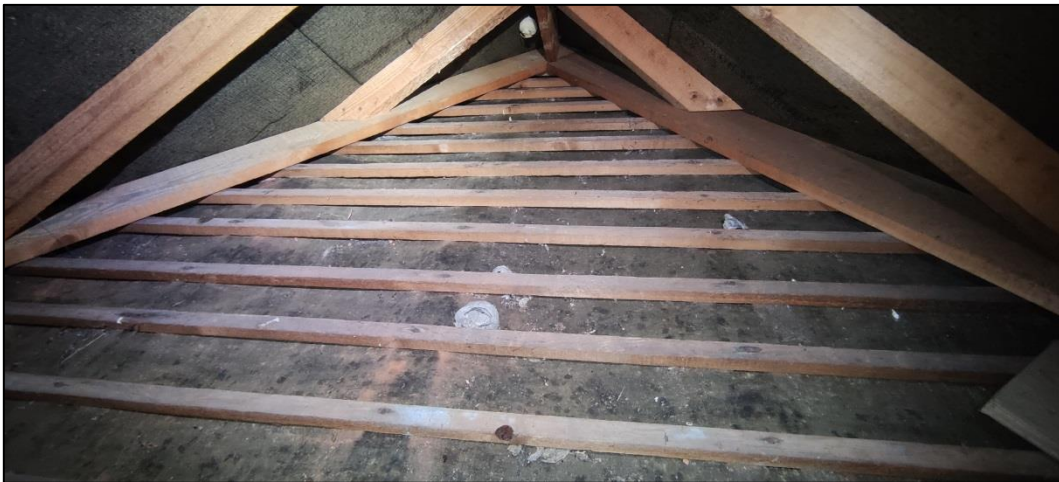
Figure 19 – showing previous sections of roof as the building has been extended

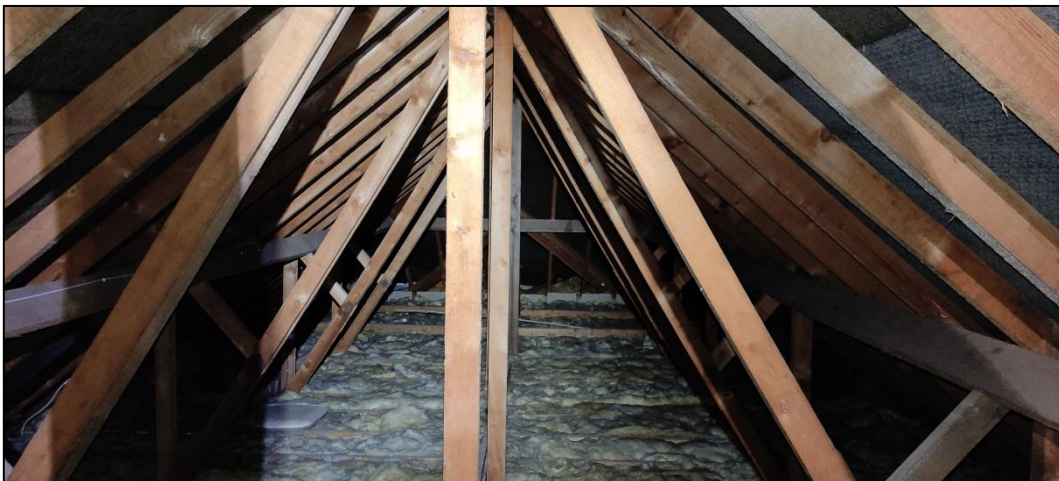
The western most section of the roof void was smaller, being approx. 1.5m high throughout (Figure 22). There was also a brick chimney in this section (Figure 23), which was in good condition, although some light could be seen entering around the exit point.

Figure 22 – showing western-most section of the roof void with low height

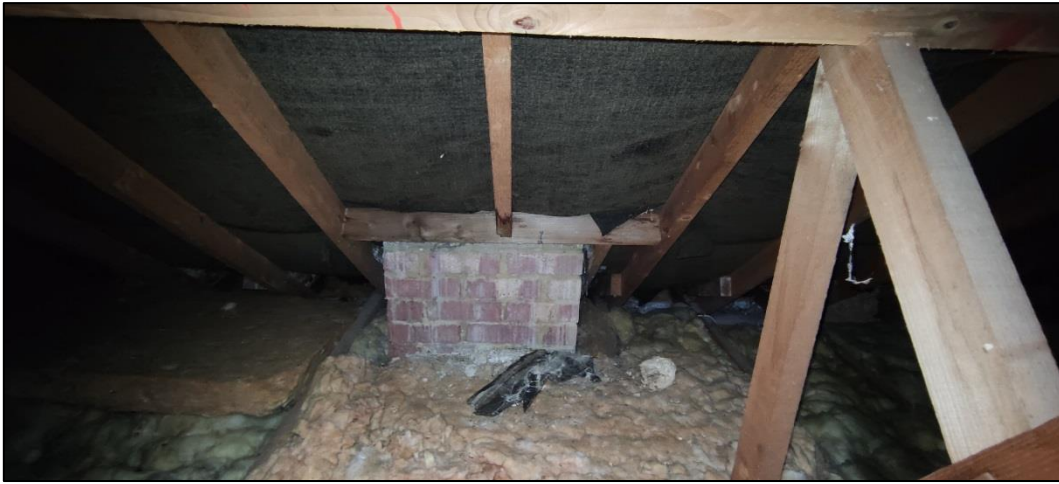
Figure 23 – chimney stack in the western-most section of the roof void

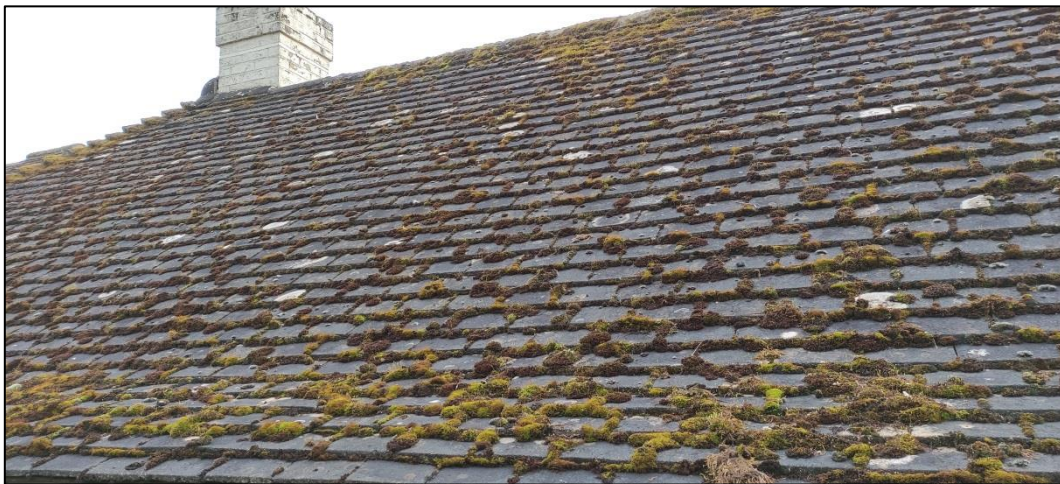
The primary roof covering consisted of machine-made, tiles over the entirety of the house (Figures 2, 3, 27 and 28). The primary roof covering was in fair condition as the tiles were flaking and crumbling (Figure 21) across large areas of the roof. Whilst the majority of tiles were tightly fitting (Figures 2, 3, 20 and 21), there were several areas where tiles were missing, lifted and displaced.

Figure 27 – roof showing machine-made, concrete tiles, chimney and hip bonnet tiles

The ridge consisted of half round tiles (Figures 27 and 28) which were all present, although the mortar along the ridges was missing in several areas (Figure 29), which could provide bats access to both the internal roof voids. The chimneys were in good condition with no visible gaps in the brick-work or mortar that could be utilised by bats. The lead flashing around the bases of the chimneys was in good condition although lifted in some areas (Figure 30).

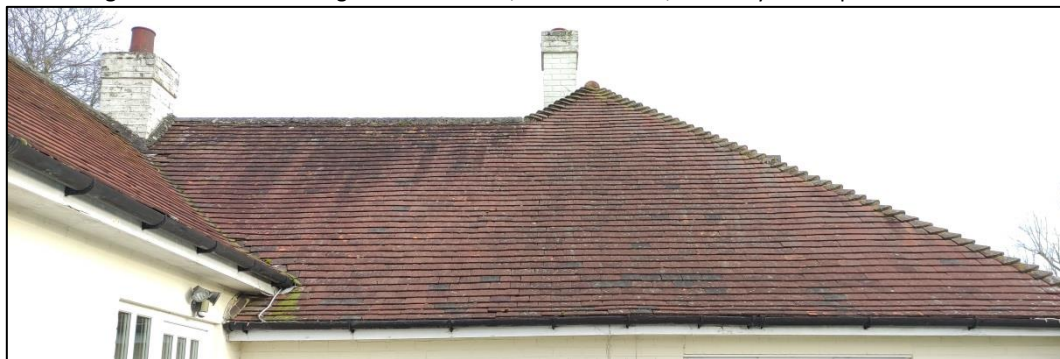
Figure 28 – image showing machine-made clay tiles, hopped sections, valleys and chimneys

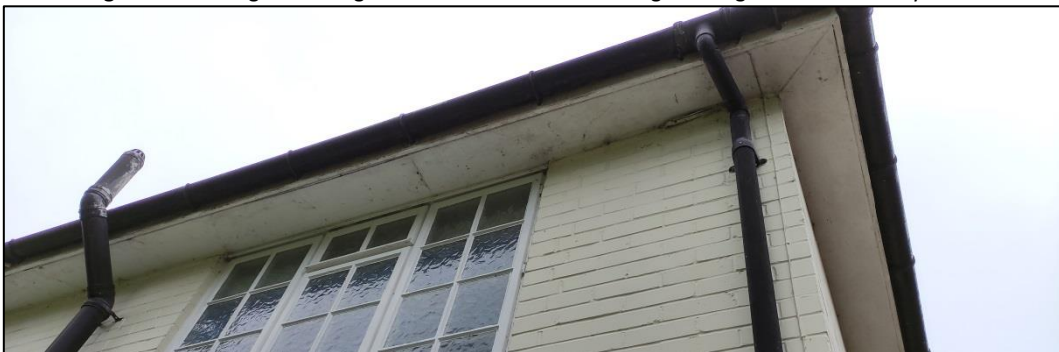
The eaves were sealed around the entirety of the building (Figure 31), which prevented potential access to the batten space and roof voids, via this route. However, there were a few further areas that appeared to have potential for use by bats, including; the valleys and hip

Figure 31– showing sealed eaves around the building

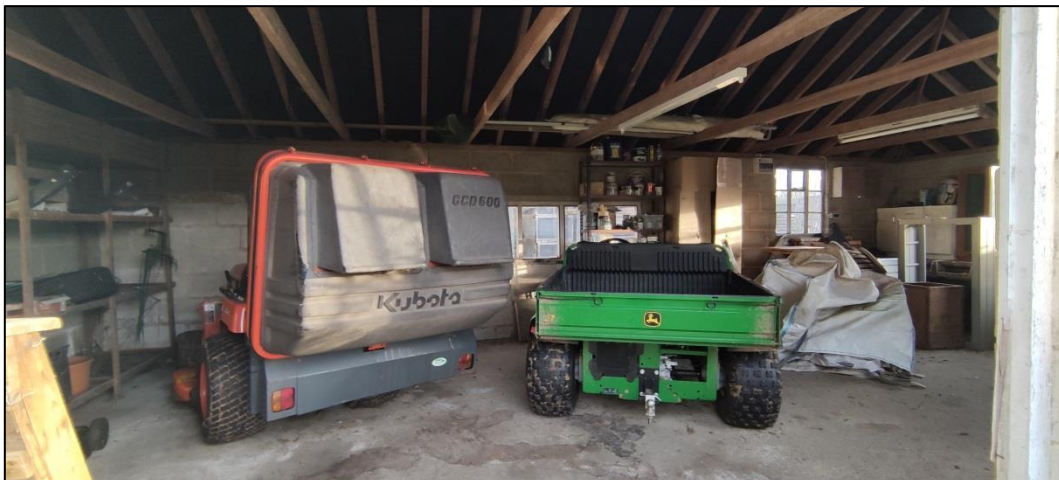
Building 4 is a large single-storey, breeze-block, solid walled shed used for storage (Figures 8, 32 and 33). The single-skin, solid wall construction provides very little insulation for the interior space. Internally, the building is one large void, with no enclosed roof space, that could be used by roosting bats. The interior is well lit, due to the four large windows located across the southern, eastern and western elevations (Figures 32 -35). The windows are all metal framed, single glazed units, which provide little insulation and in addition to the gaps around the timber double doors; increase air movement throughout the building.

The well-lit nature of the interior space, increased air movement between the internal and external environments and exhaust fumes from the storage of regularly used farm equipment (Figure 32), will reduce the building's suitability to support roosting bats.

Figure 32– showing large internal void, with no separate roof void and farm equipment

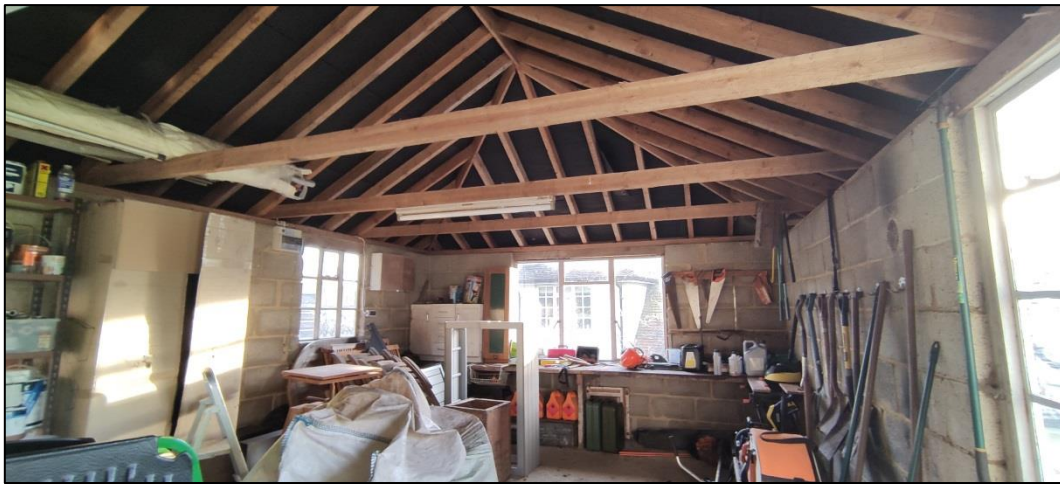
The roof structure is constructed from modern timber rafters and trusses. These were in all in good condition, with no gaps or joints that could be utilised by bats (Figures 32 to 33). The underlay beneath the primary roof covering (Figure 33) consisted of Type 1F bitumen felt, which was in very good condition, with no sagging areas, tears or missing sections.

Figure 33– showing internal light levels, modern timber trusses and single glazed windows

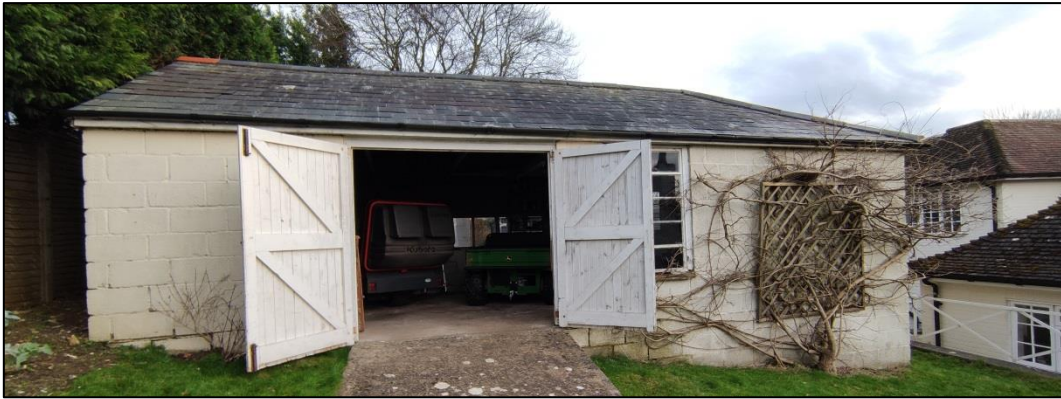
The external walls of the Tractor shed consisted of concrete breeze-blocks on the southern, western and eastern elevations (Figures 8, 34 and 35). On the northern elevation there was timber weatherboarding on the upper half of the external surface (Figure 36). The timber weatherboarding consisted of modern machine-sawn planks, which were all tightly fitting with no gaps between them that could be utilised by bats (Figure 36). No mortar was present at the verges on the northern gable end. As a result there were some small gaps (<5mm), between the uppermost weatherboards and the slates on the roof. The size of these gaps, low height of the roof (<2m) and the presence of a fence and trees within 1.5m of any potential access points (Figures 34 and 35), severely reduce the potential for use by bats: this is due to a greatly increased risk of predation for any bats using this area.

Figure 34 – showing large double doors, slate roof and single glazed windows

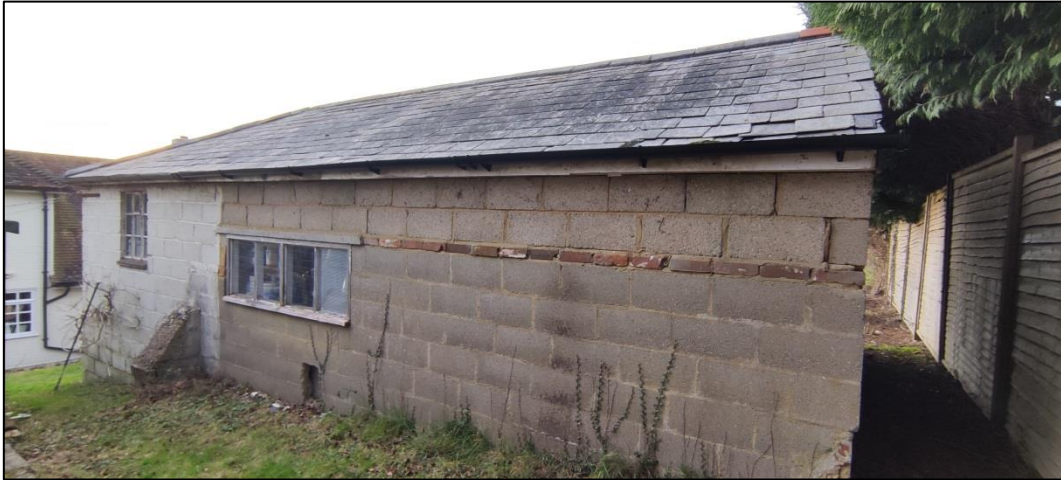
Figure 35– showing breeze-block construction and proximity to fence and trees

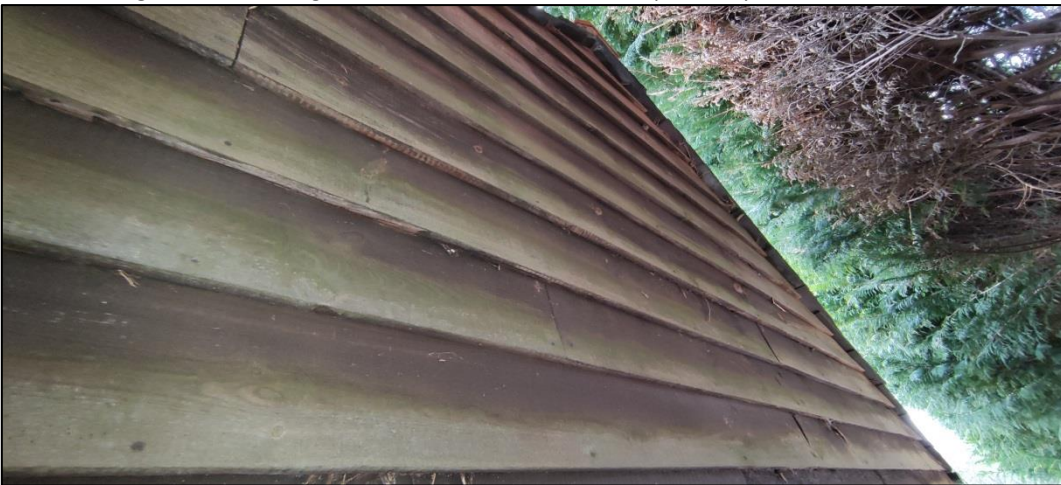
Figure 36– showing tightly fitting weatherboarding and proximity to trees

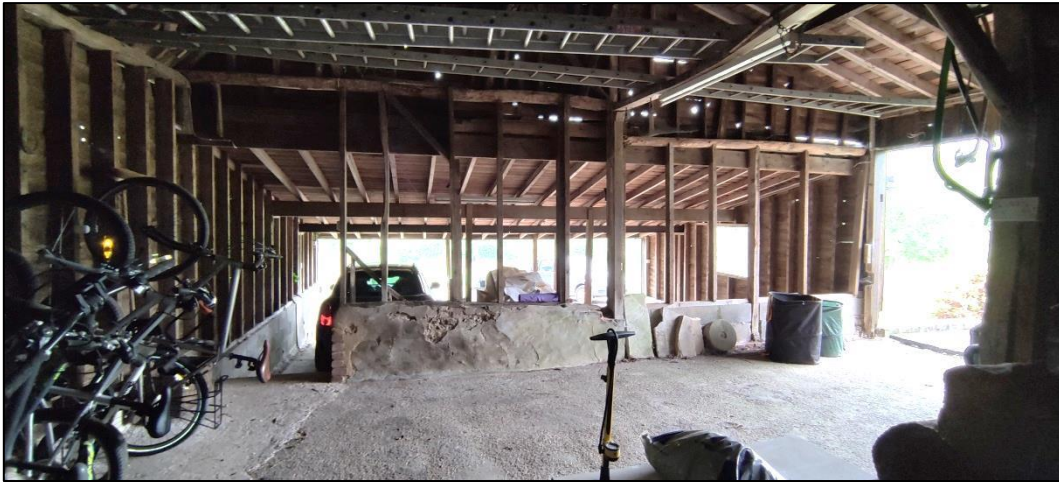
The single-skin, timber weatherboarding on all enclosed walls (Figures 38 – 40), has numerous gaps throughout the building. Consequently it provides very little insulation for the interior space. Internally, the building is one large void, with no enclosed roof space, that could be used by roosting bats. The interior is well lit, due to the open wall on the southern-most elevation (Figures 11 and 38) and the large opening on the western elevation, where the barn doors would once have been (Figures 10 and 39). The open nature of the barn results in continuous air movement throughout the building.

The original roof structure is constructed from natural, hand-hewn timber rafters and trusses. The complex wooden beam structure is exposed, along with the underside of the wooden sarking boards that support the slate tiles (Figures 38 and 39). The hand-hewn timbers in the northern section of the barn have numerous rustic mortice joints, notches (Figure 40) and holes; many of which could provide roosting opportunities for crevice-dwelling bats.

Figure 39 – showing light levels and open sides around the barn

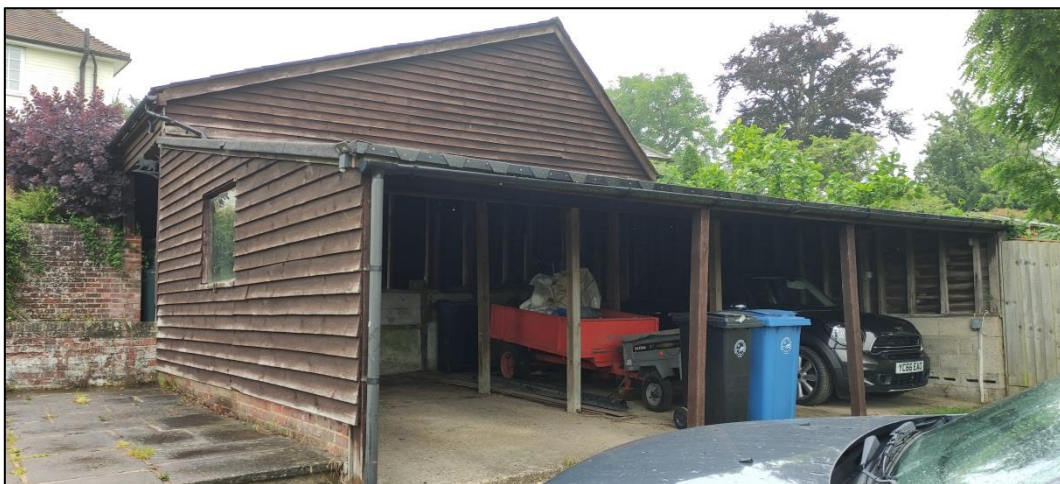
Externally, the original section of the barn at the northern end has an asymmetrical pitched (gabled) roof, with a slate covering (Figures 45 – 47). The smaller section of roof crosses into the neighbouring garden (Figures 47 and 48); which sits at a higher level and gives a clear view of the roofs condition. Externally, the slates appear to be fixed directly onto the sarking boards below, meaning there is no batten space that could be utilised by crevice-dwelling bats. There was only one gap across the pitched section of the roof, which provided some roosting potential for bats. This was located close to the ridge, on the eastern elevation; where a missing slate resulted in a gap providing access under the ridge tiles (Figure 48). There were also numerous gaps along the verges of the pitched roof, where the weatherboarding and slates did not meet. However, as the weatherboarding was a single layer, these gaps led directly into the internal void.

The sloped flat roof on the southern end of the Barn, consisted of bitumen roofing felt fixed directly onto the sarking boards (Figures 45 and 46). The felt covering was in good condition, with no lifted sections and no obvious gaps that could be utilised by bats. There are numerous potential entry/ exit points for bats around the exterior of Building 7, including; open walls, gaps in the weatherboarding, gaps at the verges and eaves and potentially at the ridge tile.

Figure 45 – showing open end used as a garage and weatherboarding on the exterior

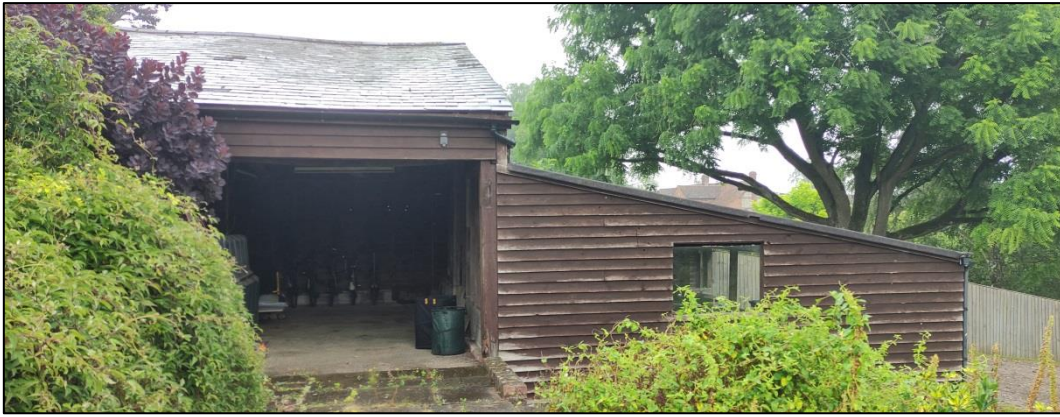
Figure 46 – showing open area where doors would have been and sloping bitumen roof

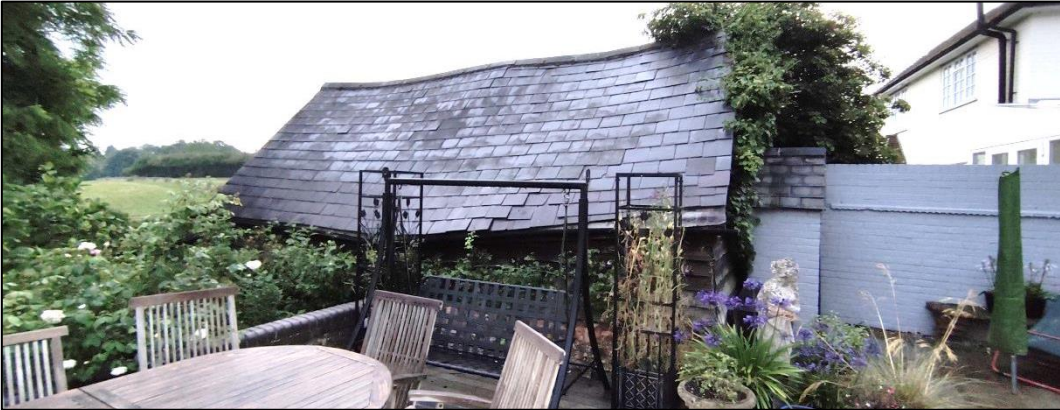
Figure 47 – showing side of barn in neighbour's garden, with higher floor level

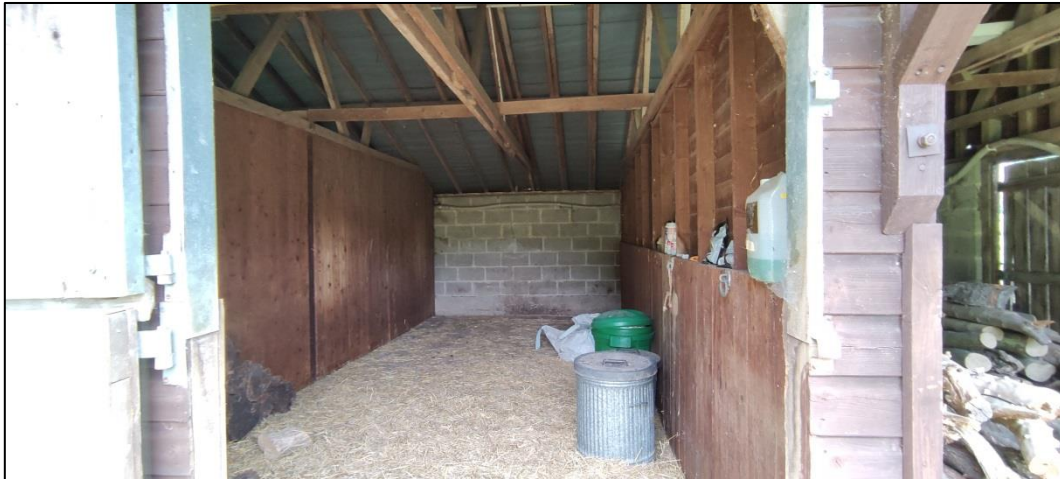
As with the other two outbuildings inspected during the updated roost assessments; internally Building 8 consists of a single large void, with no separate roof void that could be used by bats. The internal space was partitioned into four sections, by two timber walls that extended to just above eaves level (Figure 49). Chicken wire was fitted between the roof and top of the timber partitions (Figures 49 and 50), which would prevent bats being able to fly along the length of the building. The two gable ends were constructed of a single-skin, breeze-block walls to the eaves level with single-skin weatherboarding panels on the upper sections (Figure 51).

The roof structure is constructed from modern timber rafters and trusses. These were in all in good condition, with no gaps or joints that could be utilised by bats (Figures 49 to 51). The underlay beneath the primary roof covering (Figure 33) consisted of reinforced plastic sheeting, which was in very good condition, with no sagging areas, tears or missing sections.

Figure 49 – Showing timber walls partitioning the interior of the stables

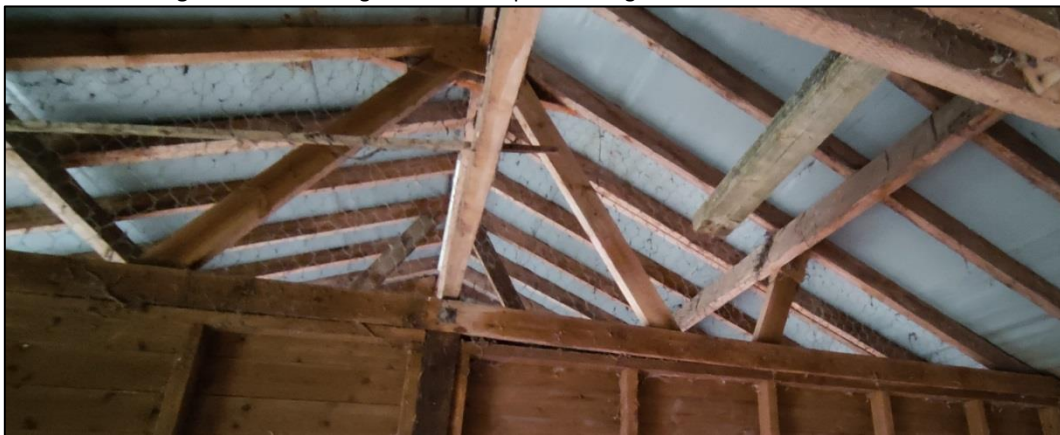
Figure 50 – showing chicken wire over the gaps above timber partitions

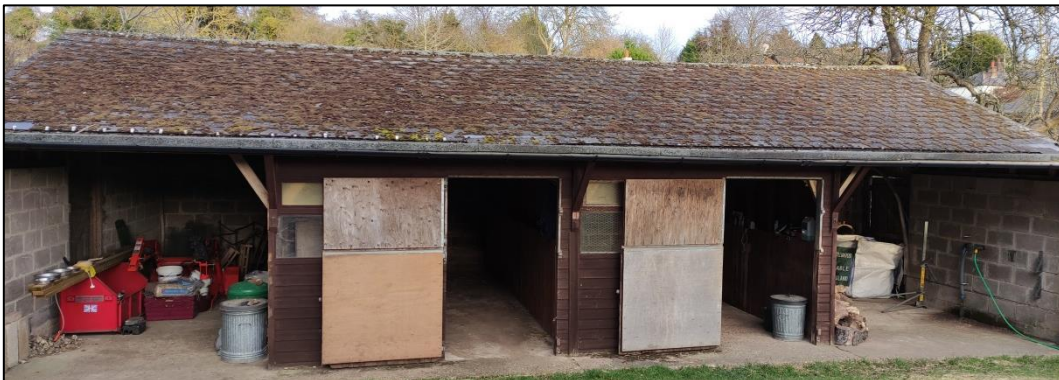
Building 8 is a modern stable block (Figure 51) located in the western corner of the site. The external walls are constructed from concrete blocks with wooden panel cladding on the exterior. The south western aspect of the building is completely open, allowing a large amount of light and air to enter. The roof is pitched with slate tiles on top of a plastic underlay; the tiles are in good condition with no obvious gaps suitable for use by bats. The external walls are covered with timber weatherboarding, which in general is very tightly fitting (Figure 53). However, there are gaps at the gable ends of the building, especially noted along the verges which may be suitable for roosting or accessing the batten space under the slate tile covering.

Figure 51 – showing open sided nature of the stable block and slate roof

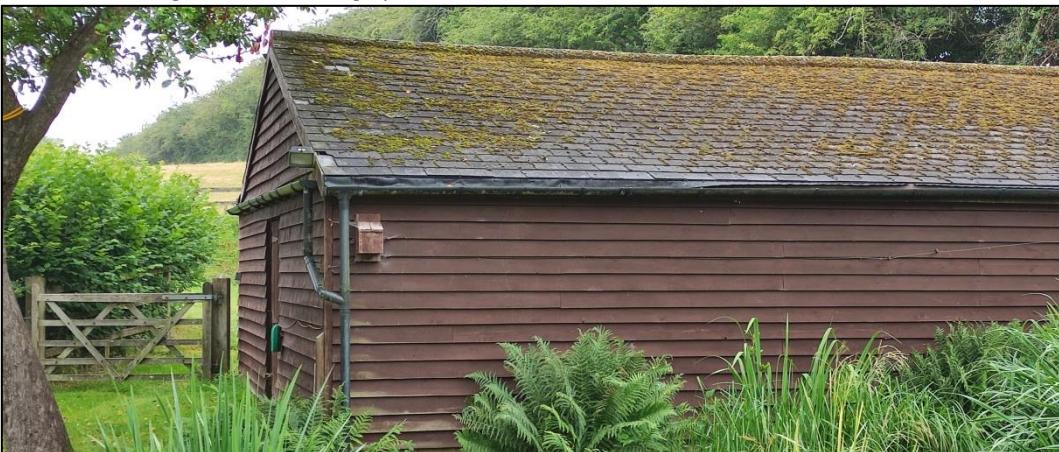
Figure 52 – showing slate tiles and weatherboarding covering the external walls

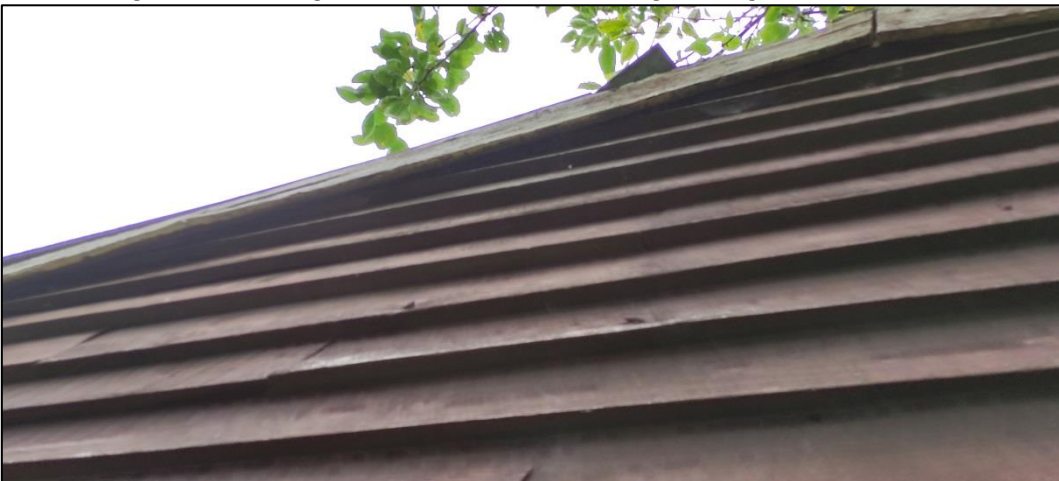
Figure 53 – showing tightly fitting weatherboarding found on majority of the building
