Asbestos Pre-Refurbishment and Pre-Demolition Survey 2021

WOODLAND FARM RINSHALL STOWMARKET SUFFOLK, IP14 2LY

Survey Type Asbestos Pre-Refurbishment and Pre-Demolition Survey

Project Number TAL 04062

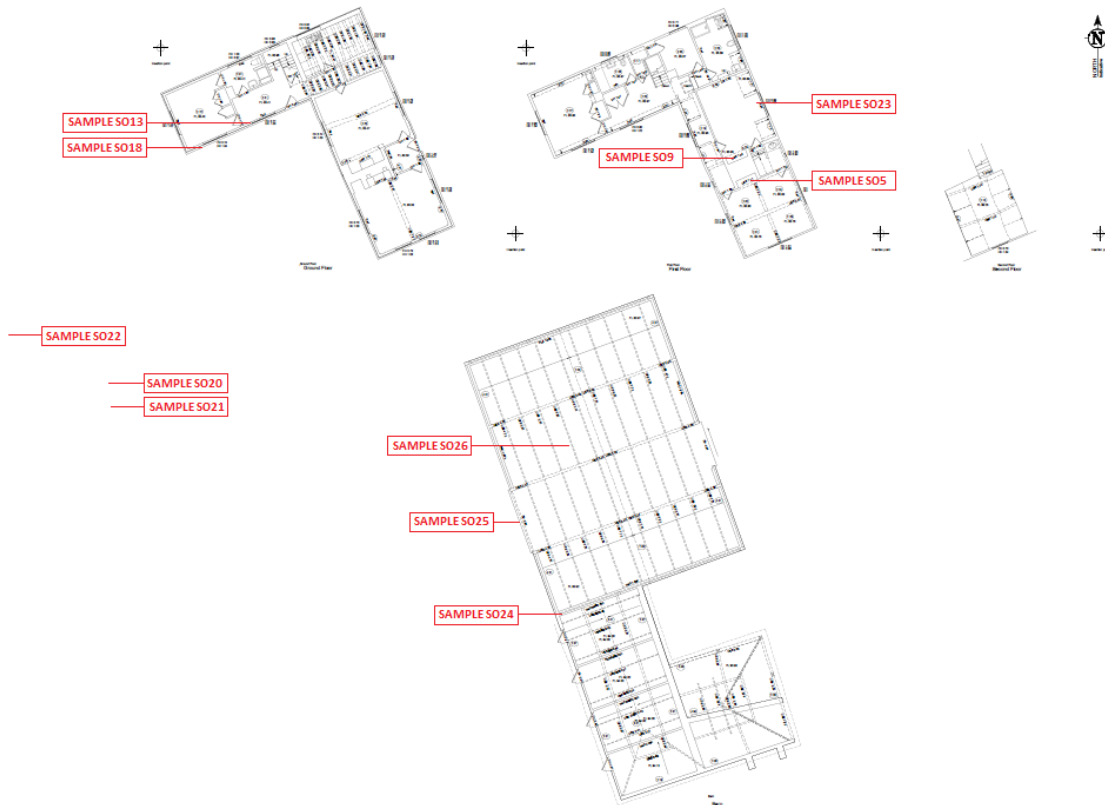
16.0 - Site Plan

Note- The arrows marked on the floor plan only indicate POSITIVE (ACM's) and the area the samples were taken from, please see material assessment notes and Asbestos register for all areas that contain Asbestos materials.
