BS5837:2012 Tree Survey  
 Land at Muffins Gap  
 Lombard Street  
 Orston  
 Nottinghamshire  
 NGR SK76797 40787

Report prepared by: C Barker	Date Issued: 15 January 2021
	Reviewed by: KLB	Report Version: V2
	Report ref: <b>P2167 /1120 /01</b>	C B E Consulting Highbank, 5 Grantham Road, Navenby Lincoln. LN5 0JJ. Telephone (01522) 810086. <a href="http://www.cbeconsulting.co.uk">www.cbeconsulting.co.uk</a>

# BS5837 Tree Survey, Land at Muffins Gap, Orston

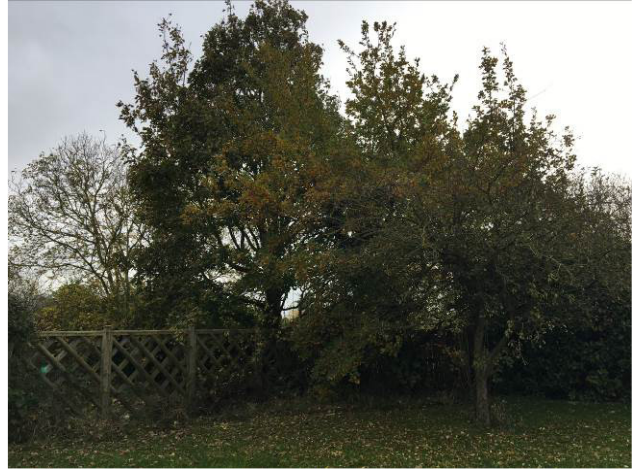
T12 – T16

**Trees G12 – G29** are situated along the southern boundary of the garden within or close to the boundary hedge although individual tree **T17 and T18** are positioned in an island border within the lawn within the garden interior.

These trees represent some of the better specimens planted within the garden with a number being placed within Categories A and B. Supported by the boundary hedgerow these trees providing screening and shelter to the garden within a linear canopy. However, crowding is becoming an issue and some thinning is advisable to retain good quality individual specimen trees for the future.
