BS5837:2012 Tree Survey  
Land at The Cottage  
Mill Lane  
Normanton on Trent  
Nottinghamshire  
NGR SK78998 69036

Survey by  
Christopher Barker CEnv dipHort ACIEEM

Report prepared by: C Barker	Date Issued: 15 December 2021 Report Version: V1
Reviewed by: KLB	C B E Consulting Highbank, 5 Grantham Road, Navenby Lincoln. LN5 0JJ. Telephone (01522) 810086. <a href="http://www.cbeconsulting.co.uk">www.cbeconsulting.co.uk</a>
Report ref: P2444 /1221 /01

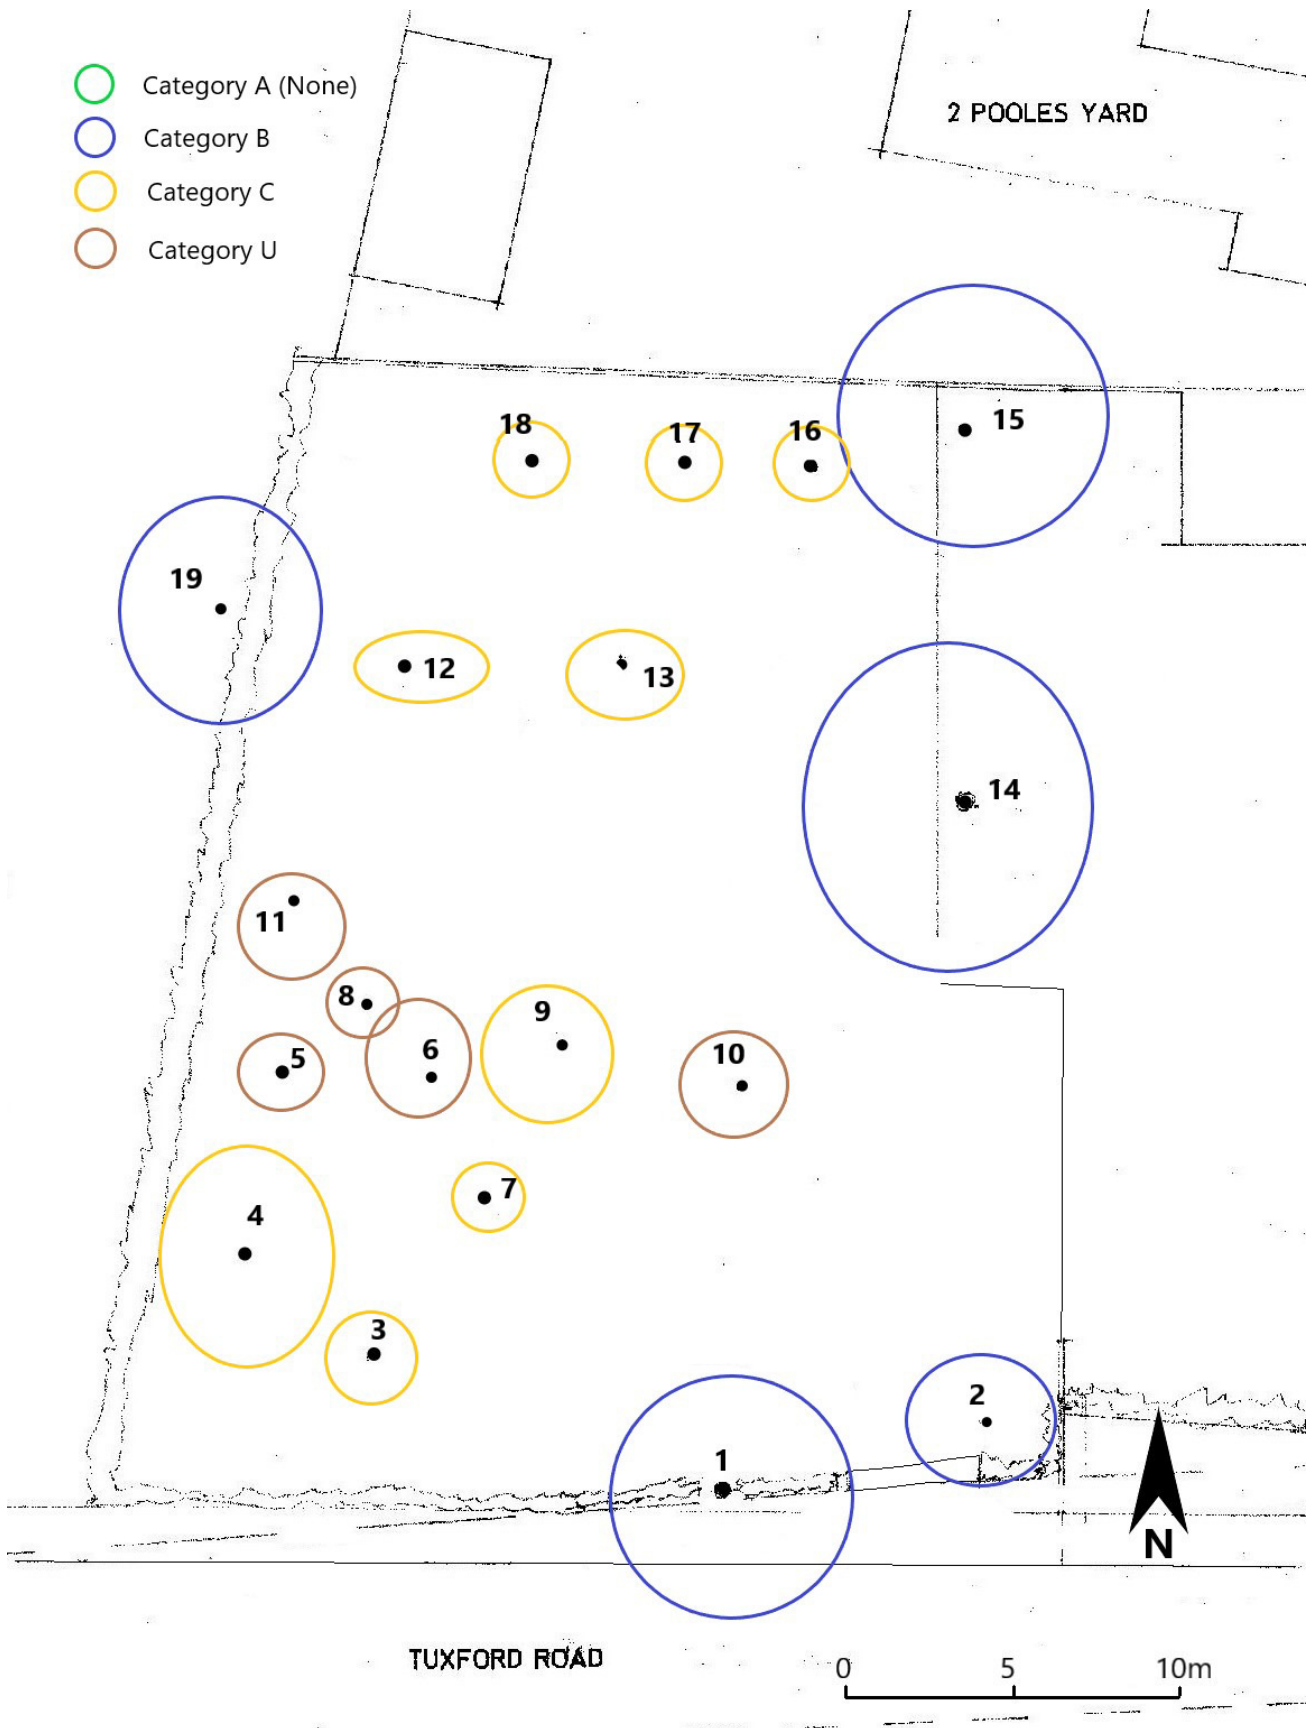
Figure 3 – Tree Category Plan

The position of significant individual trees or groups of trees measured out on the site is shown on the Tree Location Plan **Figure 3**. Within the summary table (**Appendix 1**) a calculated corresponding radius of the circle for each RPA has been calculated. The Root Protection Areas are formulated to assist when designing layouts in relation to trees and the calculated RPAs in Appendix 1 should be used to inform the design layout of this site. At the time this survey was completed a conceptual development plan was available and this has been used to assess the potential impact of the proposed development within **Figure 4**. If this development plan changes **a detailed Constraints Plan showing RPA's and protection areas will need to be prepared using the development plan as a base.**

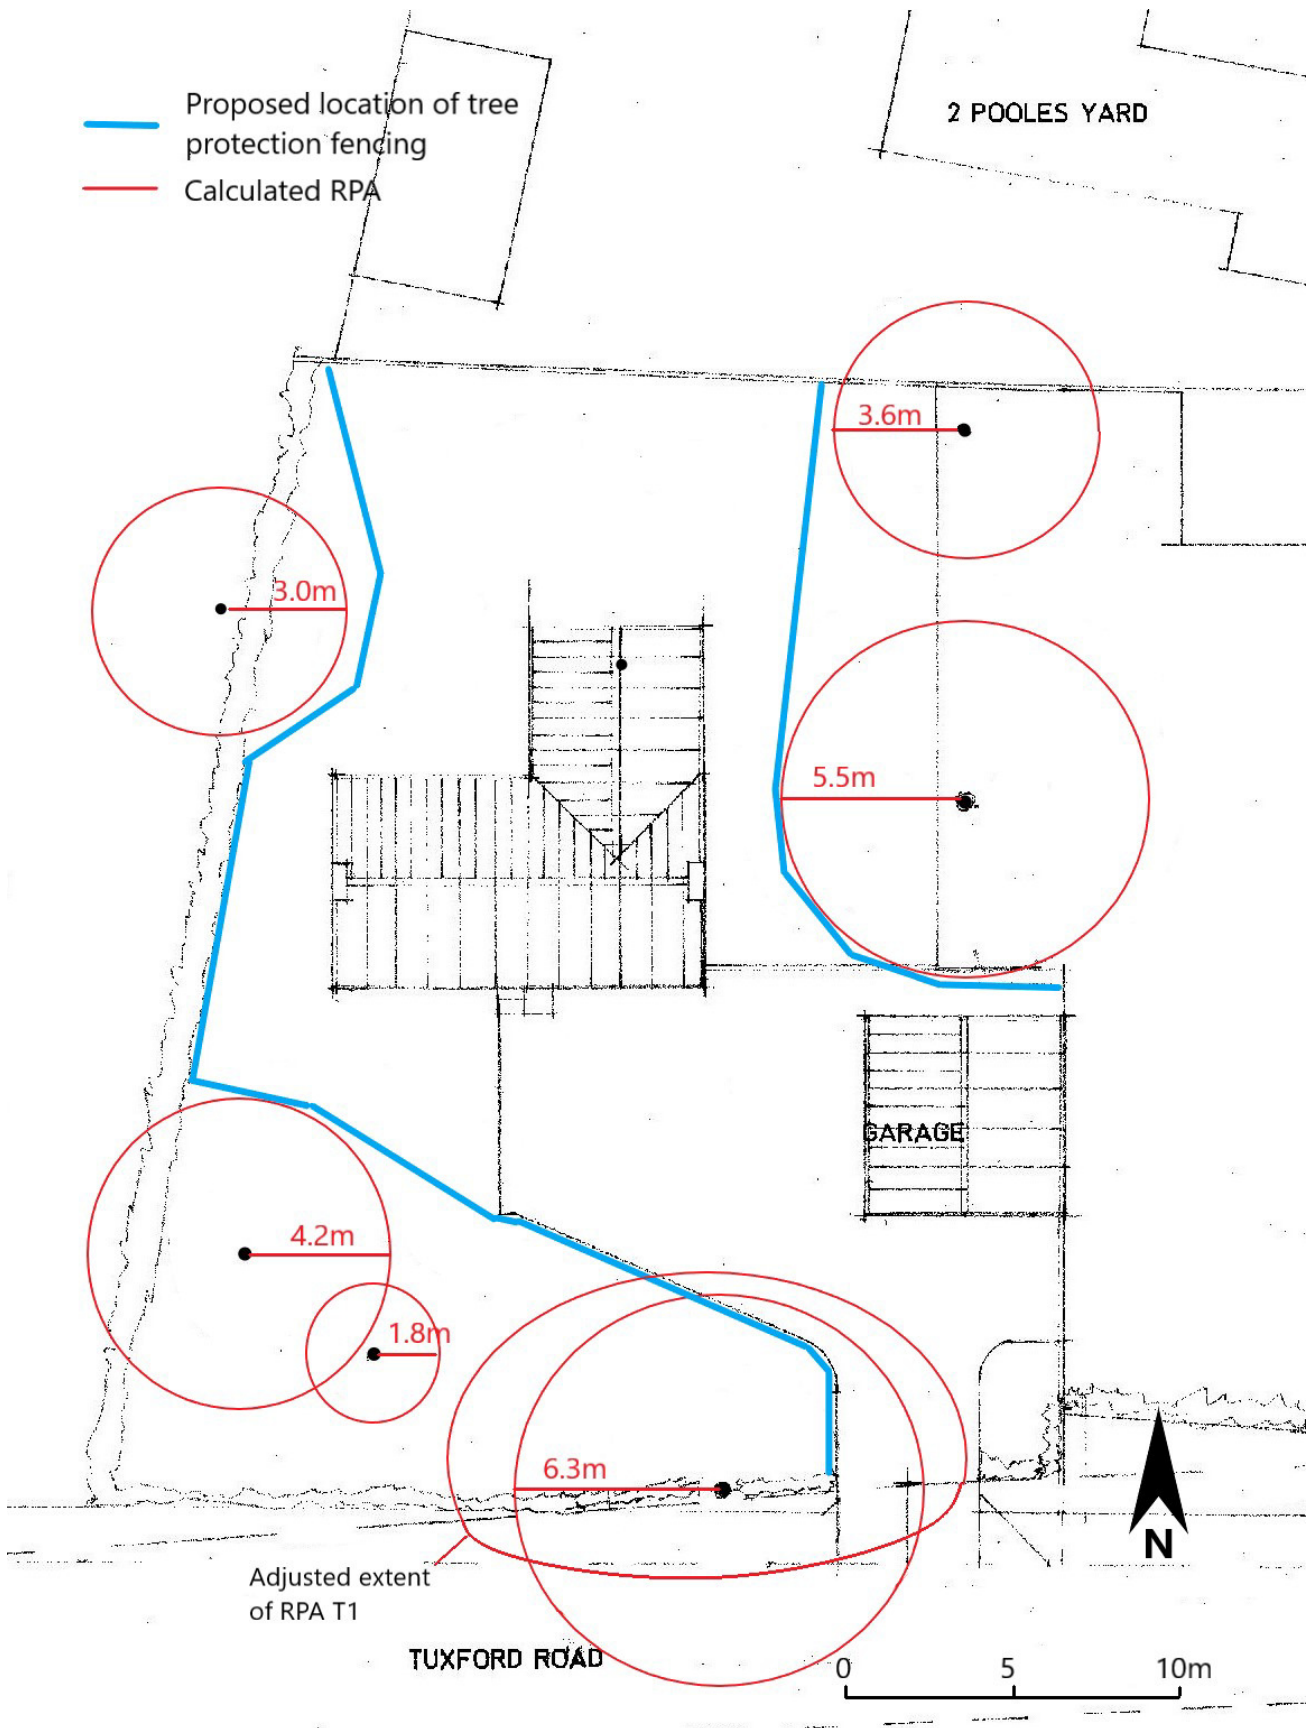
Figure 4 – Root Protection Area Plan

In the context of this site the proposed development comprises a new detached residential dwelling with a detached garage, accessed from a new driveway off Tuxford Road. The proposed position of the new building and access is shown within **Figure 4**. The table below summarises the potential impact of the proposed development based on the layout provided on the trees present within the area surveyed.
