Barry Hillman-Crouch
Design & Recording Services

Phasing and Discussion

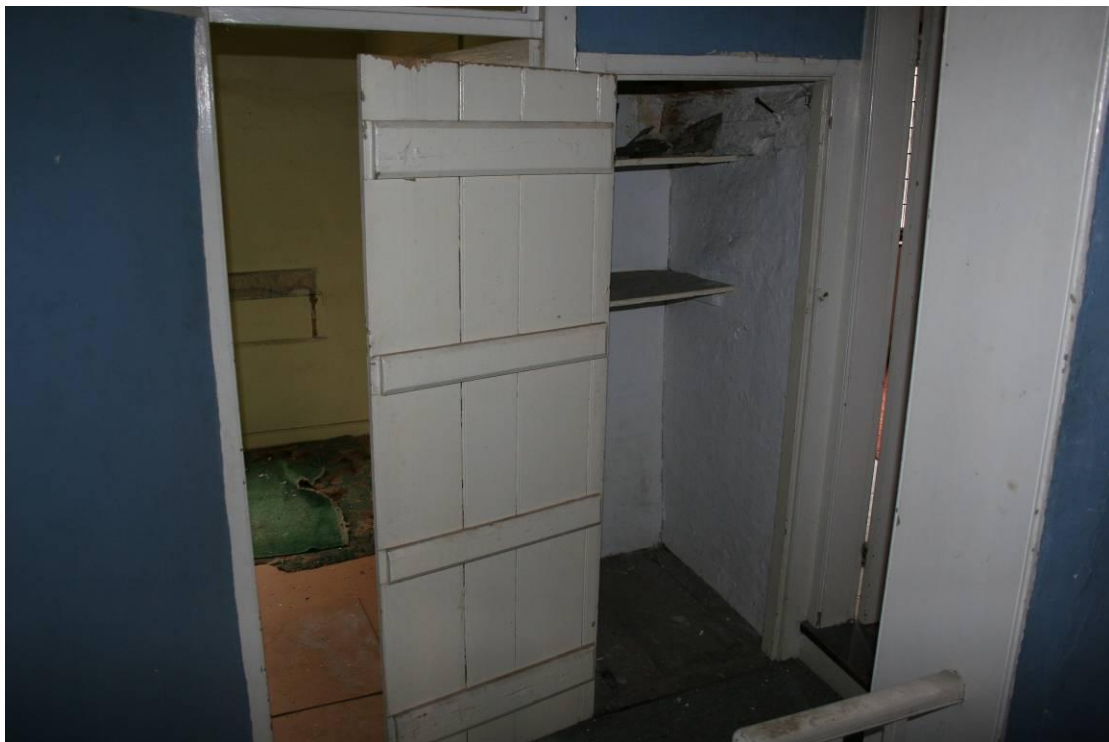
The Landing closet with C19th door.

There is a built in closet of 1950's style but there is also a C19th linen closet accessed from the Landing. This has a machine made edge-moulded vertically boarded door with four ledgers and is hung on flat-strap hinges all screwed in place. The arrangement of a linen cupboard at the top of the stairs is a very common LC19th feature in older houses.

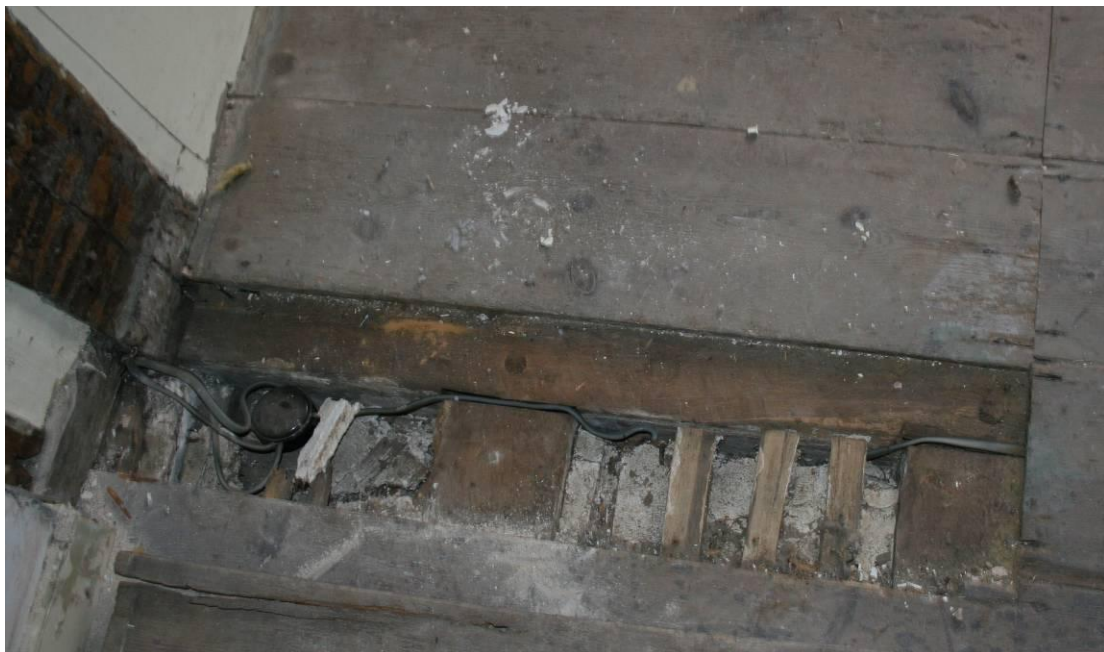
The first floor frame by the storey post.

The storey post in the north partition wall has a redundant mortice as though for bracket and the cambered tie-beam has a an empty mortice for an axial main joist. This would indicate an older ceiling has been removed and the current one put in at a higher more comfortable height. The first floor frame can be seen correctly pegged with 6in flat joists. The oak boards have riven laths applied with a thick lime mortar between the joists.

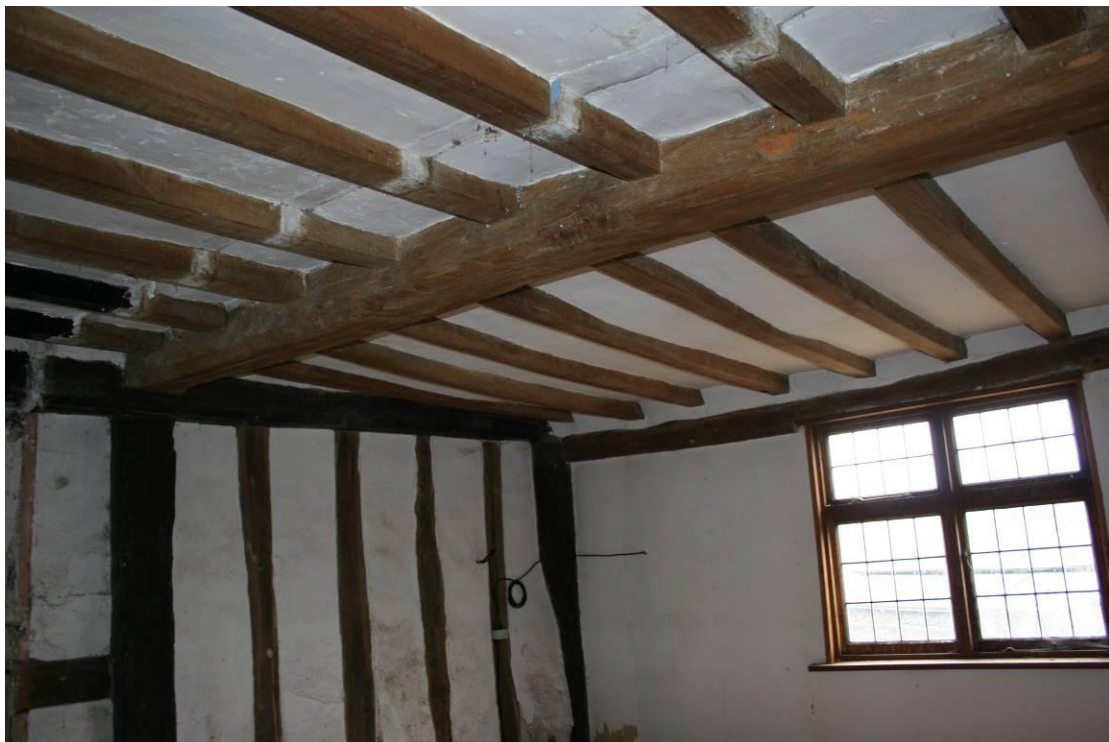
Detail of the attic floor frame.

There is a c.1800 brick firestack that rises from the Kitchen (where it serves the Aga) with a very small fireplace for a cast iron insert or even a stove. The Kitchen staircase rises beside it in a precarious way such that it would be easy to fall down it. Another staircase rises to the Attic Room above and passes behind the firestack. The attic floor is exposed and has near square common joists set on edge in a deep main joist with a rough chamfer and sharp cut stops. The floor appears inserted in the C17th.

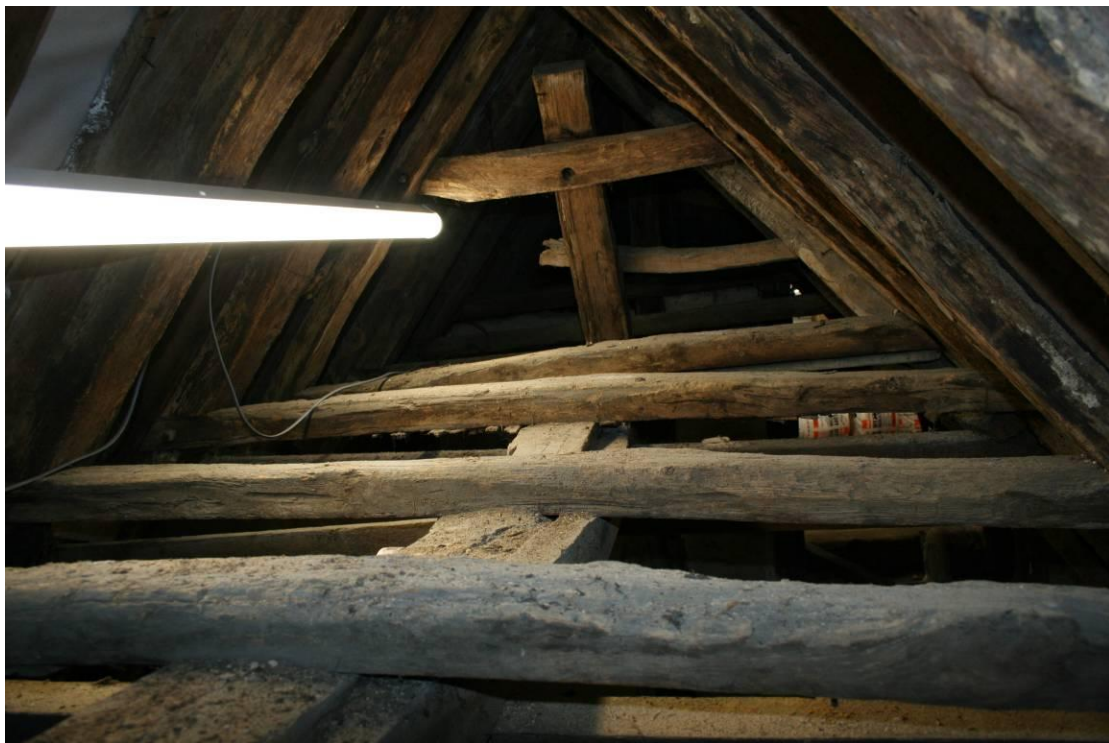
Looking S over the collar purlins. The upright is part of a hipped reinforcement.

There is the remnants of a crown post collar purlin roof over the central hall and over the Attic Room (where it is hidden by Rockwool insulation).

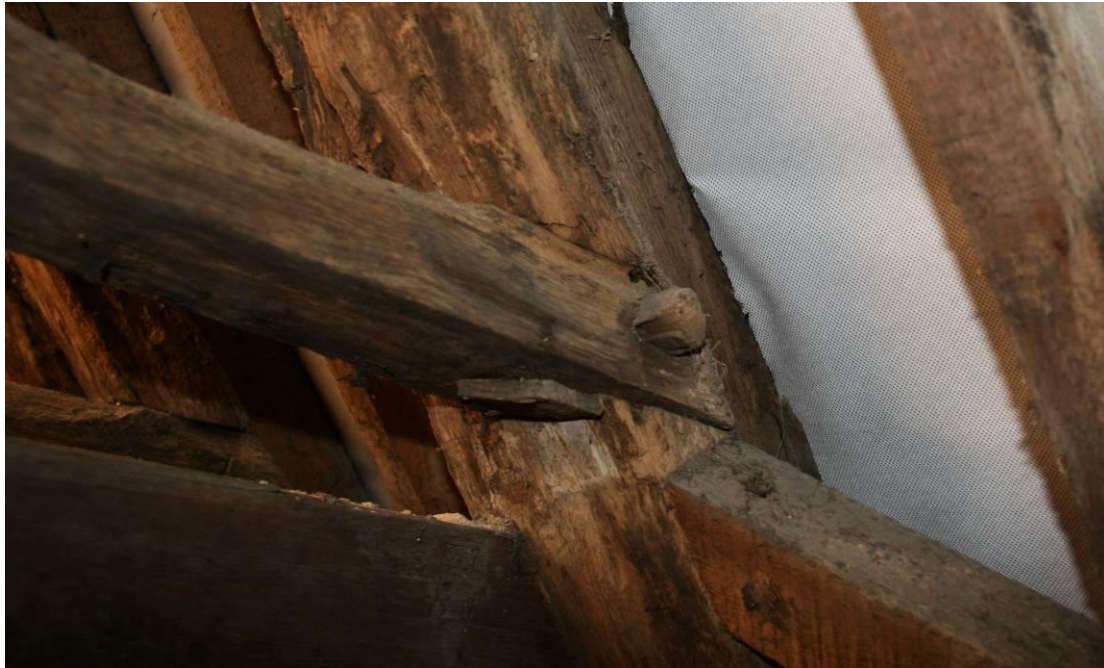
Detail of one of the side lapped collar purlins.

The original flat rafters are paired with side lapped collars resting on the collar purlin which has broken its back historically and has several ad hoc repairs. The rafters are blackened as would be seen in an open hall. The roof space has been crowded by C18th, C19th and C20th ad hoc repairs and insertions including EC20th side nailed plank collars. The collar purlin has been cut short and hipped struts inserted to prevent it rotating. These look Georgian but are also reinforced with E-MC20th machined struts. The two gables on the eastern elevation are M-LC20th structures made from machined softwood and rendered with EML. They replace Victorian additions of which only a few timbers remain.

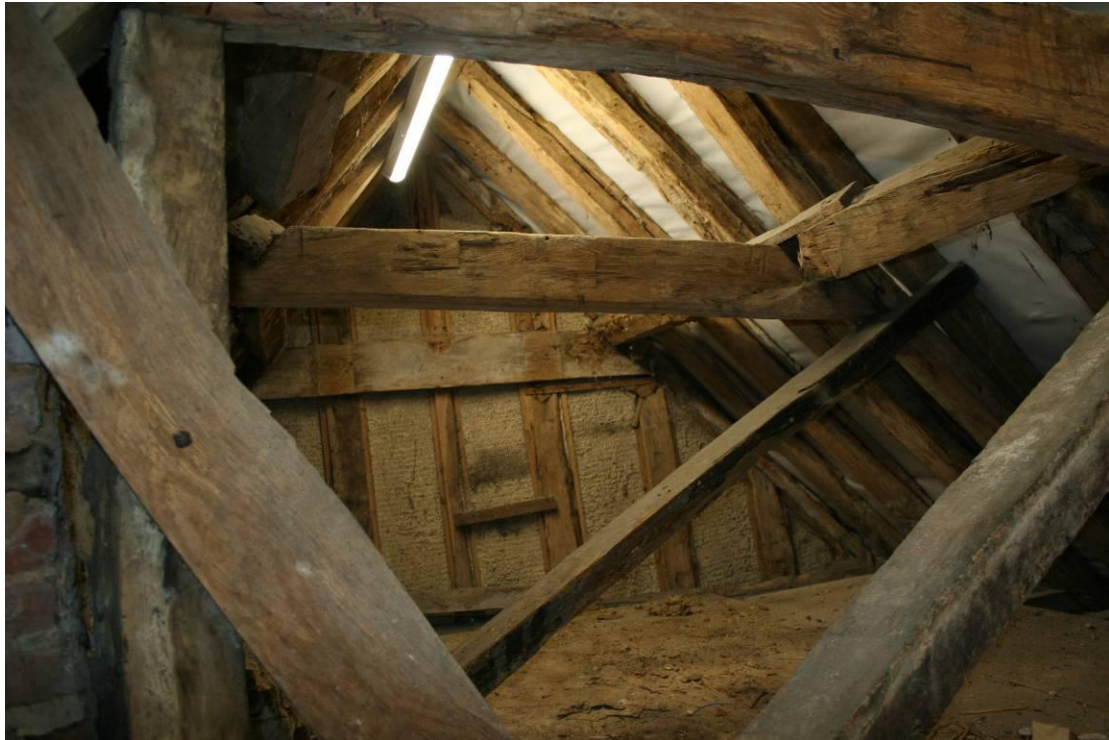
Looking NE in the Cross-wing over Bedroom 5.

The cross-wing has a clasped side purlin roof with heavy, slightly cambered collars and deep section purlins with simple scarves that have split apart. The paired rafters are numbered in sequence and there are several hand hewn blocks nailed in as gussets with heavy C18th style clout nails. The rafters are set on edge which would suggest they are C17th or later.

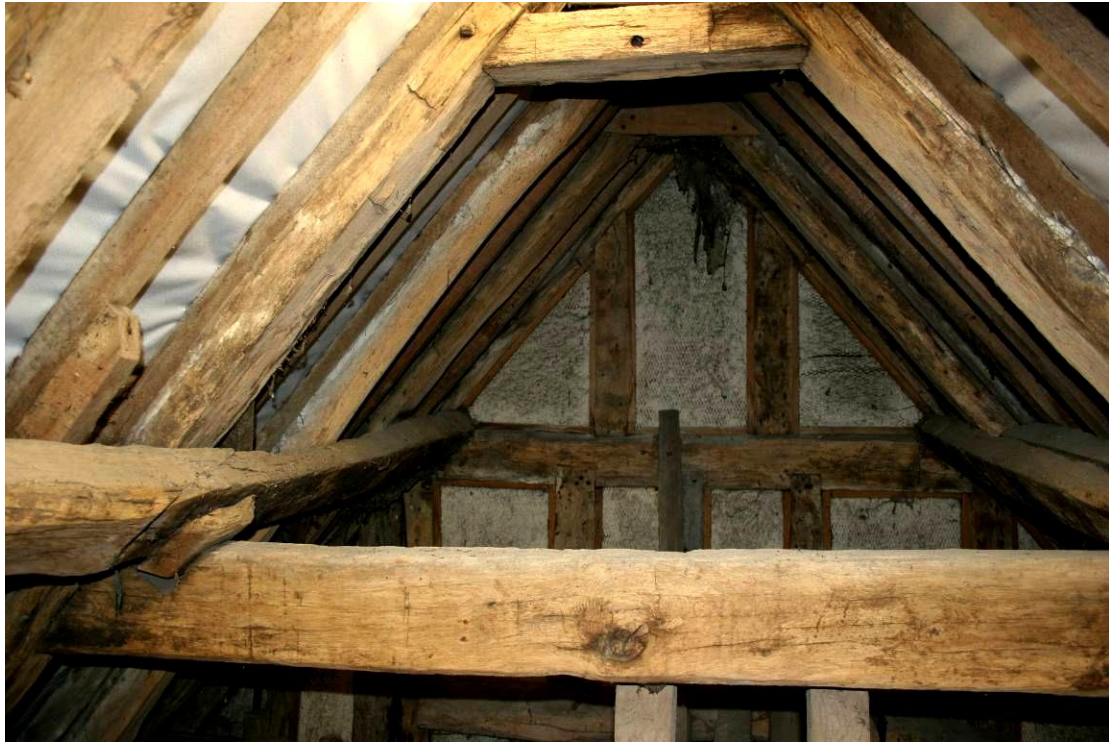
Looking W in the roof over the Rear Cross-wing Bedroom 5.

There is a fully framed partition between the east and west bays of the cross-wing. Parts of the frame were removed to add the chimney which cants over to the ridge in C19th style. The gable end has been rebuilt with side nailed studs in Georgian style and the exterior finished with hard render on EML.

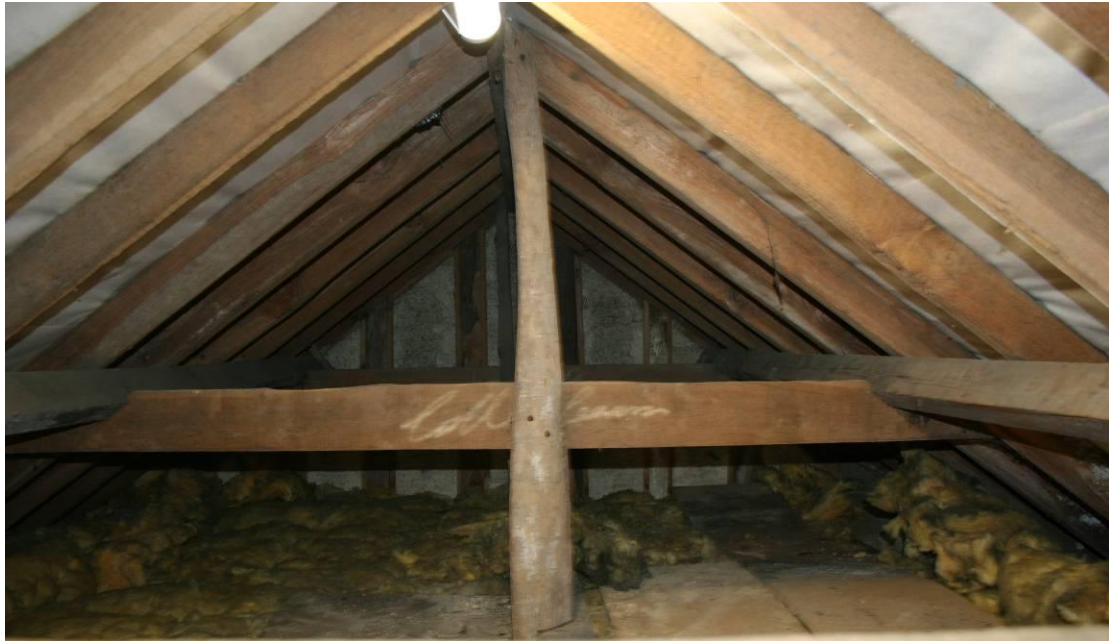
Looking W in the roof over the central extension.

The roof over the central extension is LC19th and made of machined timbers with narrow section rafters on edge and nailed to a ridgepiece. The roof is a simple clasped side purlin design with two plank collars each marked in chalk 'Collarbeam'. Most of the rafters are recent 2x4in machined softwood. The ceiling beam is support by a hand cut hanger side nailed in place.

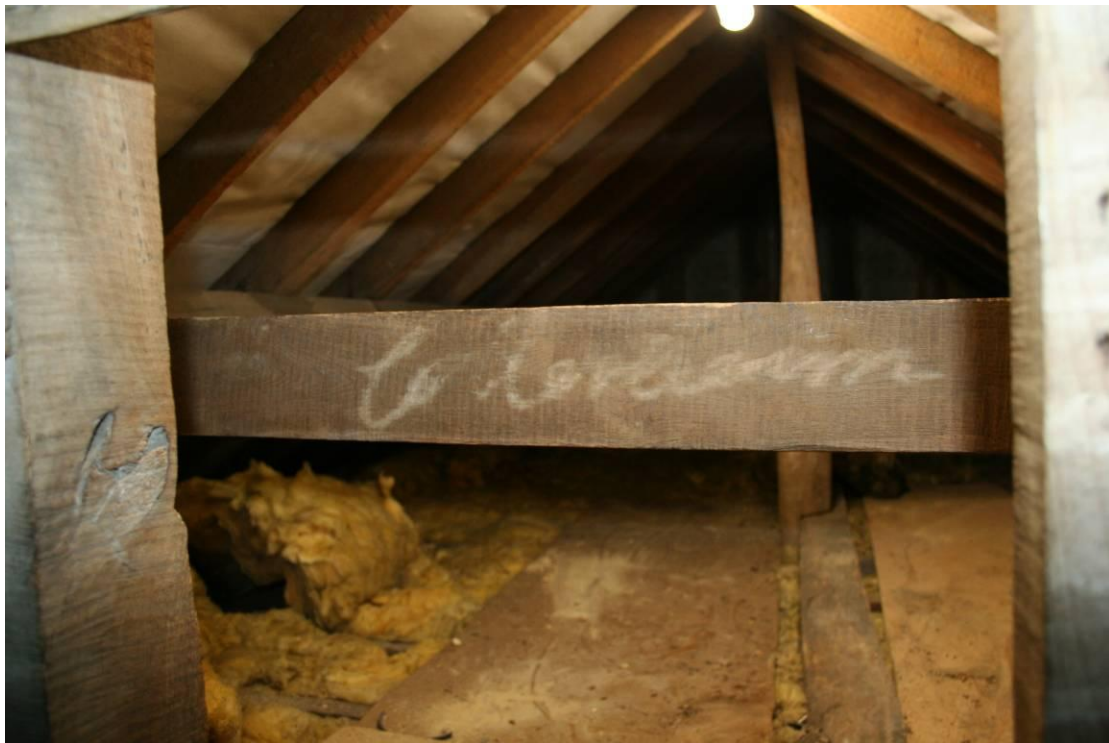
The collars have a title chalked on them.
