BARNS K, L, and M Report on a Visual Inspection of Proposed Barn Conversions Under Permitted Development (Class Q) at Rose Farm, Shapwick Road Westhay, Glastonbury, BA6 9TU for the T W Willcox Will Trust

- Version 2
- 26 September 2022

MBE REF-MBE-2021-025-Rose Farm Barns – KLM – v2

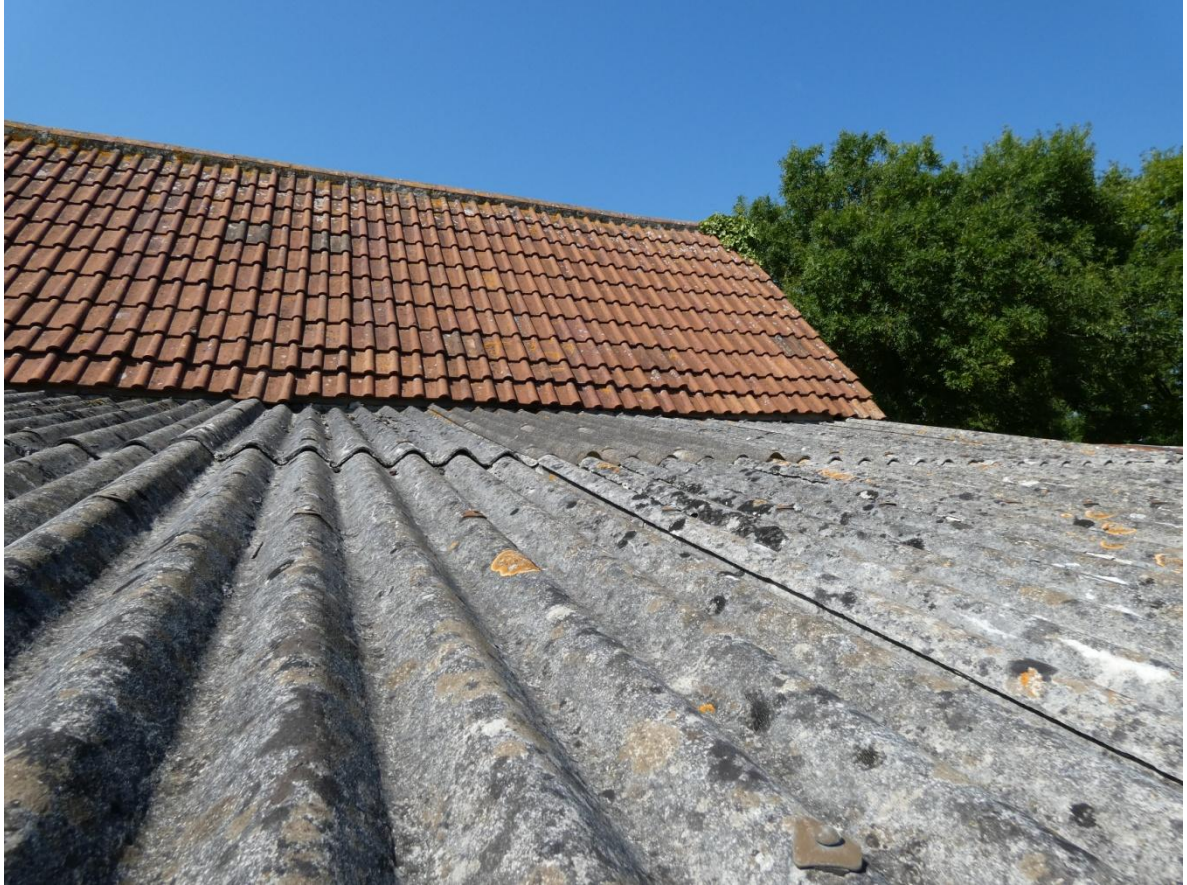
Photo 10 – Barn L / M roof – Viewed from east elevation of Barn M looking west (cont'd)

- 3.5.14 The roof timbers are generally showing signs of insect attack and timber decay. Some portions of the roof have collapsed where the lathings / battens carrying the roof tiles have decayed as shown on Photos 9 and 23 in Appendix A.

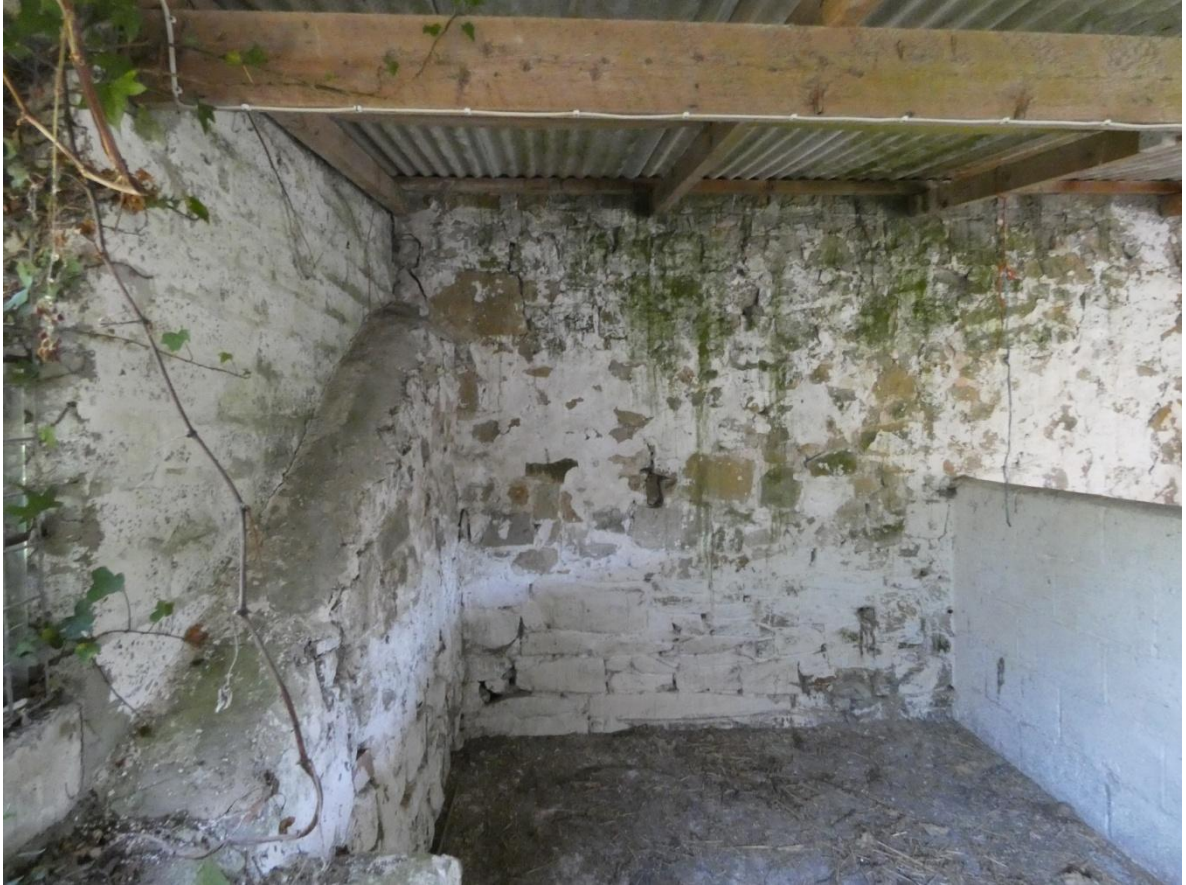
Photo 12 – Barn K interior – Looking to south gable of Barn L

- 3.2.3 Barn K is approximately 5 m wide by 5.75 m overall on plan. Barn K measures roughly 2.10 to 2.7 m high to the underside of the existing roof at the low and high eaves respectively. The internal arrangement of Barn K is shown on photos 12 – 16 in Appendix A.
