Historic
Building
Recording

FORMER AGRICULTURAL BUILDING NORTHWEST OF FIELD HEAD

Newbiggin
County Durham

Project 416-22-HBR | April 2022

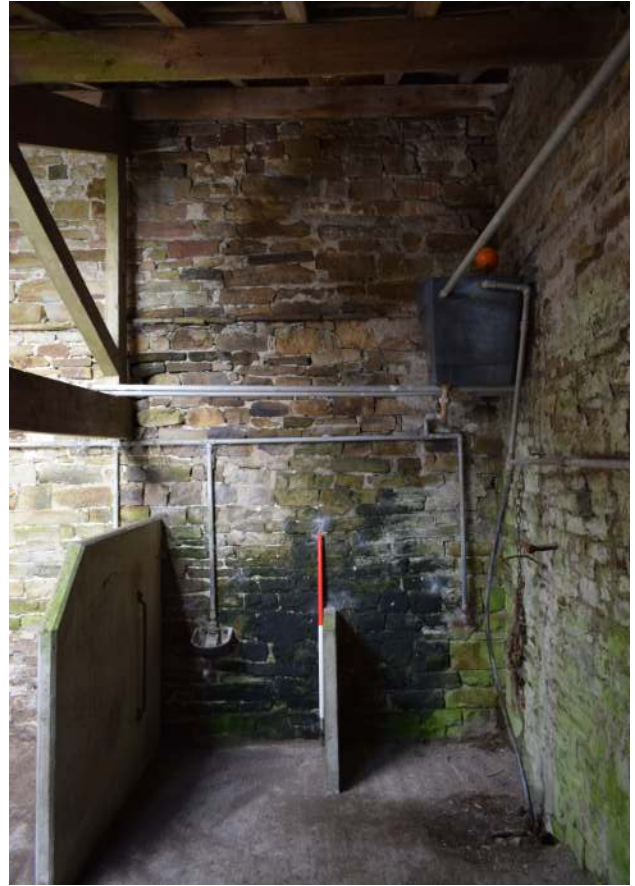
Plate 38. Animal stalls

- 4.3.5 Plate 34 shows doorway D3 from the byre.
- 4.3.6 Plate 36 shows the location of opening W9. From this side of the dividing wall, the feature is recessed on its western side.
- 4.3.7 Plates 36-38 show a course of flat sandstones running through the wall springing from the eastern side of W9, at a height of approximately 2m from the byre floor. This seems to cap a lower wall build, suggesting that this section of the wall below the course may be repaired original construction.
- 4.3.8 The features in the southern wall comprise door D1 and windows W1 and W2. These can be seen on Plates 39-41 and are late 20th century in date.
