BUCKS PLANT CARE LTD

Arboricultural Risk
Assessment for
The Old Plough,
Peggs Lane, Buckland,
HP22 5HX

2022

BPC Ref: 20789

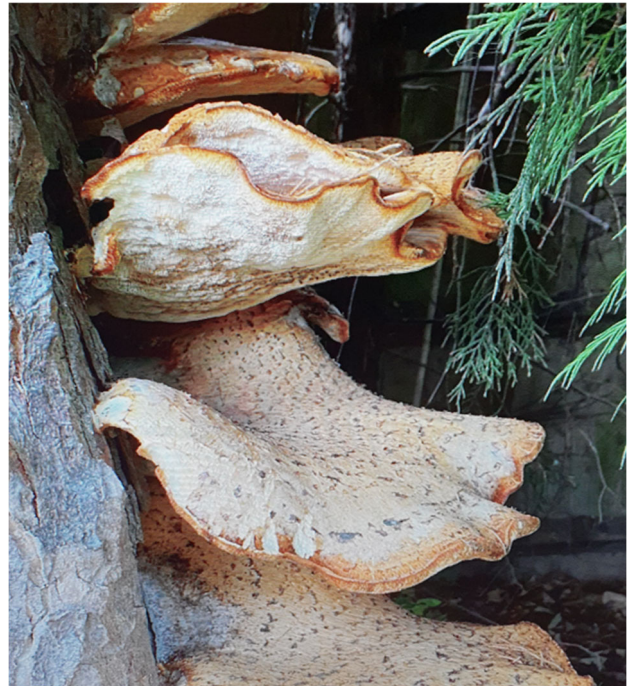
5.7. The fungi has been identified as Dryad's saddle (*Cerioporus squamosus*)

It is an annual white rot fungus, which is mainly found on beech trees, but can also be found on ash, poplar, sycamore, willow along with other broadleaf trees.

It is generally saprotrophic on dead sections of host with capacity to opportunistically colonise dysfunctional areas of wood, radiating towards the sapwood region. It can be found on

many parts of the tree such as wounds and cavities in this case.
