## The Old Rectory

Project Address: The Old Rectory, Clyst St Lawrence

Service: Timber & Render Condition Assessment

Our Reference: 212238/The Old Rectory/Report

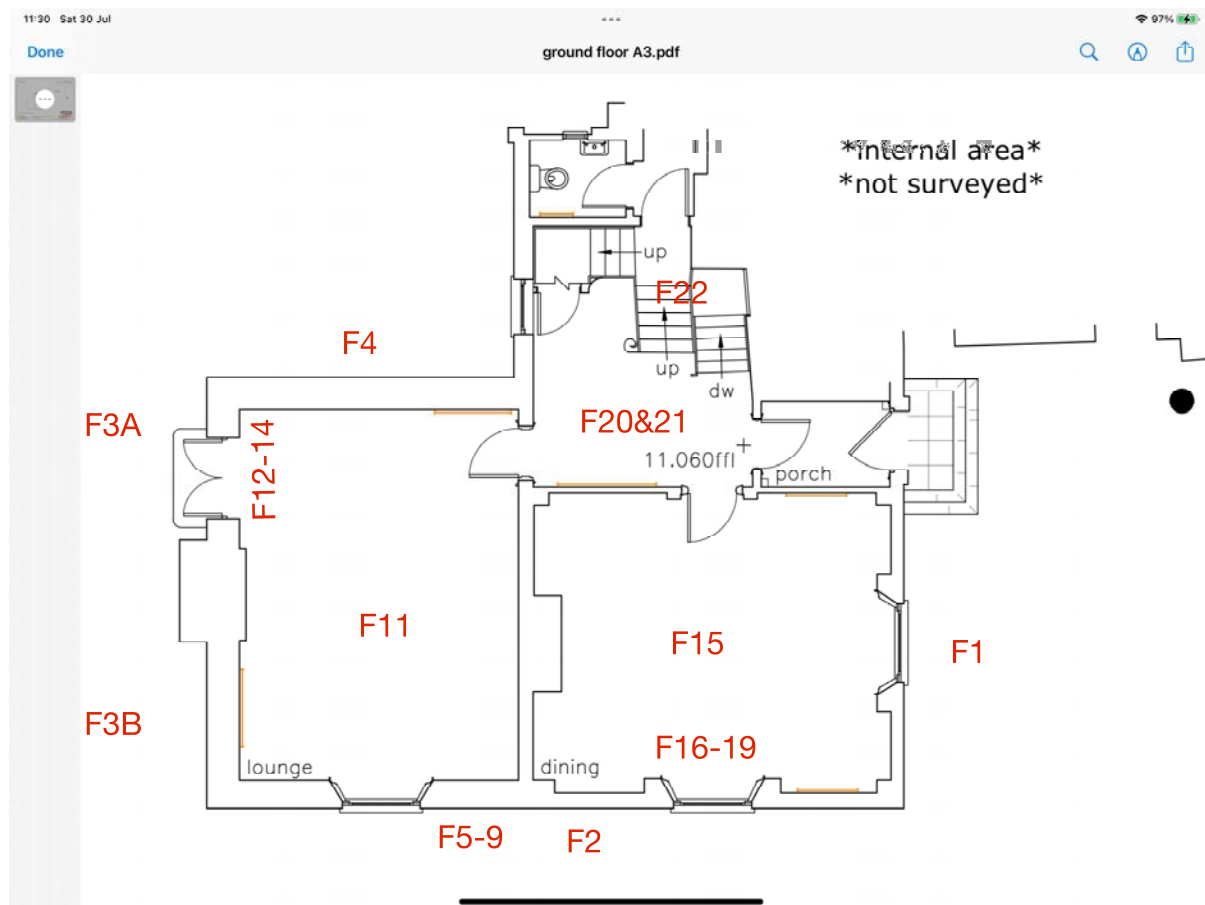
Figure10: Ground Floor Plan

I commenced my assessment in the ground floor rooms, with Figure 10 providing an annotated plan of the layout, with references to photographs .

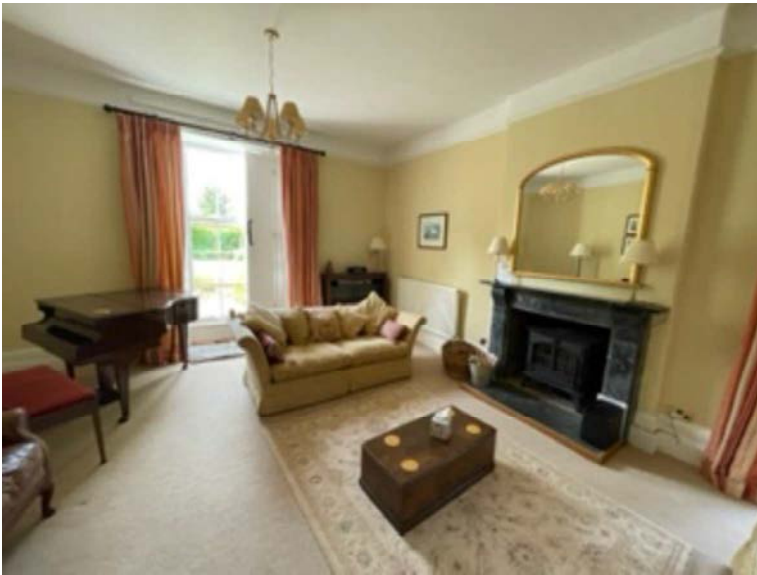
FIGURE 11: LOUNGE

The Lounge was fully furnished (see Fig.11). We focussed our attention on the area of the floor that was most deflecting, with the carpet rolled back along the westerly elevation.

Softwood timber floorboards were suffering fungal damage, with oak joists showing both fungal and beetle damage, being worst affected close to the bearing-ends. I used a Tramex moisture meter and recorded high moisture levels (above 20%) throughout the exposed area (see Fig.13), reaching moisture fibre saturation in locations close to the westerly wall; providing the optimal conditions required for fungal initiation.

In common with all other areas assessed, I used a hygrometer to measure humidity within the subfloor void. Figure 14 shows readings of 89.8%rh (relative humidity), with the moisture content of joists reflecting the high humidity levels within the sub-floor void. As a consequence of lifting floorboards and creating improved air circulation, I would expect the real sub-floor humidity levels to have been significantly higher. Of note, 90%rh is equivalent to 20%WMC, the *at risk* threshold that supports fungal development.

I found the 4 joists directly in front of the French doors to be decayed and requiring repair, however as further opening-up works commence, it is likely that more joists will be found to be defective.

It is thought likely that the rainwater discharged by the two downpipes directly outside the westerly elevation will contribute significantly to the subfloor humidity.

Additional to repairing the defective floor joists, and in order to provide a long term solution to the dampness that has facilitated the decay, I recommend the causes of subfloor dampness are further investigated. This investigation could include an assessment into the condition of nearby drainage and consideration how ground levels and surface water can be better managed around this area in particular, and the property in general.

The existing configuration of the joist bearing-ends means that they will always absorb moisture, accelerating deterioration, therefore I recommended that the joists-ends are isolated from masonry, and consideration is given to providing support from a sleeper wall.

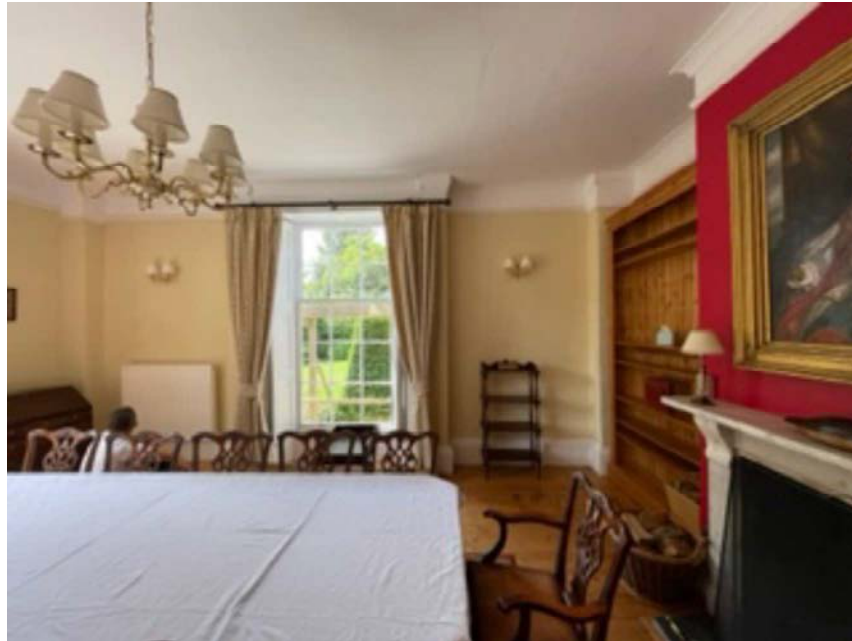
**Figure 15: Dining Room**

Figure 15 shows the Dining Room.

A section of the perimeter floorboard was lifted in front of the Southerly elevation. Again the joist-ends bear onto masonry, which has led to the timbers absorbing moisture and facilitating decay. Deathwatch beetle damage (DWB) was noted to the sapwood portion of several joists, with some of the tunnelling presenting as recent activity (see Fig.16-19).

Three joist-ends in front of the southerly window were identified as requiring repair, however considering the recent/ongoing DWB activity mentioned, there is a risk that other timbers have also been affected. It is advised that further floorboards are lifted to provide a better understanding into the extent of decay-related issues.

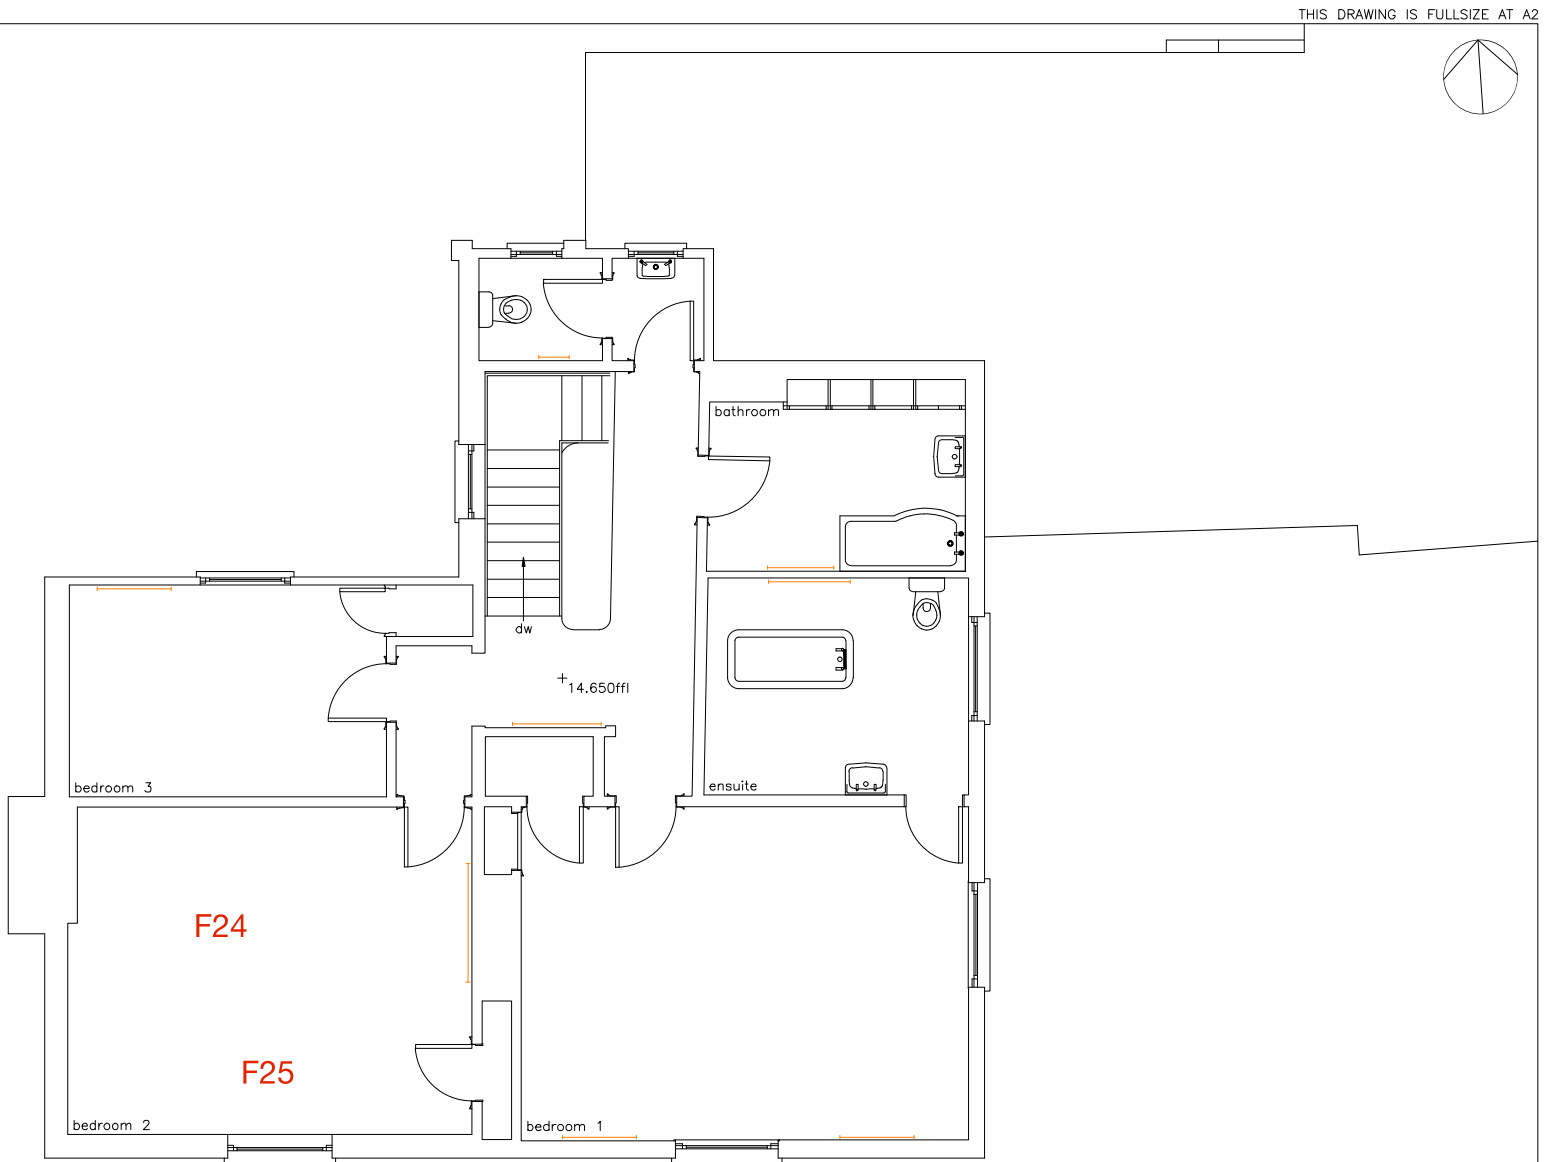
**Figure 23: First Floor Plan**

Although we did not extensively investigate the sub-floor timbers, I did not observe any significant timber-related defects on the first floor area. However, there was some cracking of plasterwork, which is likely associated with the aforementioned movement in the timber-framed walls.

Figure 23 shows the First Floor plan.
