# DESIGN AND ACCESS STATEMENT

**Fir Grove Farmhouse, Wreningham**

**Listed Building and Planning Application**

**October 2022**

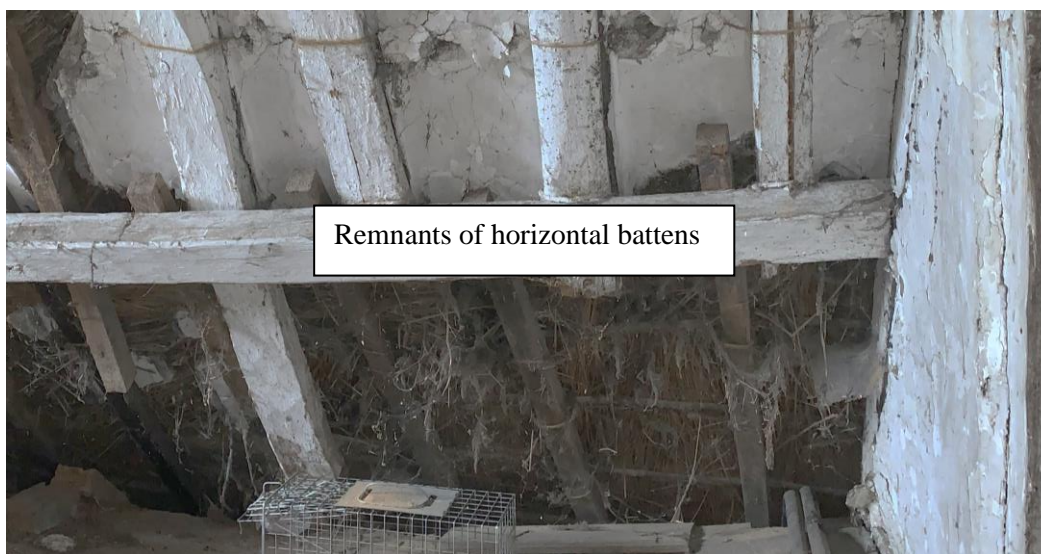
**EXPOSED UNDERSIDE OF REPLACEMENT THATCH & EXTENSIVE RAFTER DECAY**

The thatch is in need of replacement. It is causing water ingress which has led to extensive decay and breaking of the original roof framing (mostly oak, possibly with some ash or other smaller timbers). There are some older rope ties around the rafters, indicating installation before the rafter and daub ceiling were limewashed. But there is also evidence of a modern fixing of the thatch with rope which is not limewashed. This indicates original thatch was removed when the roof was recovered in the late C20th by the previous owners.

Repairs to the extensively damaged and missing rafters will need to be carried out following complete removal of the decayed and soaked thatch. Although there may have been a 'permanent' foundation layer when the thatch was laid, the long-term damage and soaking which has occurred means even a dense layer must now be removed in order to carry out traditional repairs and replacement of the most damaged rafters.

The presence of a separate layer of wattles/laths to support the daub ceiling panels suggests that retention of the daub may be possible as it is on a separate structure to the thatch. There are indications of the horizontal battens under the thatch.

Vertical laths/wattle for daub

Thatch immediately above the ceiling level is badly decayed and wet

All timber repairs and replacement will be finalised once there is scaffolding access and the old thatch is cleared. It is a shame the roof has reached this level of damage through decay but the rectification must be specified in steps to react to what is uncovered during the works.

**However** - the proposal is to remove the thatch in order to carry out the timber repairs as justified above, then to tile the main roof with plain clay tiles (or pantiles if preferred). Justification for this is the high cost of insurance for houses with thatch and the extreme difficulty in finding insurance for a house of thatch combined with timber framed and wattle and daub walls.
