Hill House, Top Green, Denston, Suffolk CB8 8PW.
Historic building recording and analysis of the House. Recorded 27 05 2022.

Site name/Address: Hill House, Top Green, Denston, Suffolk CB8 8PW.	
Parish: Denston	West Suffolk
NGR: TL7613252879.	Site Code: N/A
Type of Work: Historic Building Recording	Site Director/Team: Barry Hillman-Crouch
Date of Work: 27 05 2022	Size of Area Investigated: 20x40m
Location of Finds/Curating Museum: N/A	Funding source: Owner
Further Seasons Anticipated?: No	Related EHER Nos:
Final Report: Hill House, Top Green, Denston, Suffolk CB8 8PW. Historic building recording and analysis of the House. Recorded 27 05 2022. Barry J Hillman-Crouch MStPA DipFA BSc HND.	
Periods Represented: C15th - C20th	
<p>SUMMARY OF FIELDWORK RESULTS:</p> <p>Hill House is a typical Georgian country house of the MC18th that has built on an earlier cross-wing frame from a C15th open hall house. The western bays on the ground and first floor are framed for a cross-wing with heavy 8in wide axe finished oak studs, cambered top-plates and trenched down braces from swept jowl storey posts. On the ground floor, the few remaining studs in the eastern frame have fixture holes suitable for

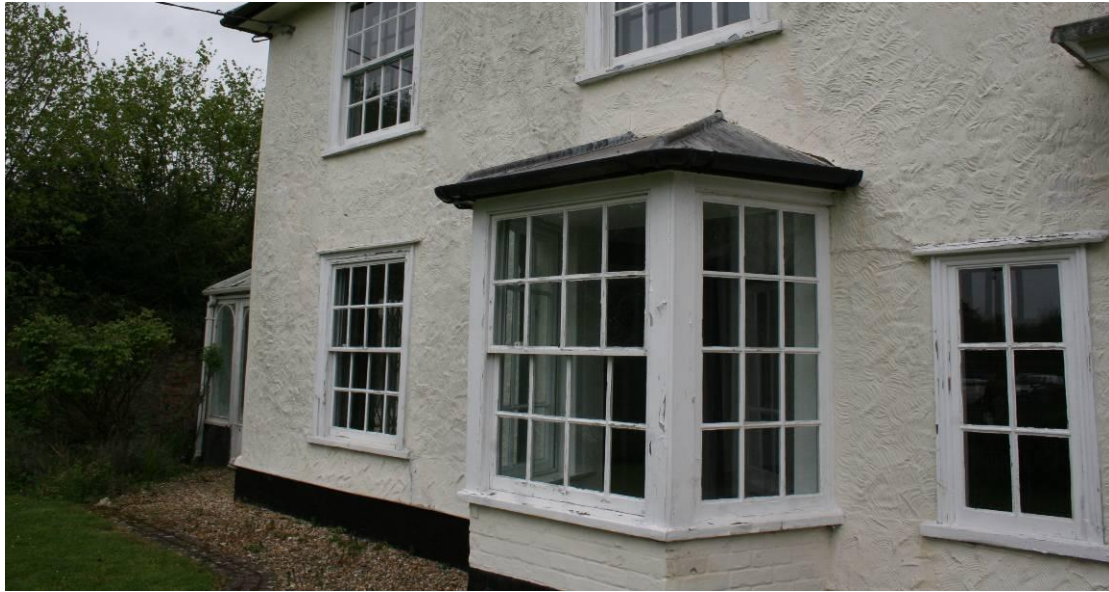
Detail of the fenestration looking NW.

The window frames and doorcase appear original and well kept with let in repair sections and recently replaced leadwork. The walls are clad with hard cement finished with a broom swept pattern on EML (Expanded Metal Lath) and with galvanised drips. C20th casements have been inserted on either side of the doorcase to light the entrance hall.

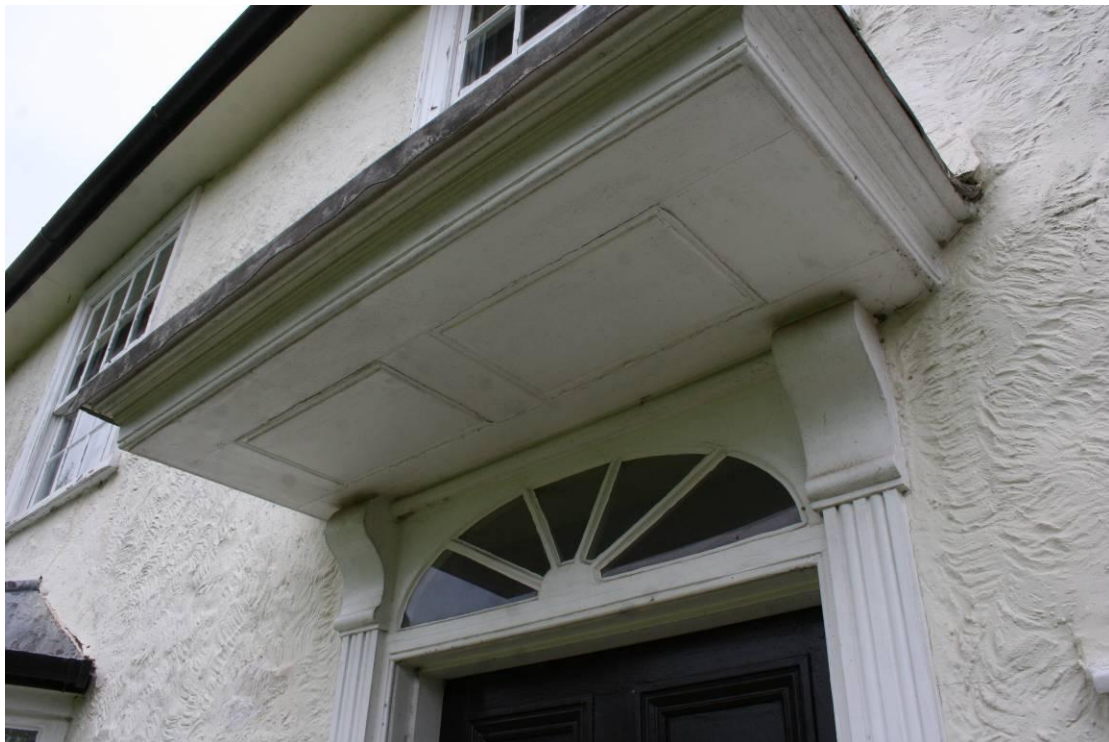
Detail of the doorcase.

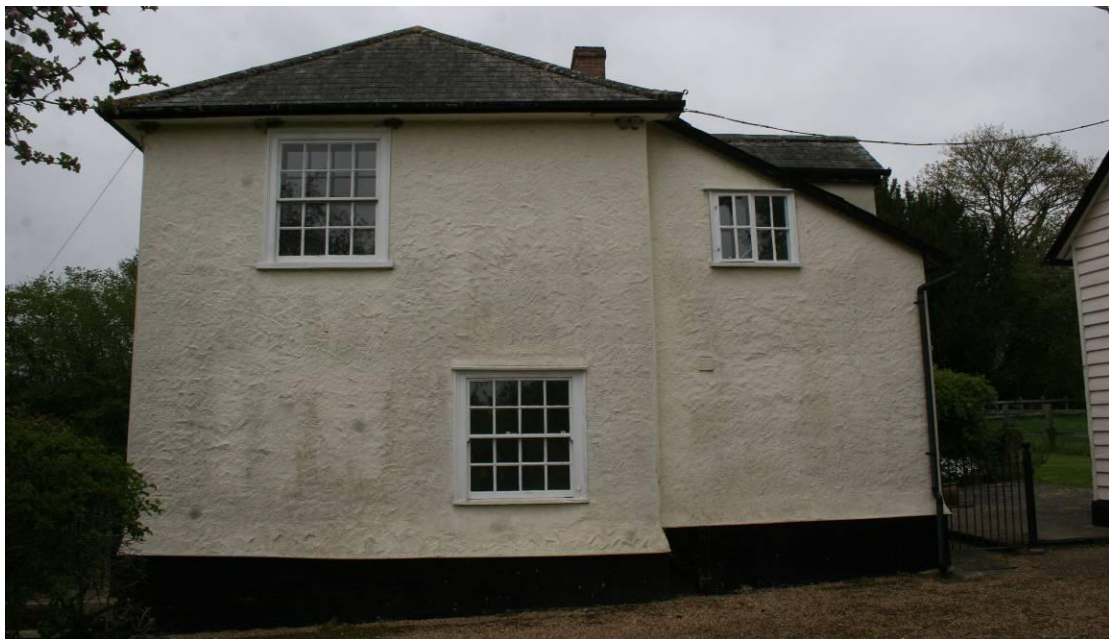
The eastern elevation.

The eastern elevation has the main block with a two storey rear extension under a single pent catslide roof. The frame can be seen shadowed on ten EML cement render and suggest two earlier window openings on the ground floor. Both windows are 8/8 pane sashes with the lower being a LC20th replica with horned meeting rails.

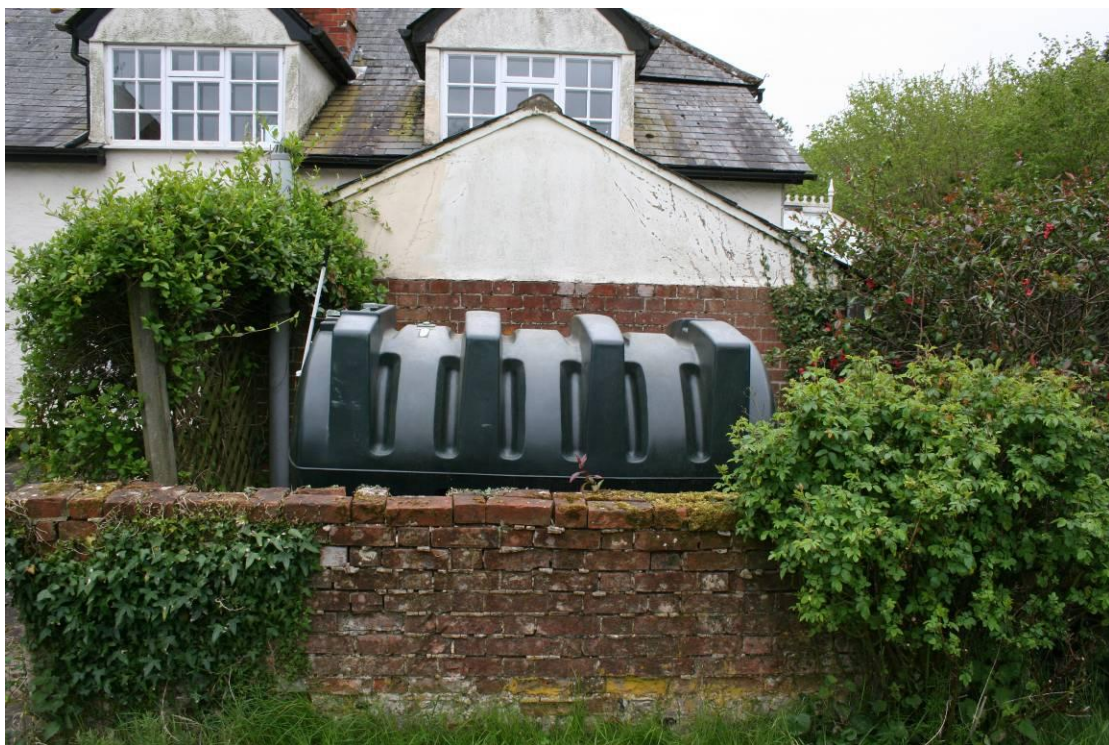
The north elevation of the Outshot is partly hidden by a plastic oil tank.

There is another back door in the Outshot which appears EC19th with edge moulded vertical boards and four hand-made ledgers and has a LC19th small letter box fitted. The Outshot has red/orange 65x110x225mm brick walls with smooth, creased faces, sharp arrises set in lime mortar pointing in Flemish bond. The gable is rendered above the eaves line and the low pitch roof is clad with grey slates.

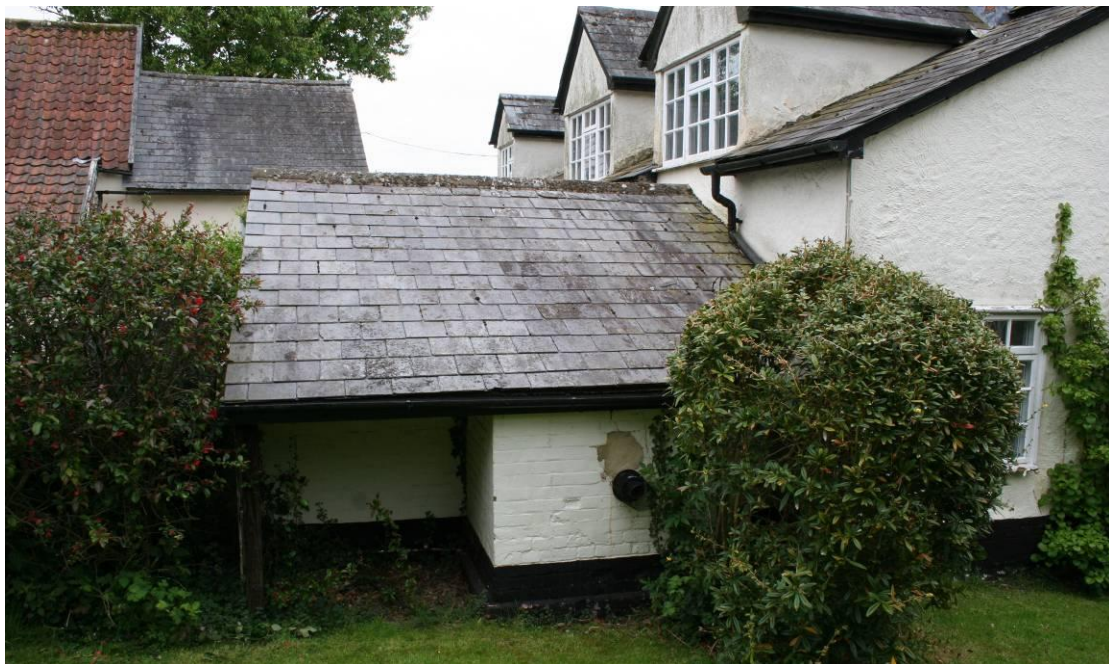
The west elevation of the Outshot.

The Outshot has been remodelled to house a boiler and create a wood store. Historic mapping implies the Outshot was extended between 1850 and 1884. The roof has been extended to oversail to form the log store in the LC20th. Cotton threaded asphalt membrane is visible under the grey slates. A timber conservatory was added to the main House in the LC20th and is now in poor condition. The whole building is coated in the same broomed finish cement render on EML and all the rainwater goods are plastic.

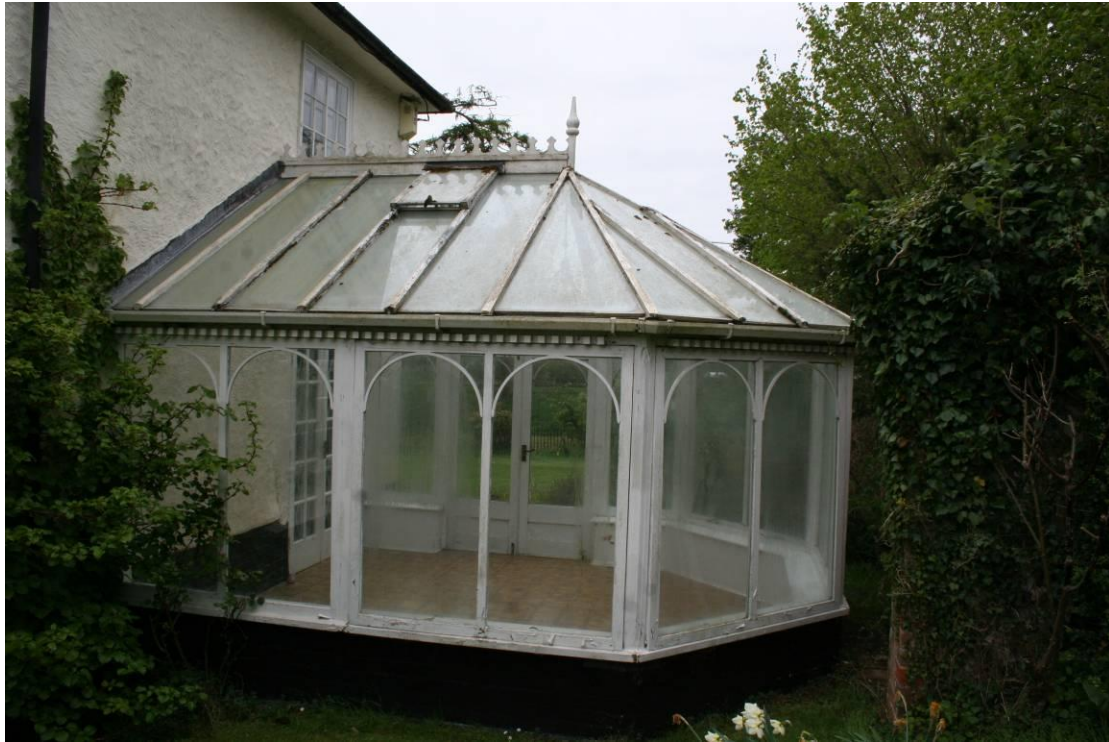
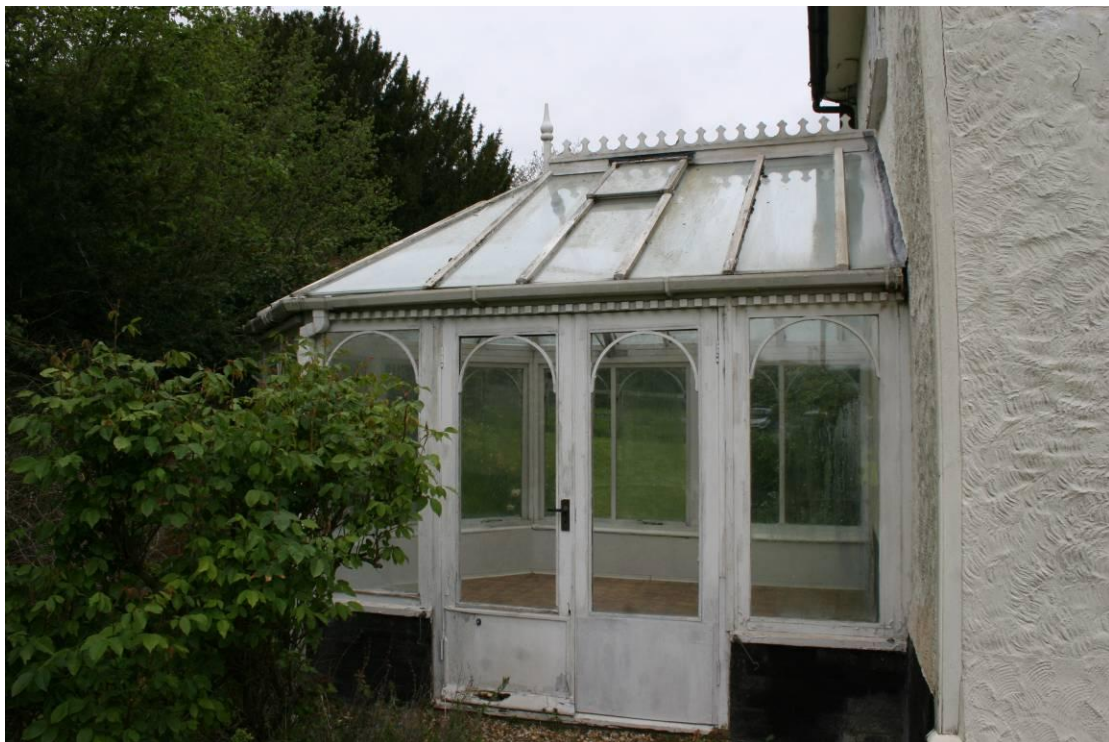
The conservatory is a typical unit erected in the LC20th on a low brick plinth with a timber frame and large pane glazing. A pair of French doors have been inserted where a window would have been along with folding security gates.

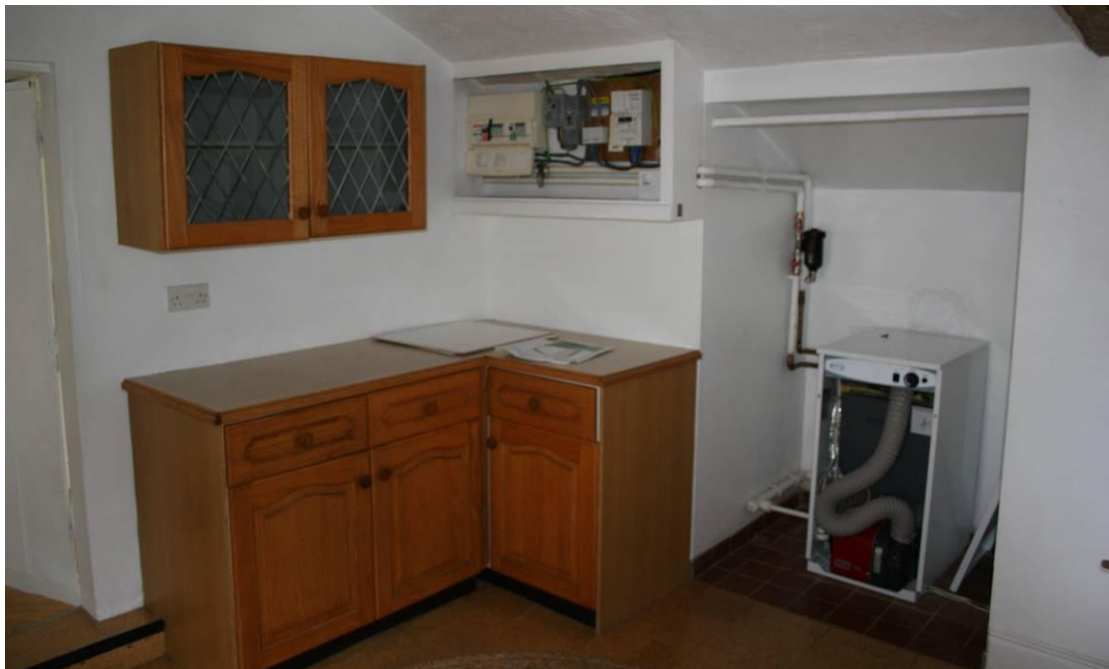
Looking SW in the Utility Room.

The Utility Room has been outfitted in the very LC20th or EC21st with fitted cabinets, a washing machine and a boiler dated to 2017. The door from the Kitchen is a vertically boarded door with four ledgers, repair sections, a modern cat hole and is hung on pintle hinges.

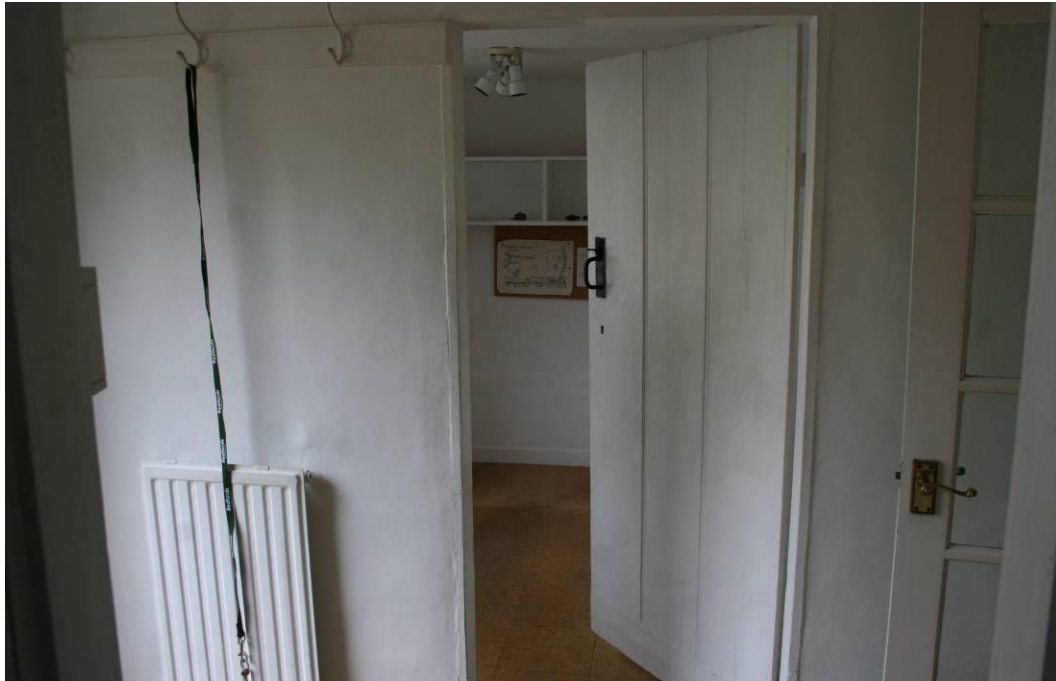
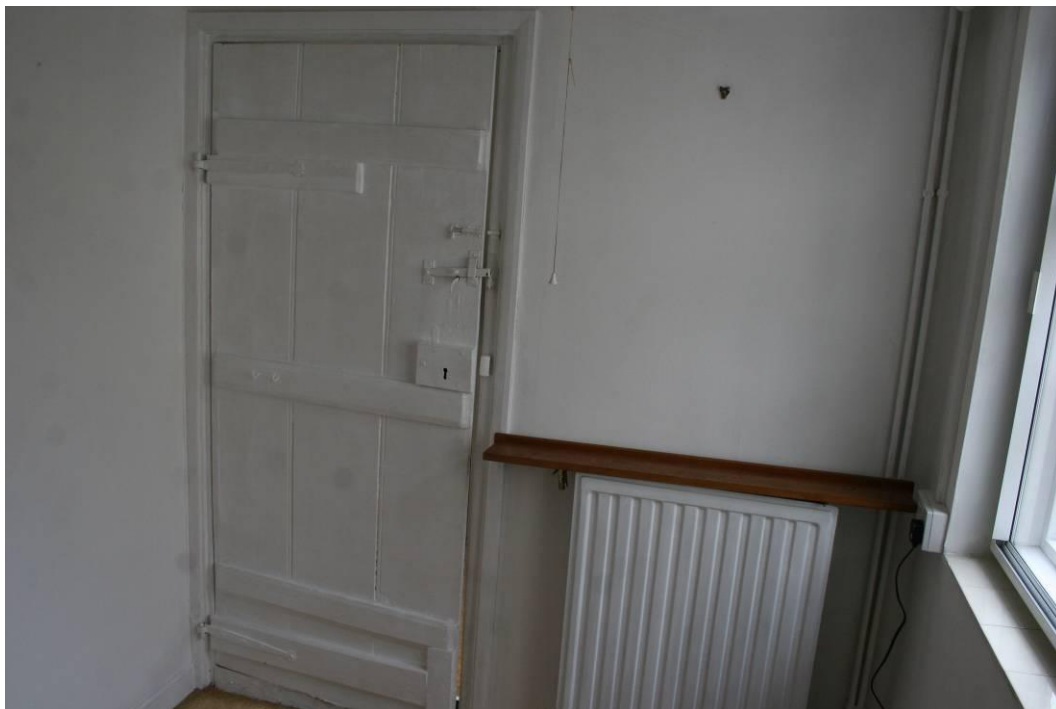
The study has a vertically boarded and ledgered door with a wooden box lock and Suffolk latch both fixed with slot headed screws. The door has been extended and rehung on pintles.

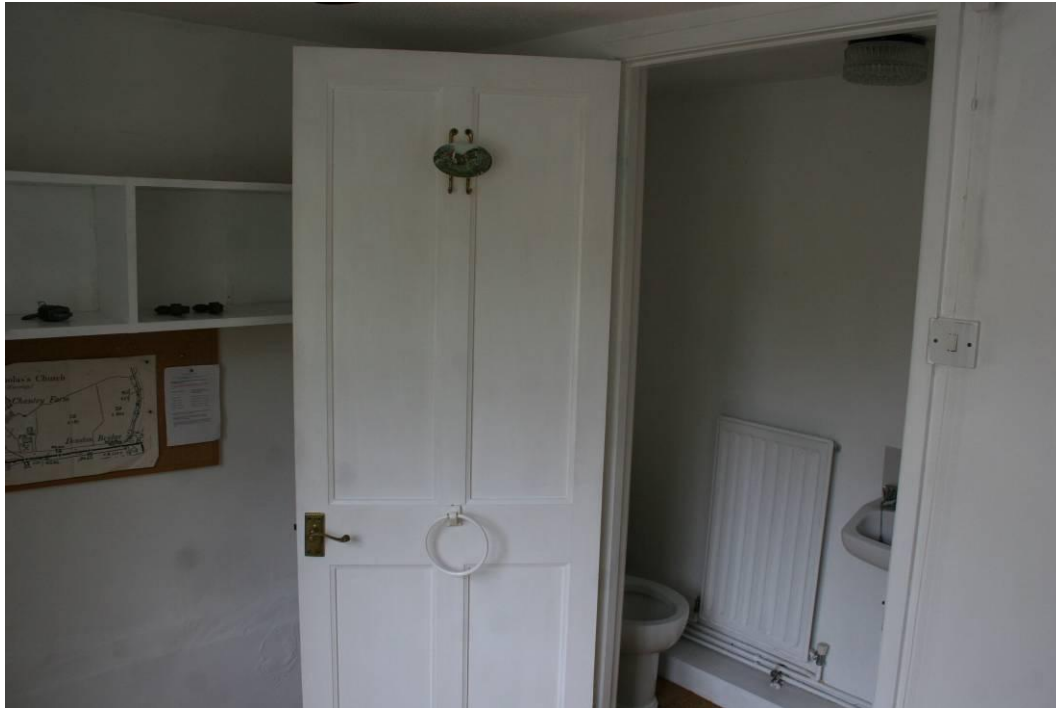
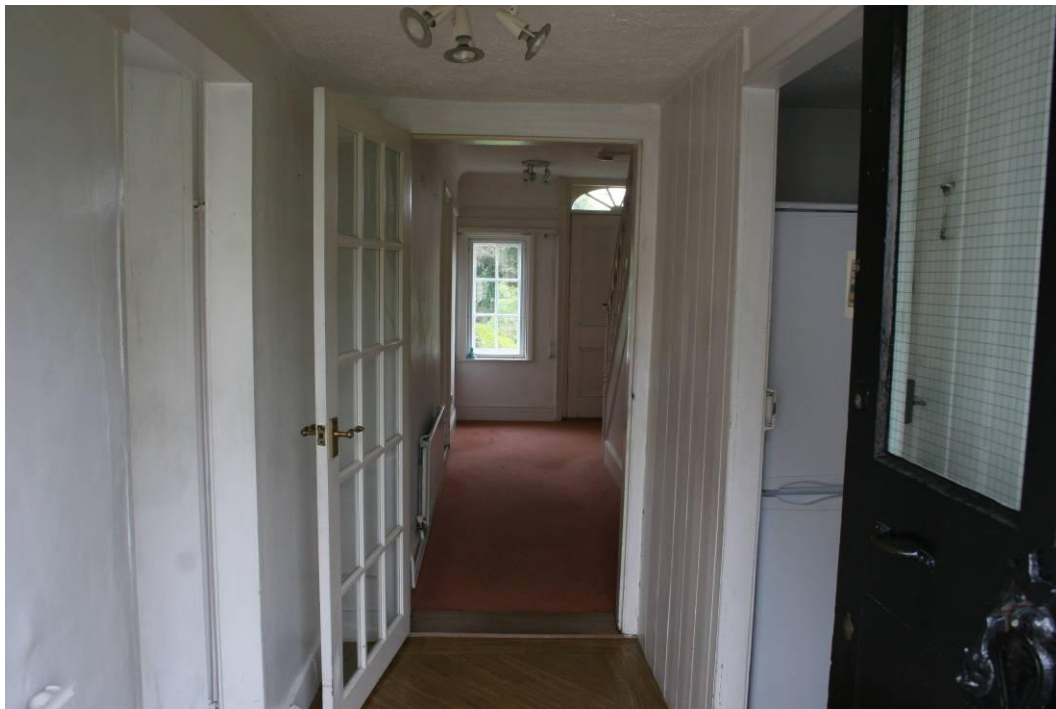
The rear extension has an eclectic selection of doors representing a series of modernisations. The WC has a MC20th copy of a Victorian four panel door (identified by its lack of mouldings and Deal construction). The Hallway has a C21st fully glazed door often put in by ageing occupants to increase the internal light.

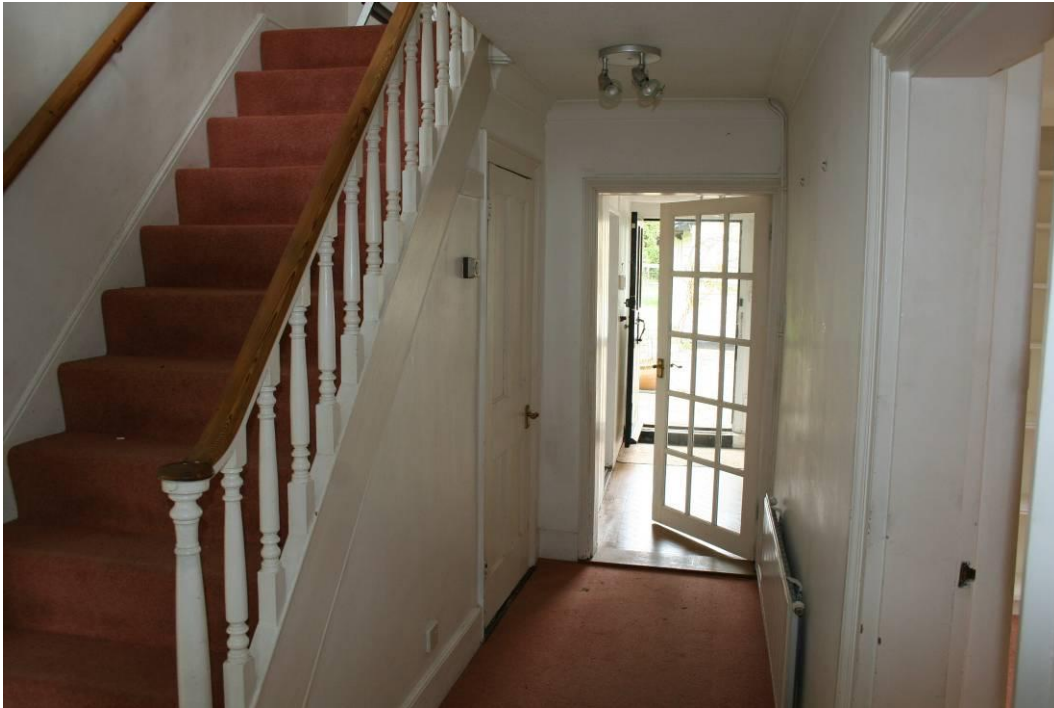
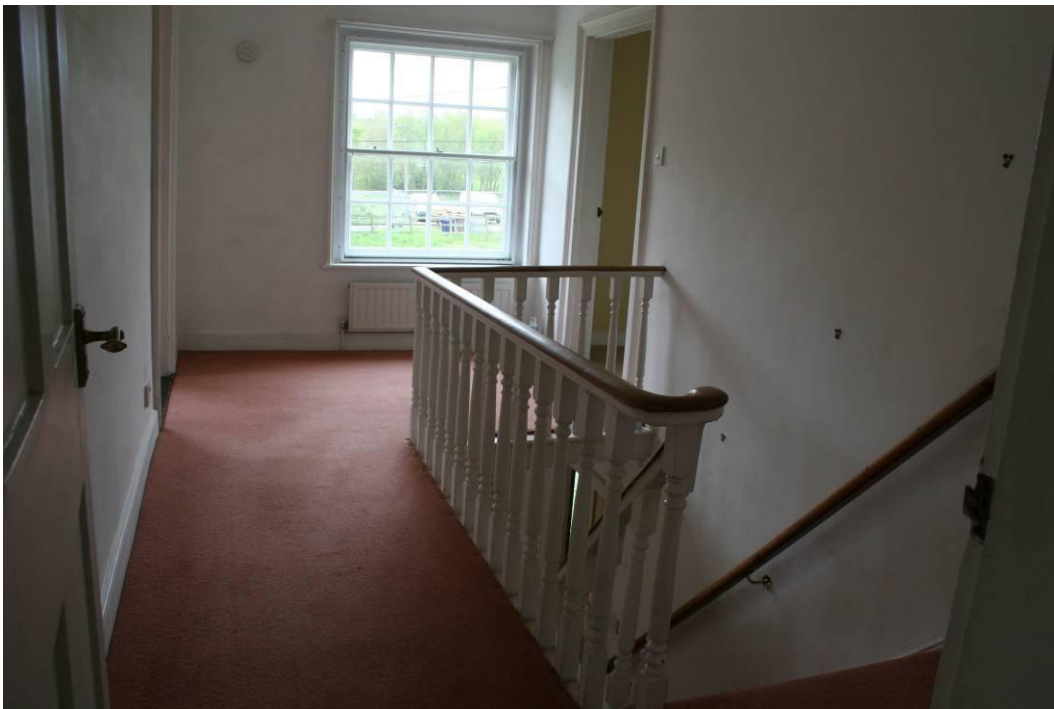
The staircase is MC20th. Looking N.

The Hallway stairs are styled for the Victorian era with alternating turned and barley twist spindles but the construction details and pine risers and treads suggest they are MC20th.

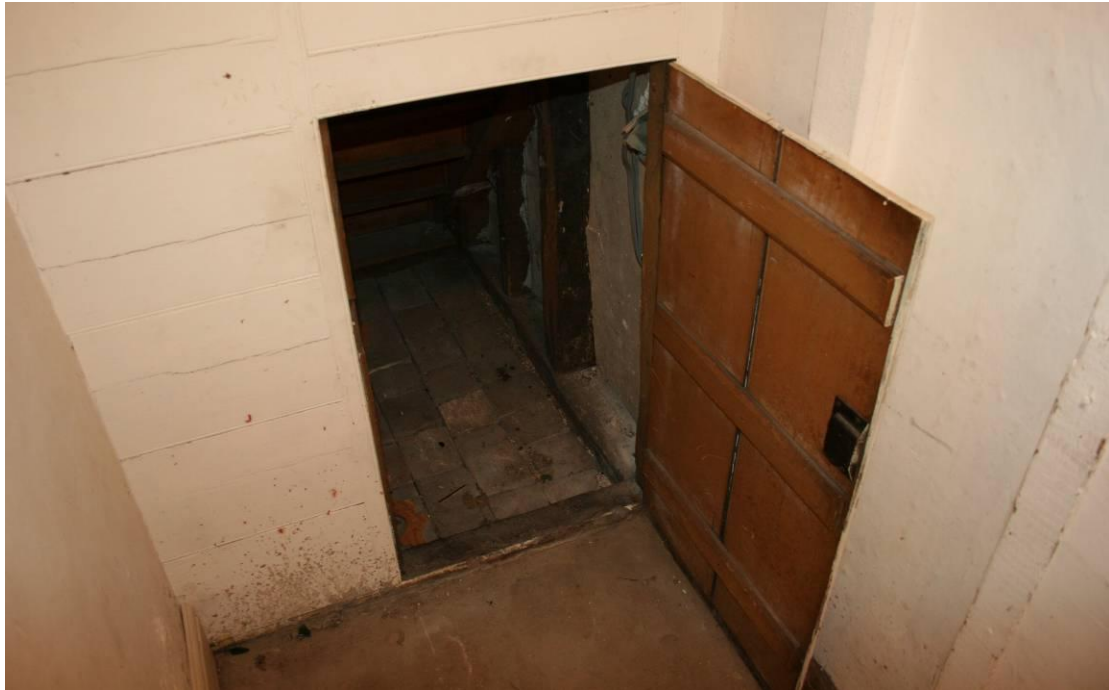
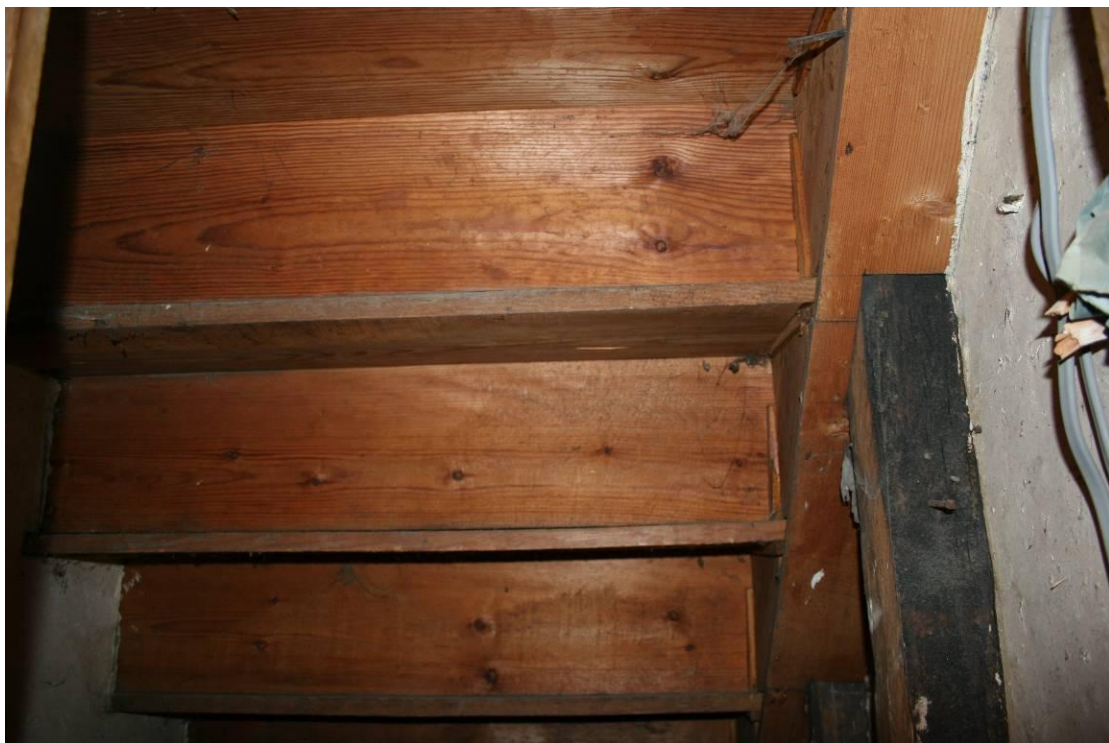
Detail of the pine risers and treads. Looking S.

The staircase is made of machined pine with screwed together treads and risers numbered up and marked up in pencil. The treads are lodged in the stringers and the risers held in with fillets. The pine has not aged and must only be MC20th or later. The carcass is older and is probably late Victorian. There is a small two board door with reused wrought iron pintle straps and small steel lock.

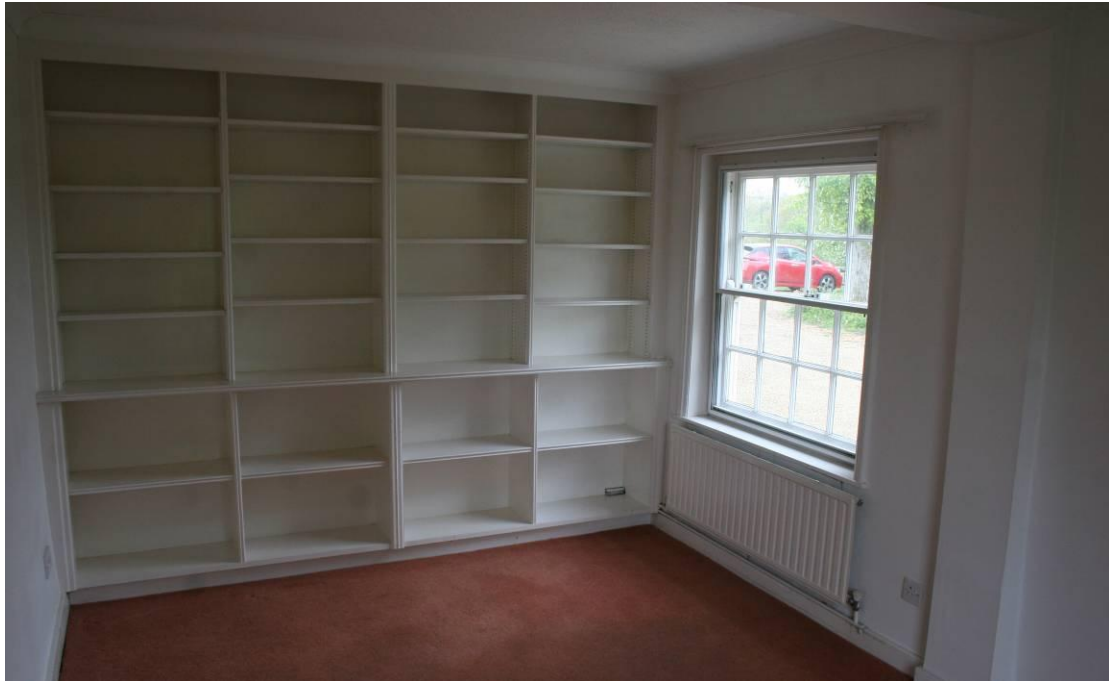
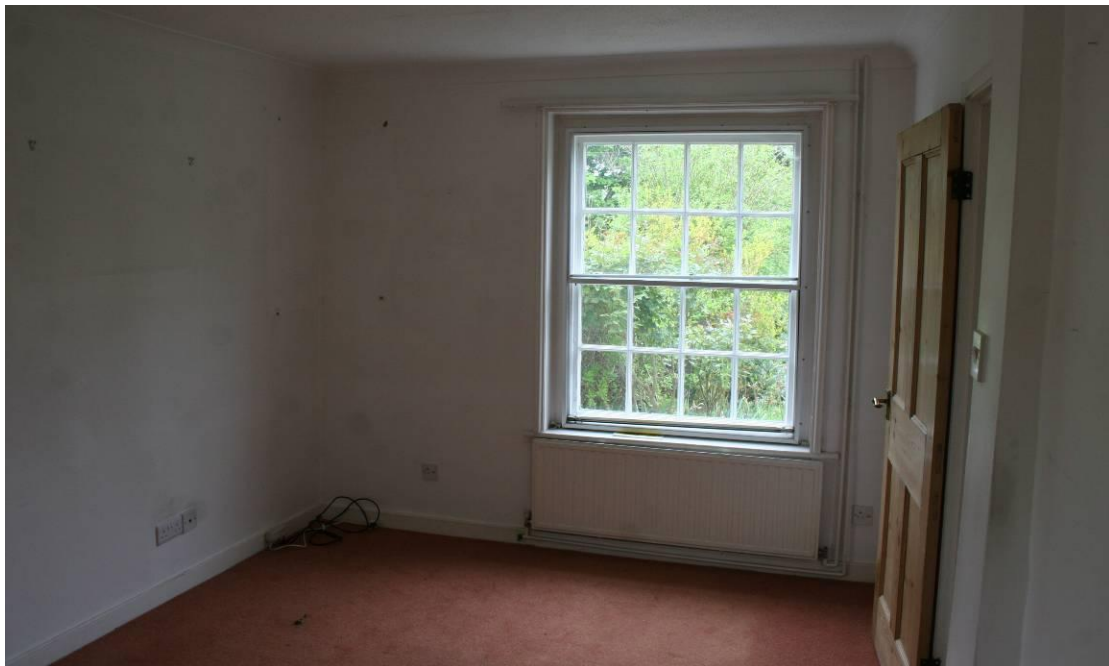
The Dining Room display no historic fabric except the windows. The four panel Victorian style door is a MC20th replica with nailed in mouldings. The original lock has been replaced with a B&Q brass door handle. The storey post and main joist have been boxed in. The walls and ceiling are plaster-boarded. The bullnose skirtings are narrow.

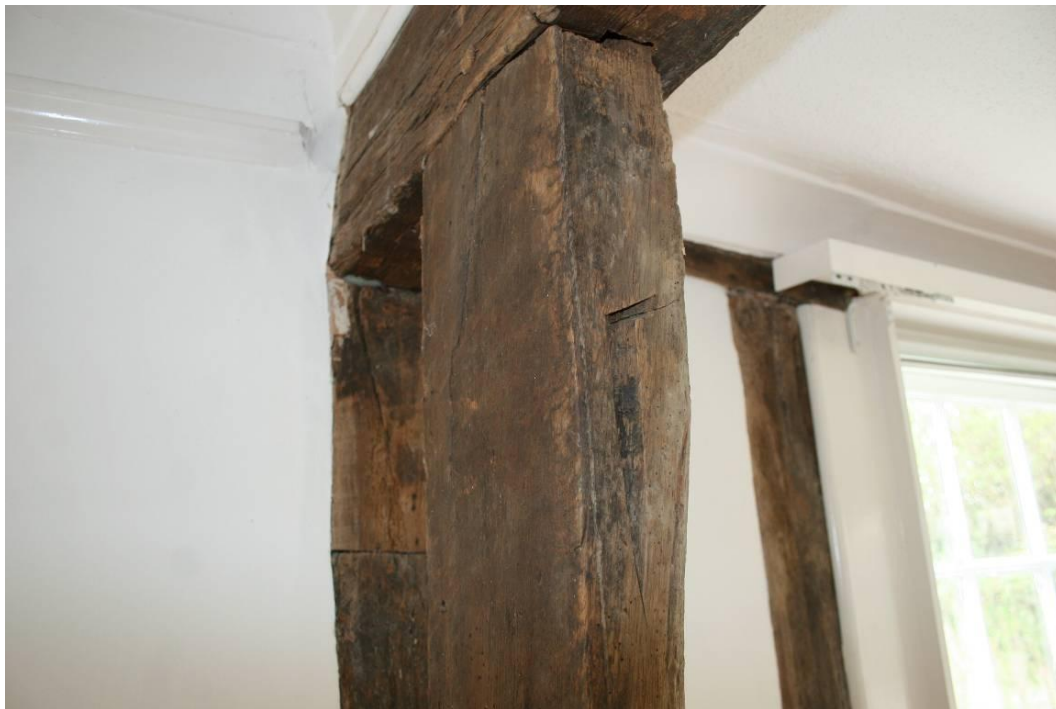
Stud with deeply cut wattling dart. Southern end of wall frame.

The dividing wall has the original storey post that carries up into the room above and three original studs with darts and mortices for ledgers for wattled panels. The faces have stripes from being lime plastered and each has a few fixture holes. The 6in wide studs are morticed into the midrails and the sole plate which is a later replacement.

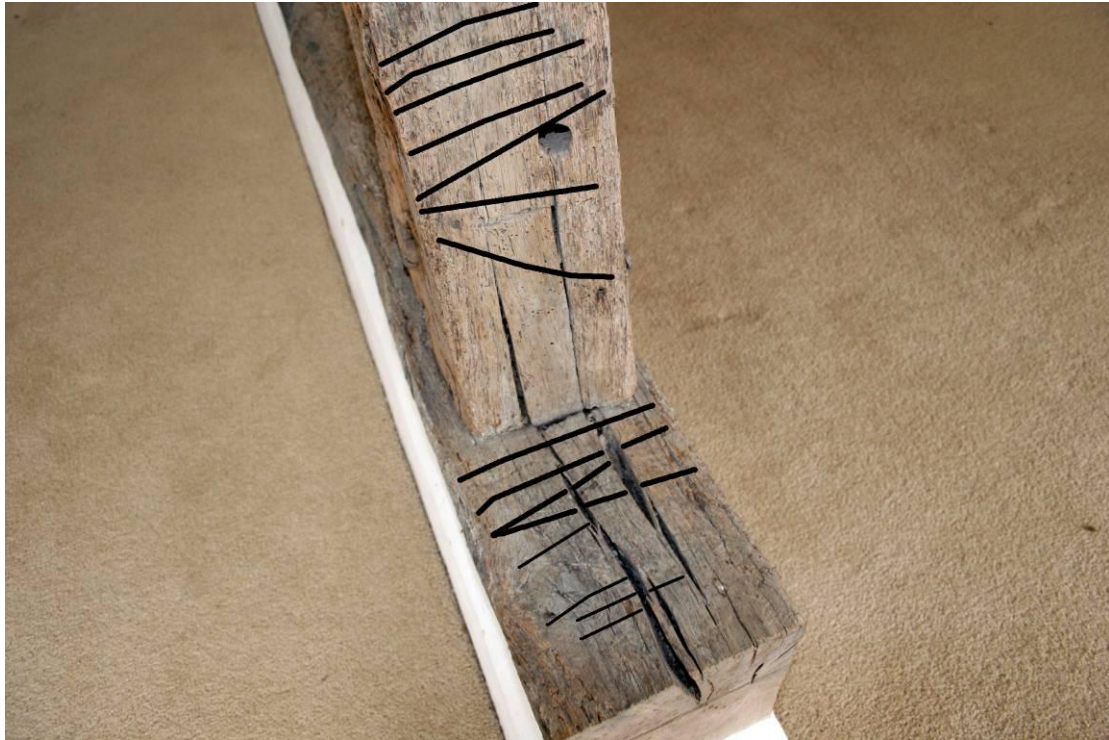
The storey post has a slip tenon which is numbered to match the sole plate.
