ARBORICULTURAL IMPACT ASSESSMENT REPORT
BS 5837:2012 'Trees in relation to design, demolition and construction. Recommendations'

Land North of Cornells Lane,
Widdington
CB11 3SP

DATE: 25 June 2021
OUR REF: SHA 1244 Rev B

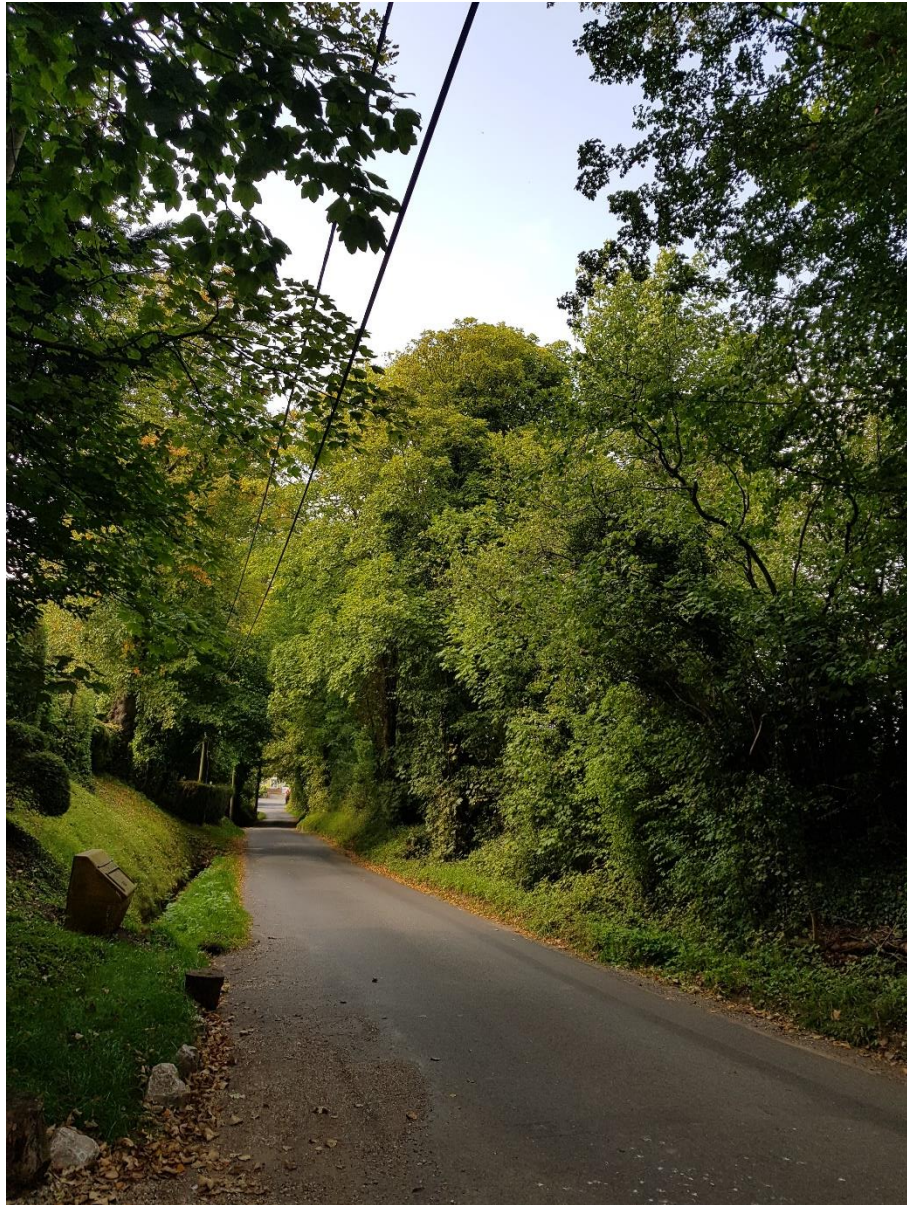
Photo 9 of the eastern part of the southern boundary, looking west. September 2020.

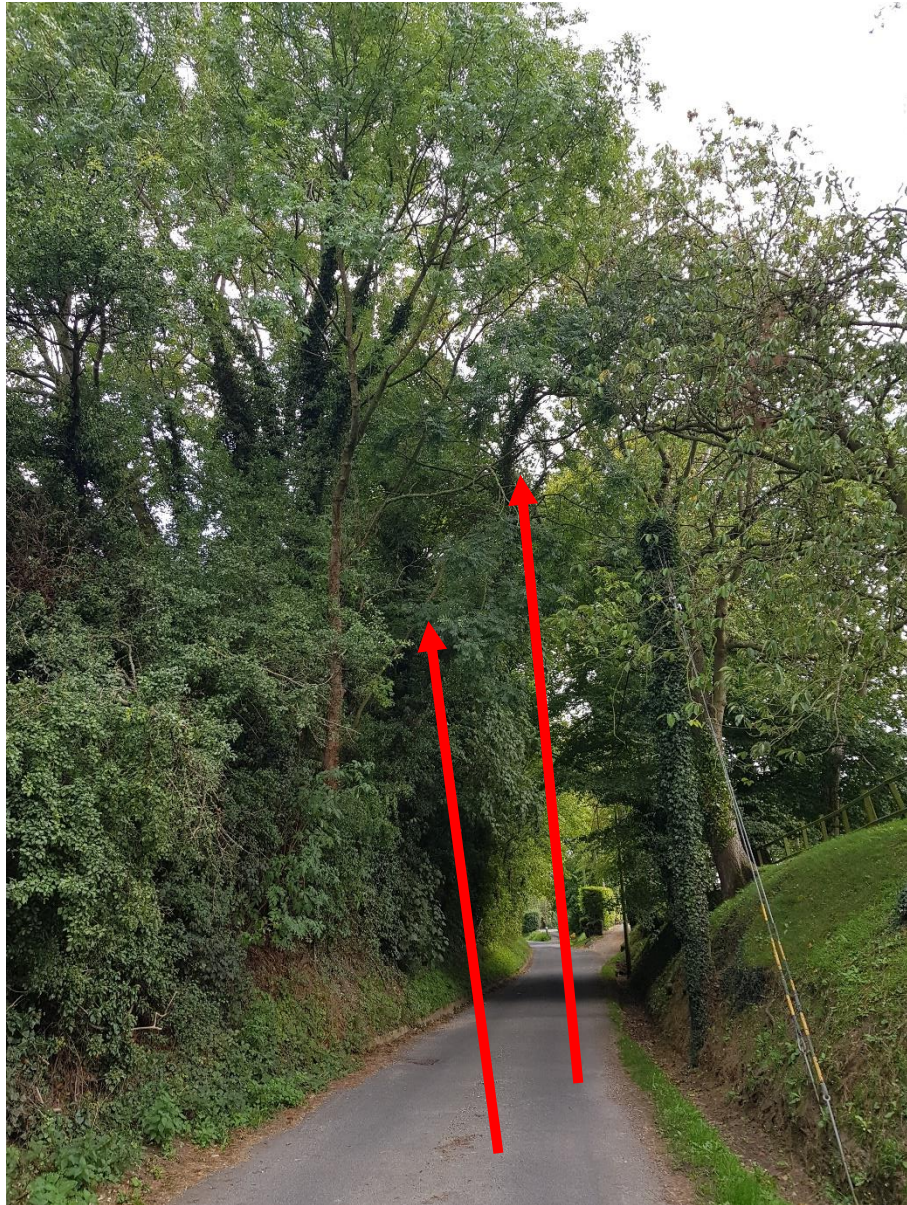
Photo 10 of the southern boundary looking west

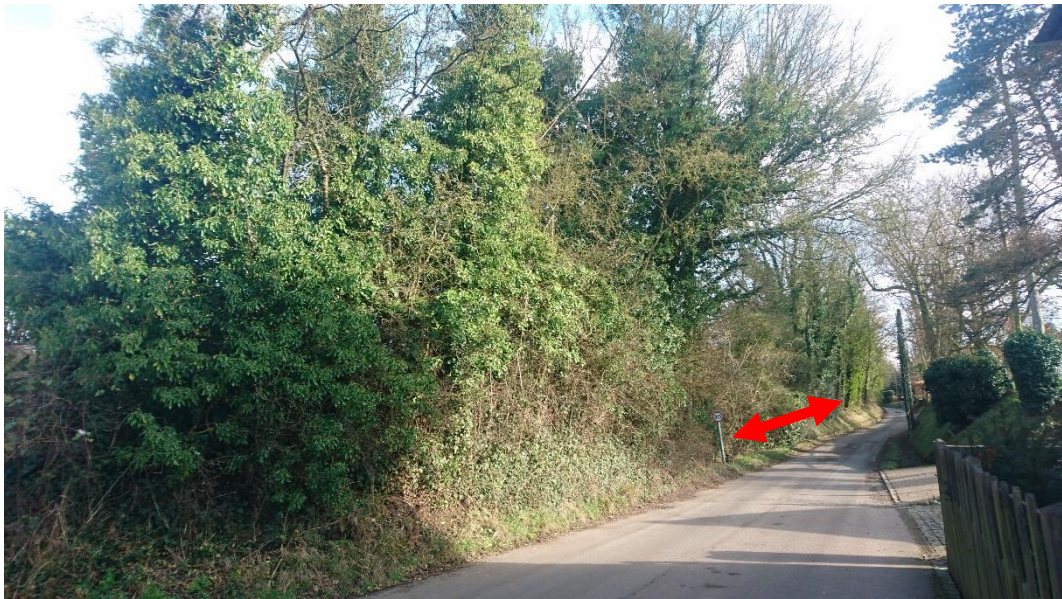
The proposed access is through G24 elm, blackthorn and elder (U), and close to T23 hawthorn (U), most of which will be removed, plus opportunities taken to review improvements to the remaining section i.e., with replacement species. This is low quality, as seen in photos 14, 15 and 16. The closest side of the bellmouth kerb to the trunk of T22 is 6.5m which is on the outer edge of its root protection area.

Photo 14 of the access shown along G24. Looking south-east along Cornells Lane showing wider landscape context. Photo February 2018

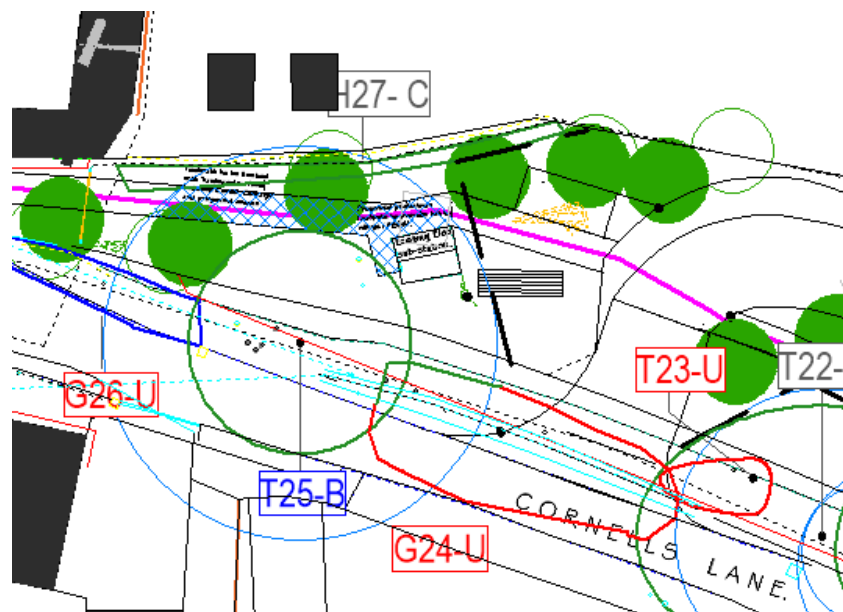
Plan 5 – extract from SHA 1244 TPPB. Do not scale. North is vertical

The site line is close to T22 and this will require minor pruning. The excavation of the bank will take place under arboricultural supervision to minimise impact on the tree. The extent of earthworks is potentially sensitive and the fact that the earthworks will be restricted will be made clear to the contractor and highway engineer by the arboriculturist. Both this tree, and T25, will be crown lifted to 5m to ensure site visibility. As a result of this, one of the coppice stems of T22 which leans heavily over the road will be cut back to the coppice stool. This is shown arrowed on photo 16. Its removal will have a negligible visual and physiological impact as the tree is a lapsed coppice multi stemmed tree historically cut periodically for use of timber.
