JPC Environmental Services
(A Division of J P Chick & Partners Limited)

07 November 2022
IE20/040/CSJ/RMC

SITE WALKOVER AND RE-ASSESSMENT OF SITE CONDITIONS TO INFORM CONDITION 9 - REMEDIATION STRATEGY (DC/22/1266/FUL) FLAX FARM, STANSFIELD ROAD, POSLINGFORD, SUDBURY, CO10 8RD

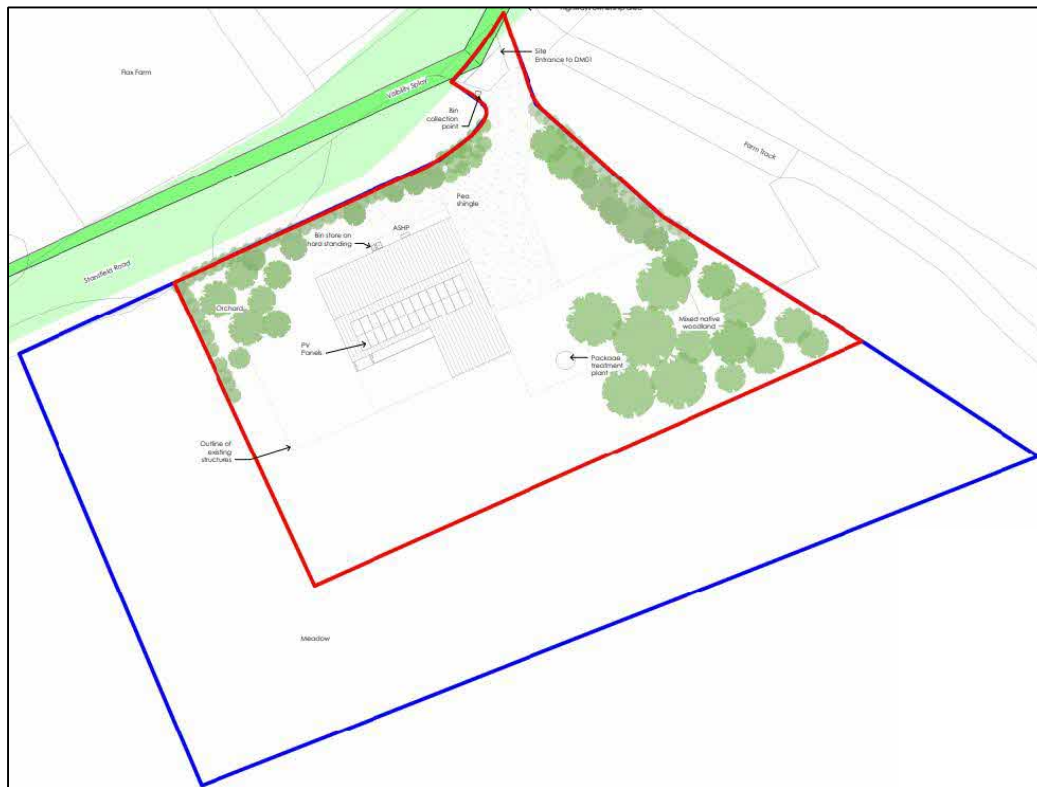
Figure 1 – Extract of Proposed Site Plan

- 2.4 The west and south boundary is now marked by a post and rail wooden fence demarcating the extent of the purchased site. This corresponds to the blue line shown in figure 1. This is now laid to meadow, and will remain meadow as part of the conditions of the new development. The red boundary shown in figure 1 between the agricultural barn area and meadow, was investigated with a series of trial pits in 2020. These showed that no contamination extended into the farmer's field. Therefore the meadow present between the red and blue lines (figure 1) will not be subject to remediation.

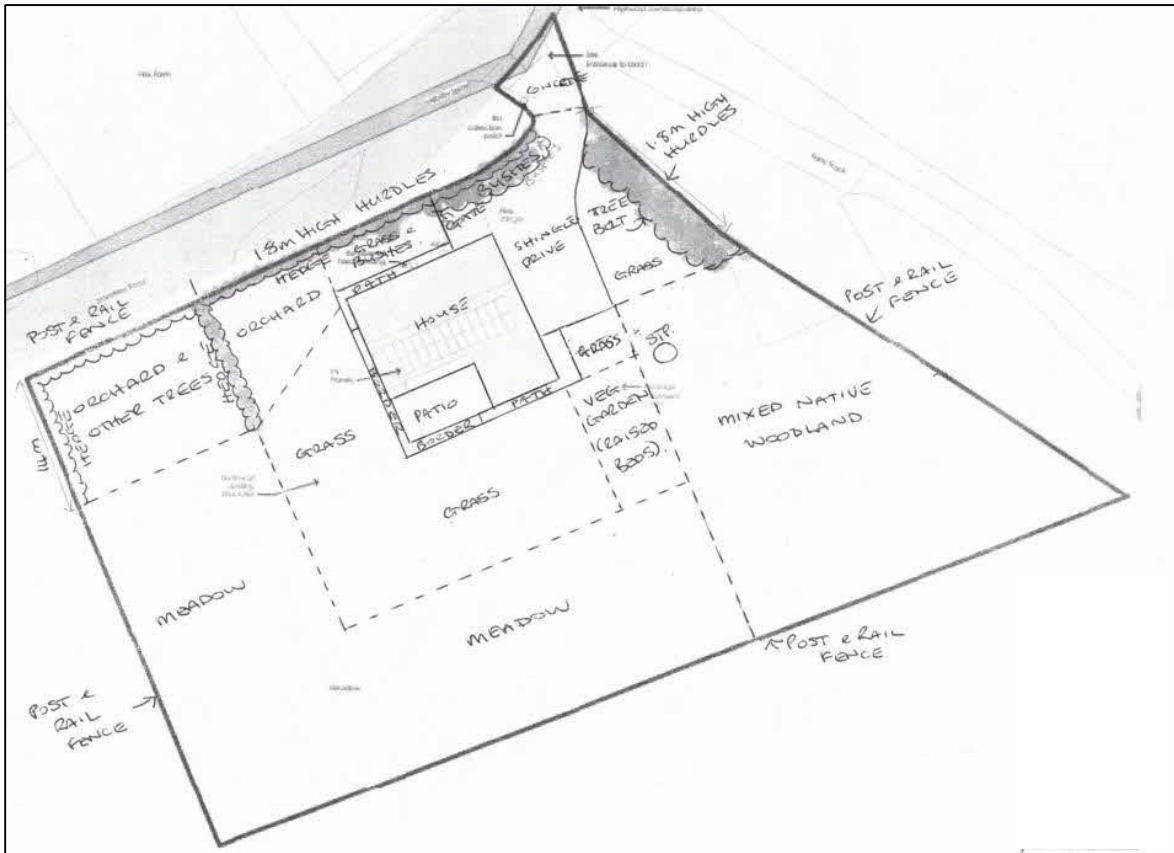
Figure 2 – Draft External Layout

3.4 A large proportion of the site will be laid to grass at the side and rear, with small areas for an orchard and raised vegetable garden, with a meadow occupying the former section of farmer's field. Previous investigations have shown that the underlying soils contain elevated concentrations of lead, mercury, polycyclic aromatic hydrocarbons (PAHs) and asbestos within the shallow soils to 0.35mbgl. Our previous remediation recommendations comprising the excavation of contaminated soils, disposal from site as waste, with verification sampling of the underlying soils. It is our considered opinion that this remains a suitable strategy, however this will be explored further within our stage 2 options appraisal and remediation strategy report.
