# Asbestos Survey Report

(Refurbishment/Demolition)

**Flax Farm Barn**

**Stansfield Road, Poslingford**

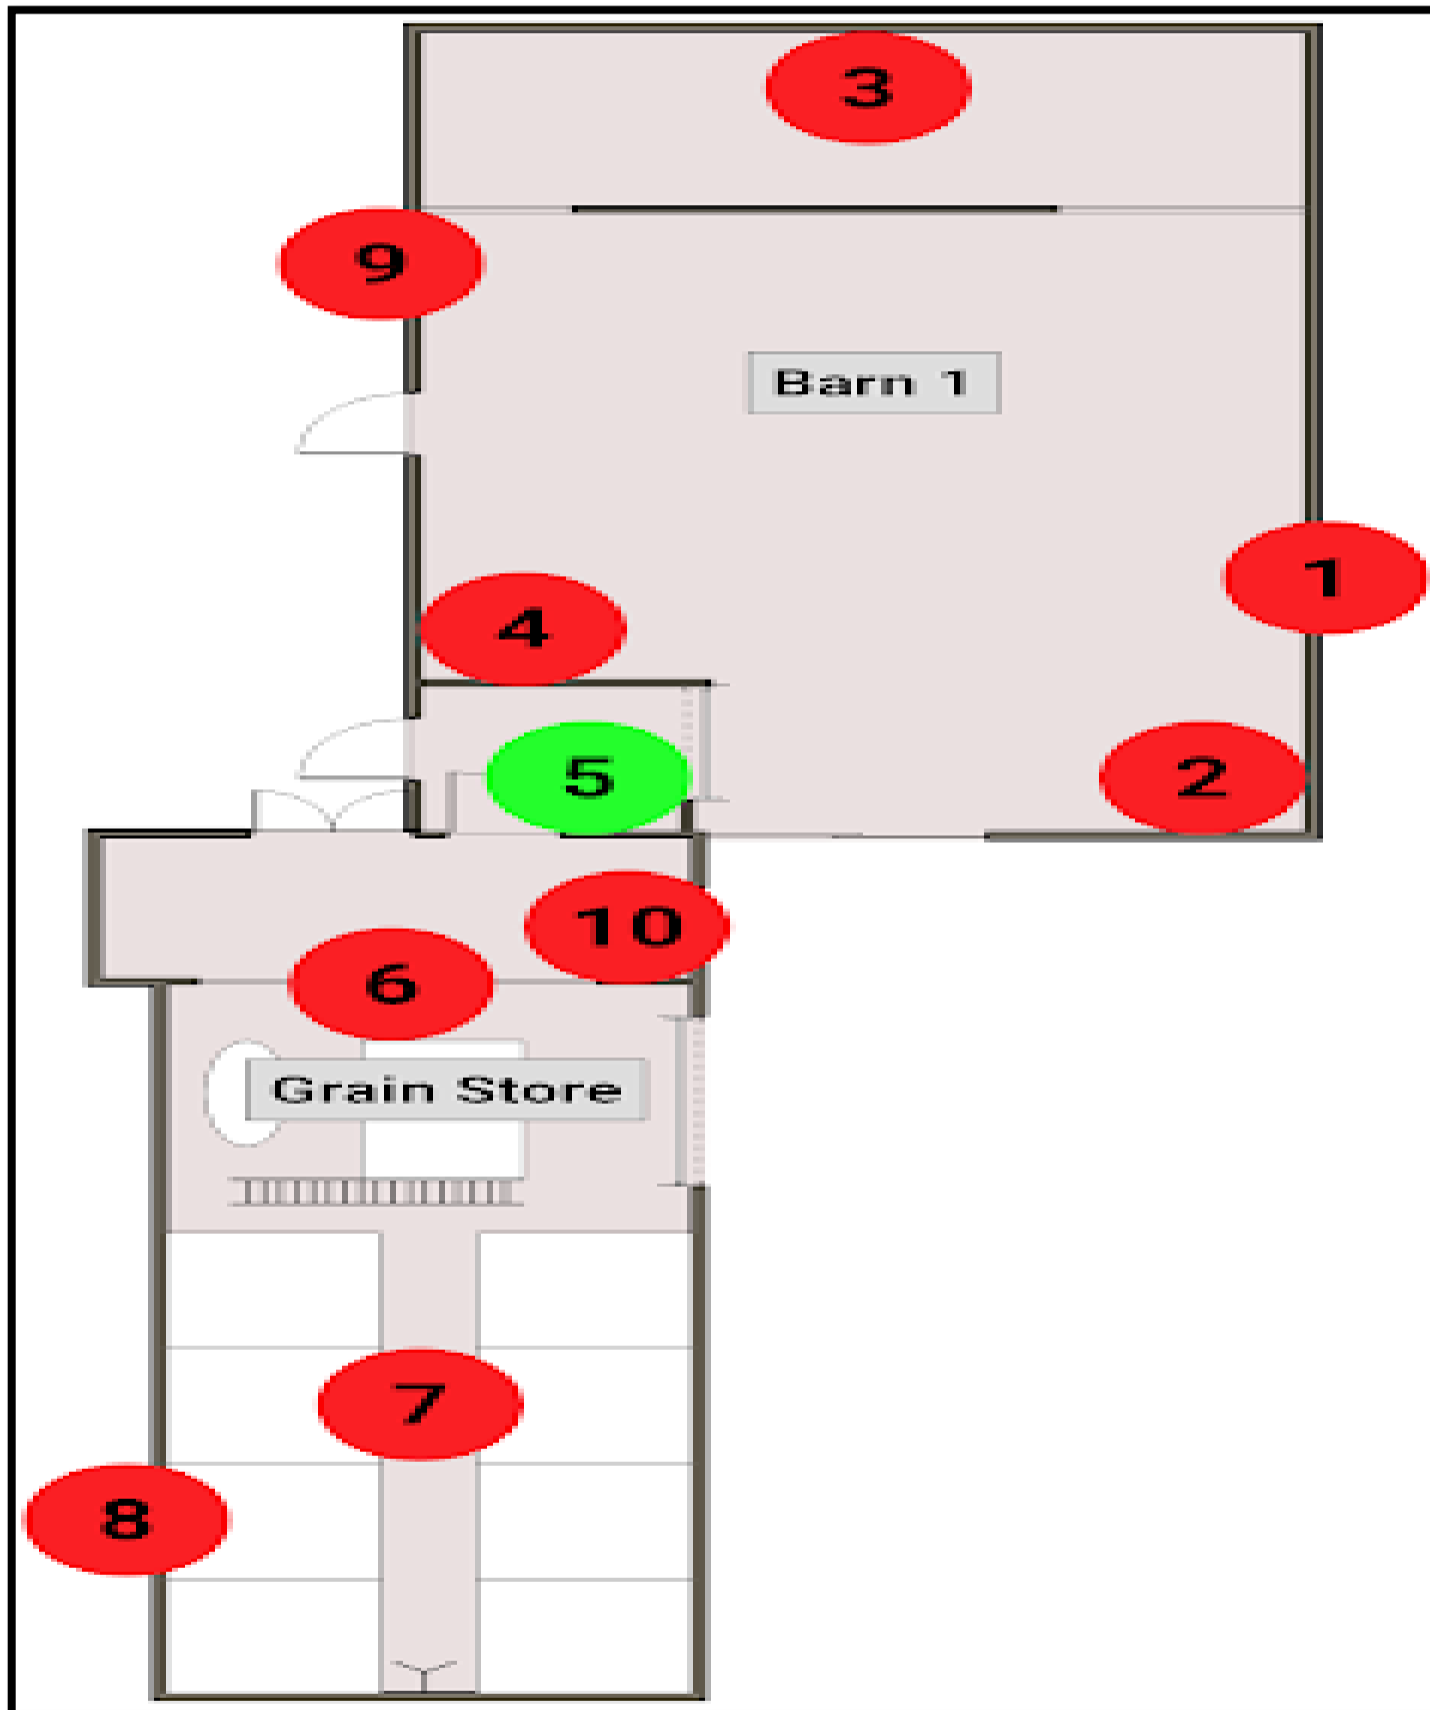
### **Plans**

Chess Environmental Ltd		KEY	01,02,03,04,06,07	Sample location Asbestos Detected
Job no:	CE - 01		08,09,10	
Date:	14.11.22		05	Sample location No Asbestos Detected
Flax Farm Barn, Poslingford, Sudbury, CO10 8RD				
Floor plan (Not to scale)	Not to scale
