**Brief Design Statement for Removal of Thatch To Mill Barn, Mill Lane, RG20 4UD**

**PRESENT SITUATION**

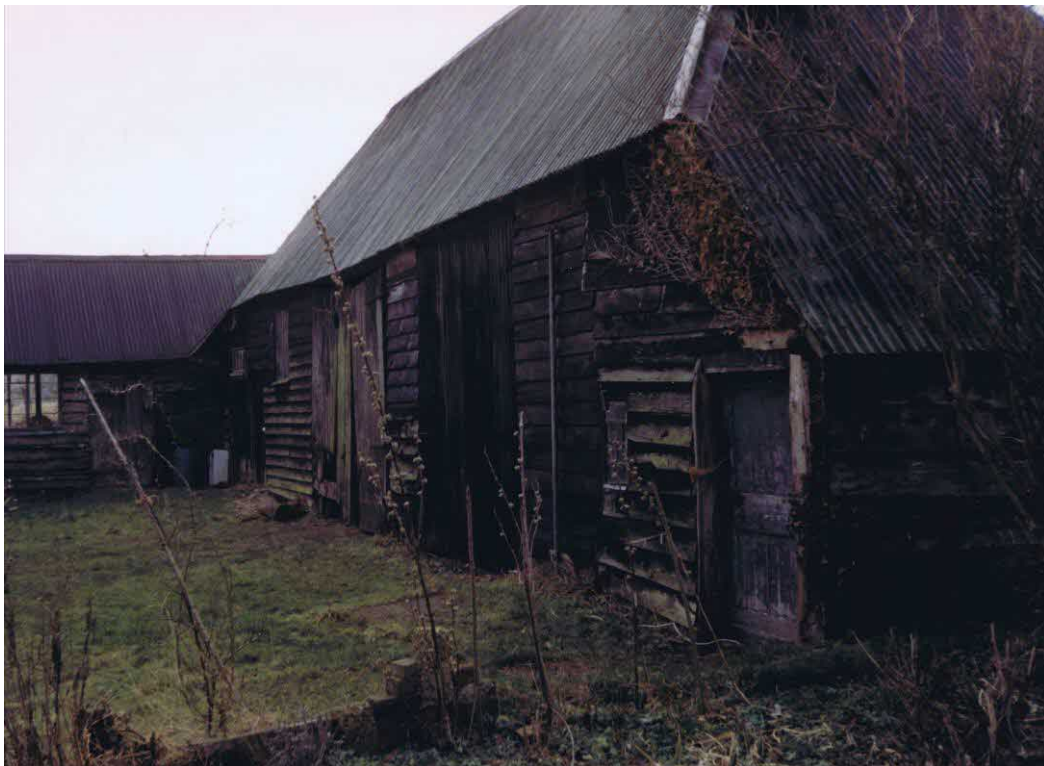
BARN IN 1990 and as LISTED

Whatever happens to the roof the rotten thatch needs removing and fixing holes repaired. The original corrugated iron roof is still in place below the thatch. This was retained for rigidity, not to disturb the original timbers and as a short term fire barrier. The barn was listed with this iron roof.
