Structural assessment

Pentre Barn

Llangattock Lingoed

T5859– Pentre Barn – Issue 1

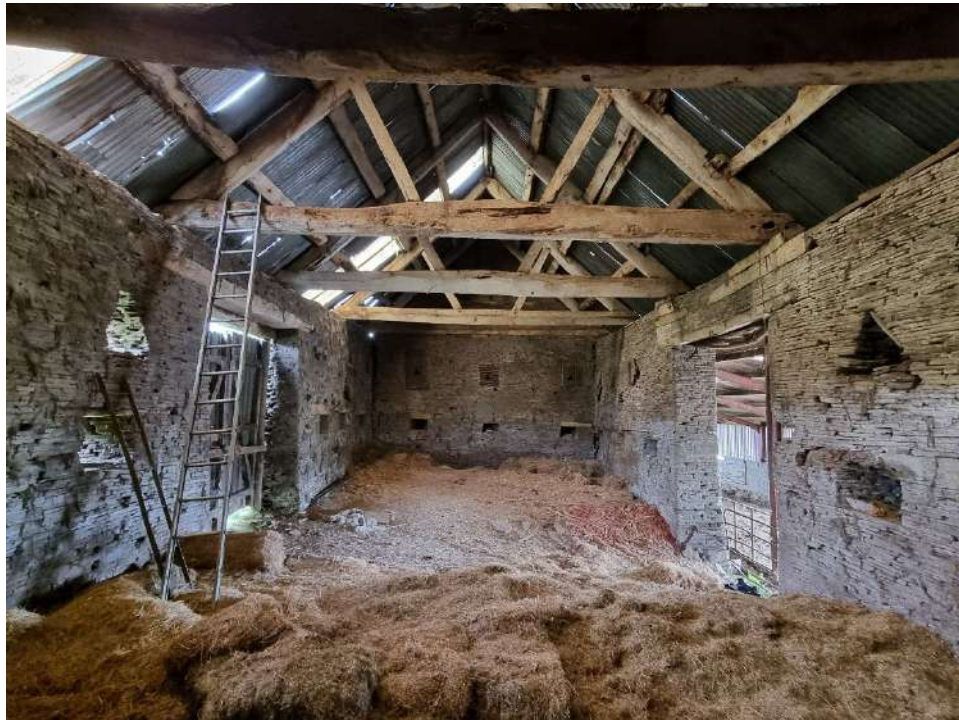
Barn interior looking east

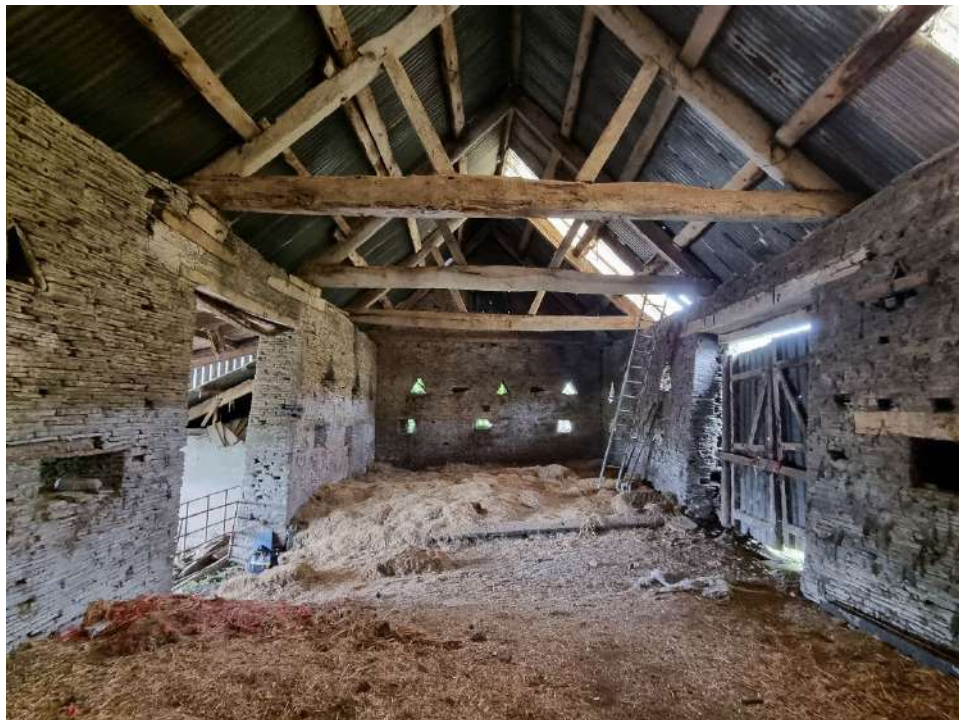
Barn interior looking west

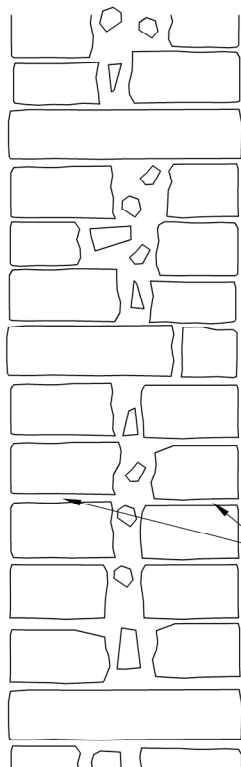
This demonstrates the nature of this largely dry-laid wall of solid construction, but adopting thin format stone. This depicts the idealised multiple over-lap bonding through the thickness of the wall.

The structural qualities of the wall are dependent upon the friction between over-lapped stones. The thin nature of the tying stones makes these susceptible to fracture and consequential delamination.

Despite the nature of the loose core, the size of individual masonry units laid in lime mortar enable mechanical tying across the wall thickness.

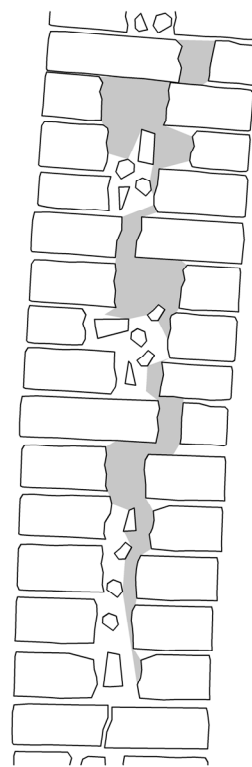
Solid wall - Common form

Core material can become mobile when wall is distorted, and through-stones can fracture.

The structural qualities of the wall are dependent upon the frequency of 'through' stones, tying the outer masonry leaves together, and the cohesion of the core infill. The infill can range from 'loose' non-cohesive granular material to a 'solid' mixture of small stones in lime mortar binder.
