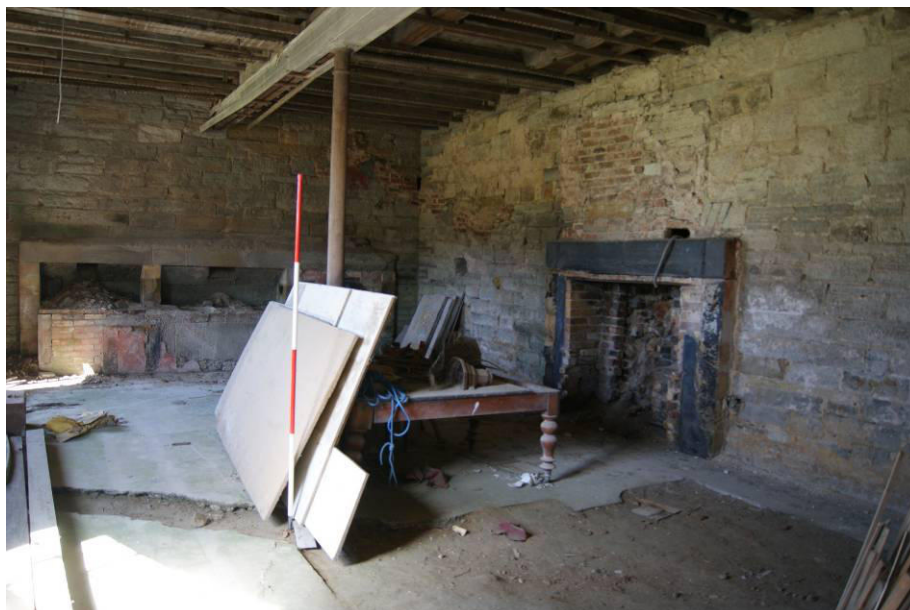
P65. R14. 'Kitchen' on the 1801 floor plan. General view looking north to the stewing range [48] and fire [50]. In the foreground the line of a backfilled 1980s service trench cuts across the cement screed flooring. Timber panels lean against the cast-iron column [70] supporting the floor above.

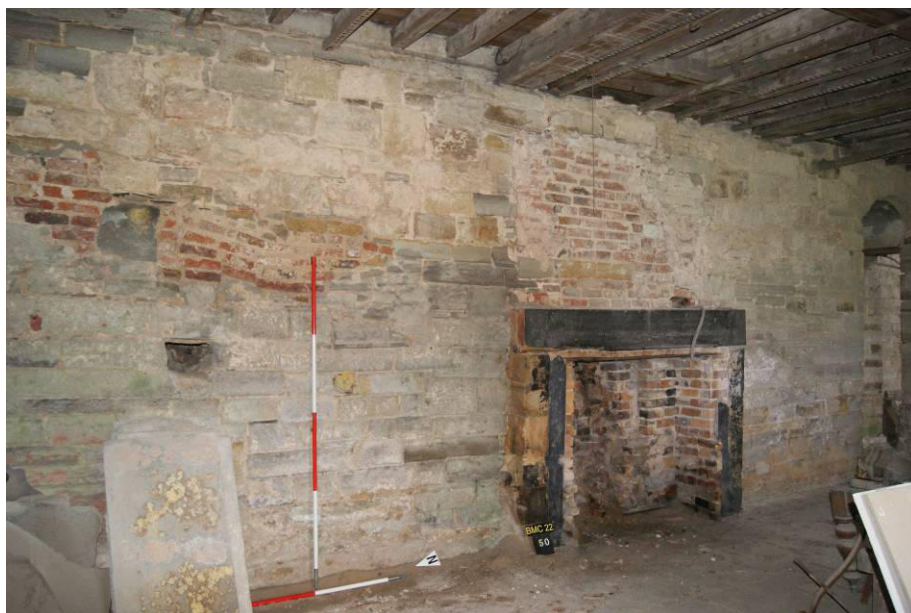
P66. R14 the 'Kitchen' on the 1801 floor plan. East wall looking south-east showing changes of masonry and ?early 19th century brick patching. The lower grey ashlar probably pre-date 1801-4.

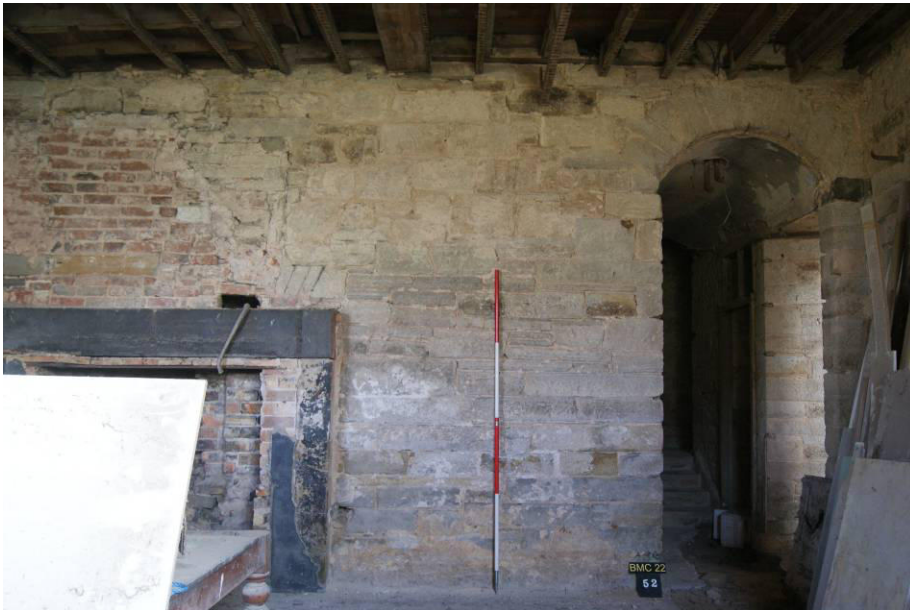
P67. R14. East wall between doorway [52] (right) and fire [50], showing lower long, purple-grey ashlars with the remains of a relieving arch cut by [50], and yellowish sandstone rubble above.

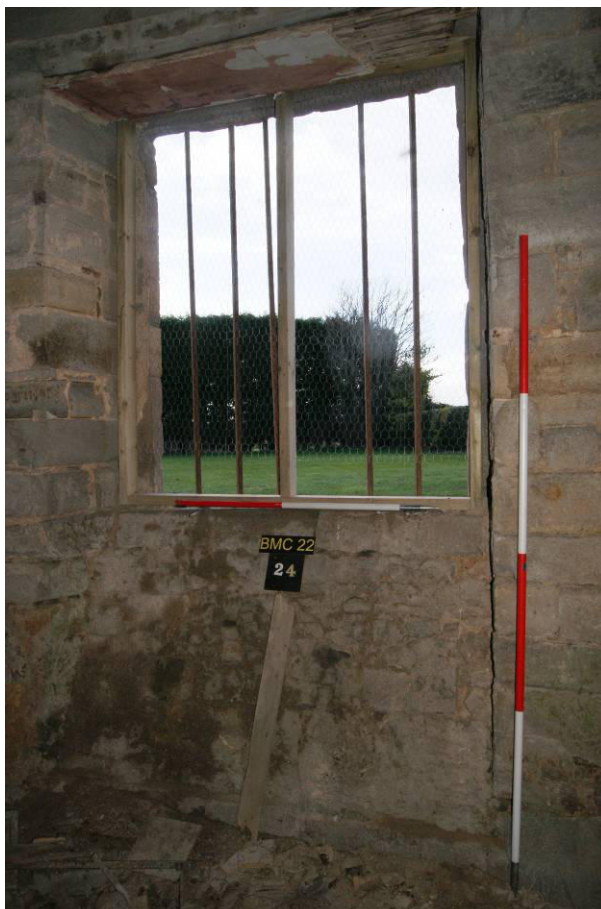
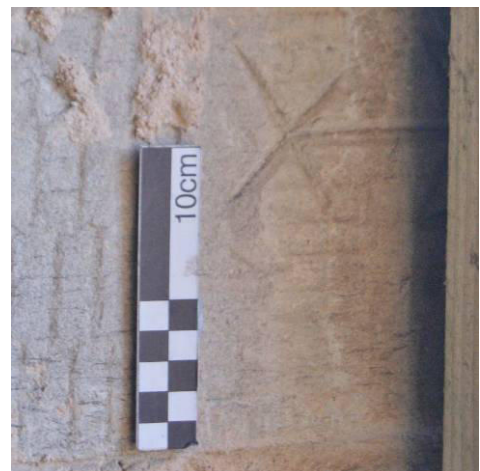
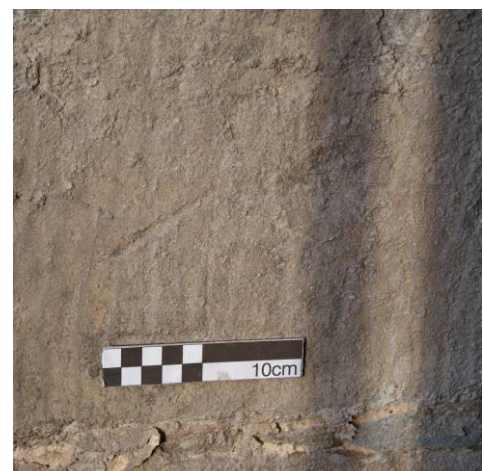
P68. R14. West wall window [24,], which has lost its frame and glazing since 2012. External iron bars are visible. Right - mason's marks on exposed jamb stones in the window reveals. This is proposed to be in a patio area.

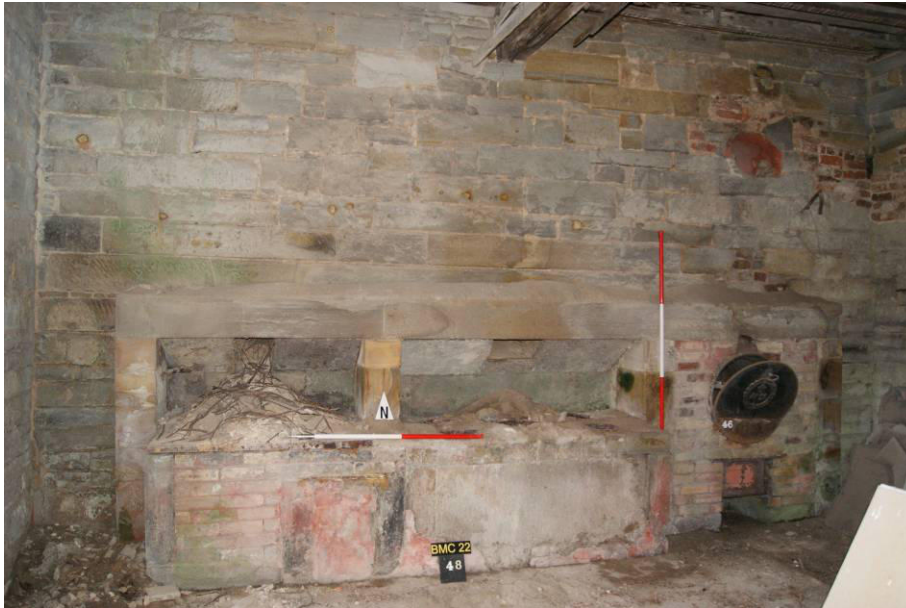
P69. R14 'kitchen', looking north to the 1801-4 stewing range. Proposals currently under reconsideration are for a new doorway in the left-hand corner involving

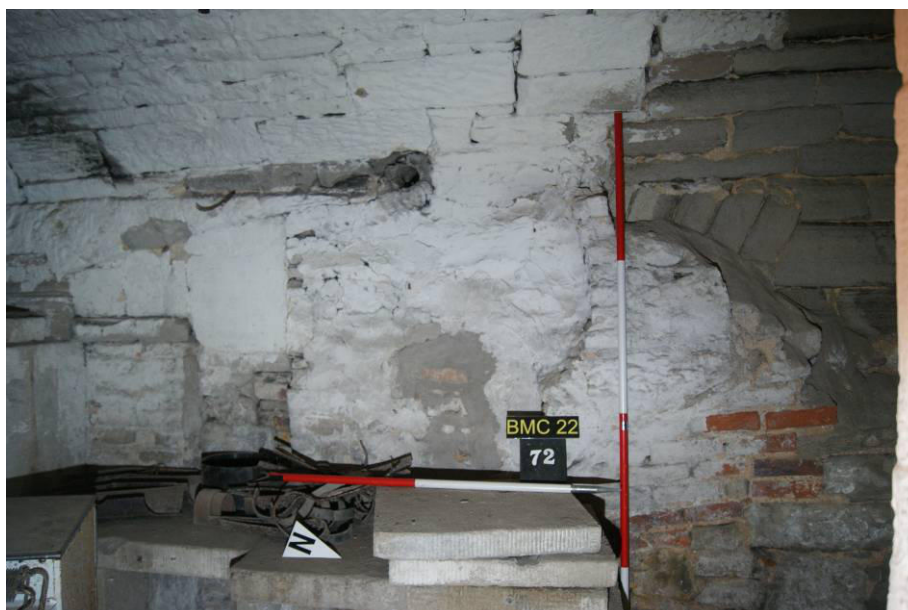
P71. R15. 'Cellar' on the 1801 floor plan. The west wall, showing patching and remains of voussoirs of an earlier arched opening [72] behind the 1801-4 stone larder shelving.

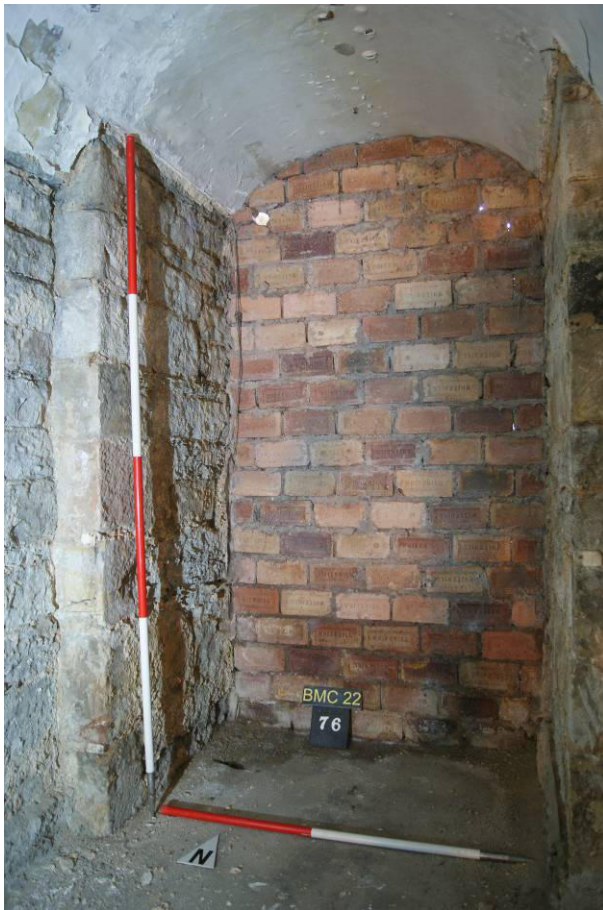
P73. R16, passage, north end, showing 20th century blocking proposed to be removed, and a new blocking wall built across the passage further south, forming a space for a W C

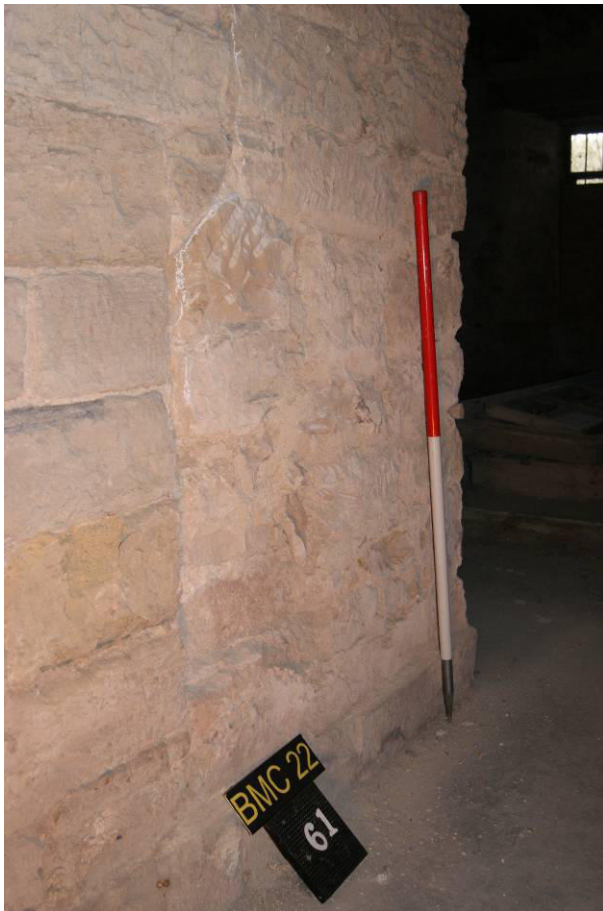
P75. R18, east end. 1801-4 masonry (left) butting the west wall of the late 16th/early 17th century range. The junction is the site of a proposed blocking wall.

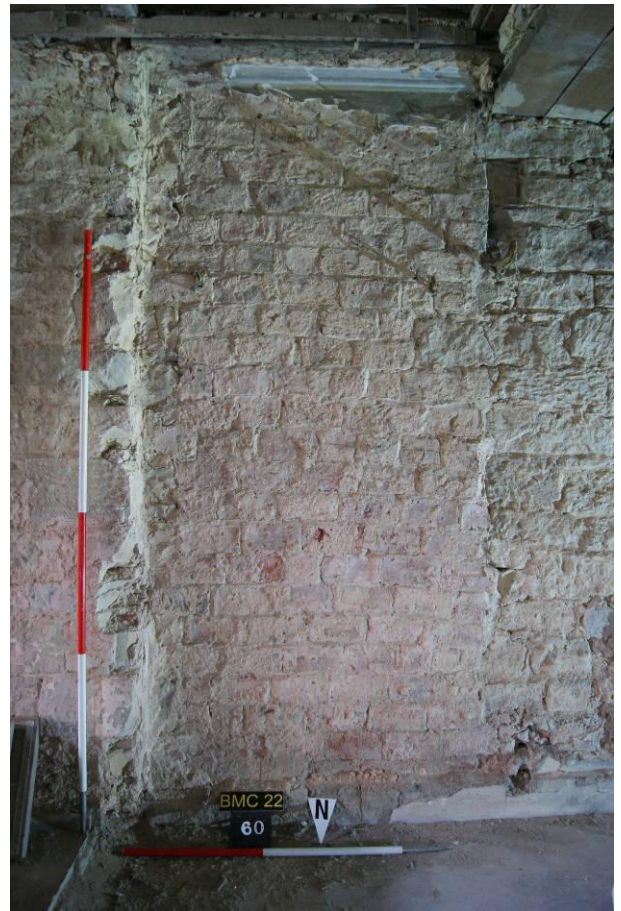
P76. R19, north wall showing on-edge brick infill of a pre-1801-4 doorway [60] which is proposed to be re-opened.

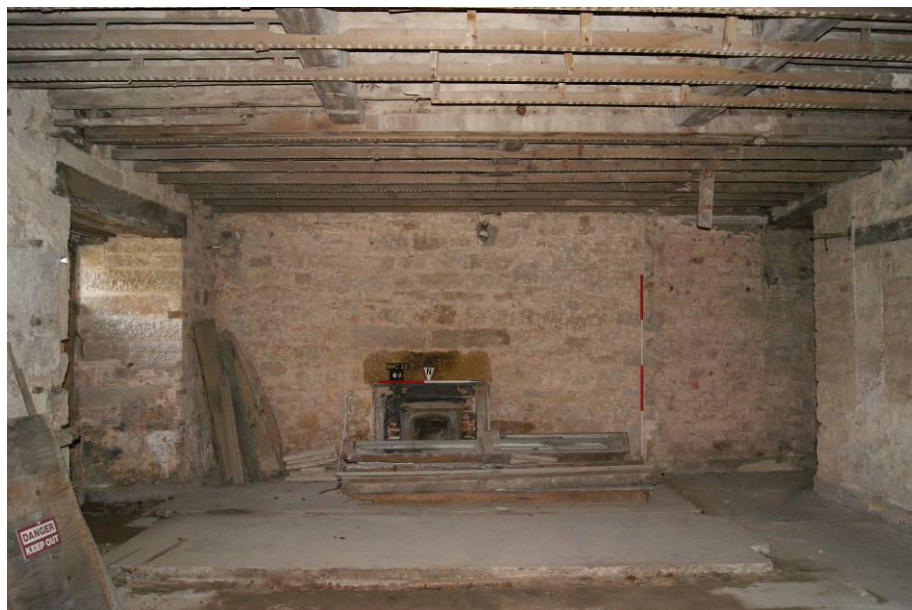
P77. R19 'Servants Hall' on the 1801 floor plan, looking south to fire [68]. Shows cement floors preserving the outlines of 18th century partitions, overlying flagged flooring. These are proposed for removal. Brick blocking of [60] is visible (right).

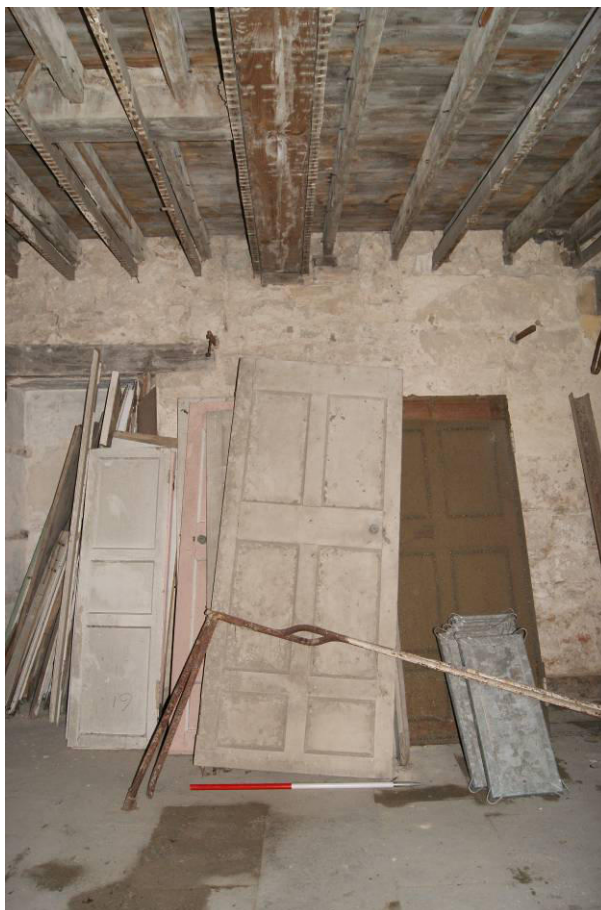
P80. R19 'Servant's Hall' showing detached doors, at least one numbered, and other fittings leaned against the west wall. A large reused beam section (top left) bears assembly or timber-merchant's marks.

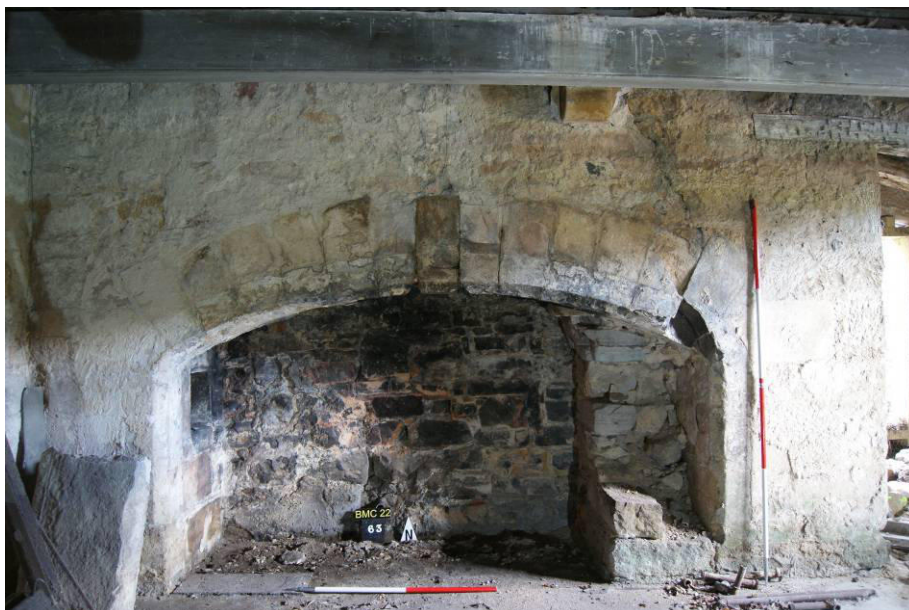
P81. R19 'Servants Hall' looking north to fire [63], showing loss of part of a right-hand voussoir of the arch and evidence of instability in the centre of the arch.

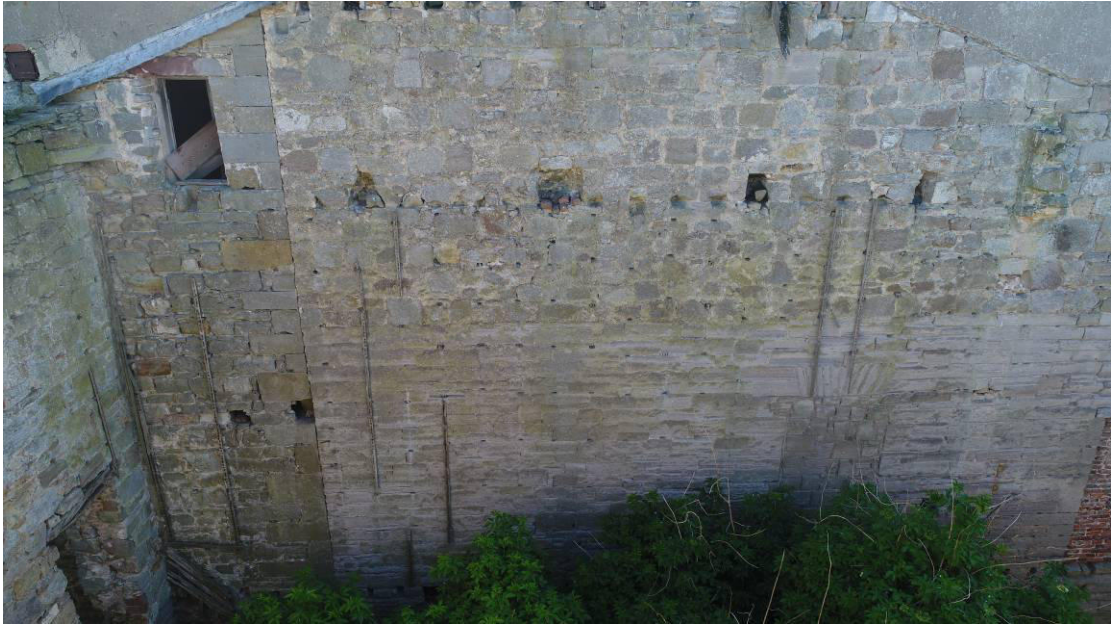
P88. R22-46, drone view showing the pre-Paterson north wall with the quoins and rubble masonry of the late 16th/early 17th century north-east wing (left) with 1801-4 access hatch, butted by the long purple-grey ashlars possibly late 17th or 18th century, and 1801-4 rubble masonry above.

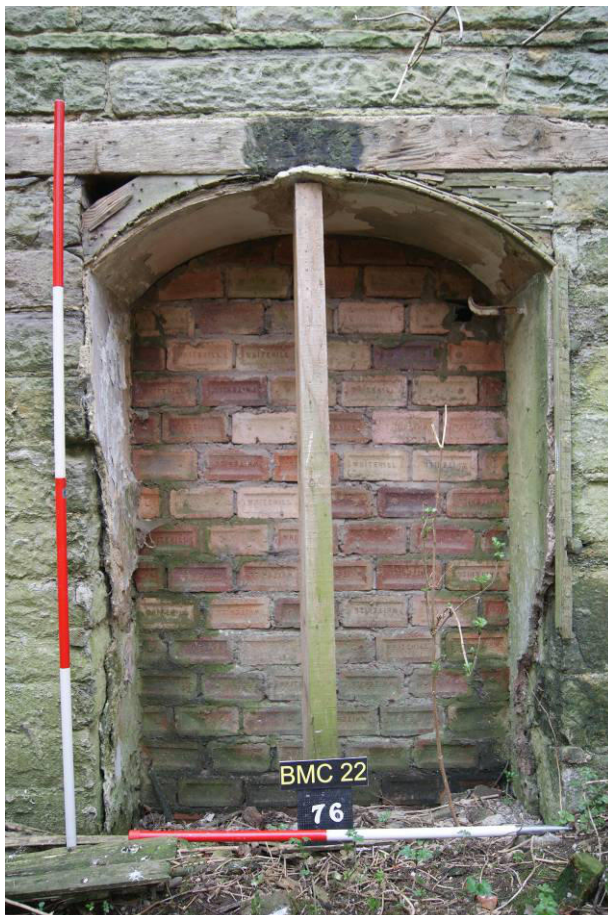
P89. R22. Door [74] to service passage R16 with 20th century brick blocking, which is proposed to be removed and the passage blocked further south in the passage to create a W.C.

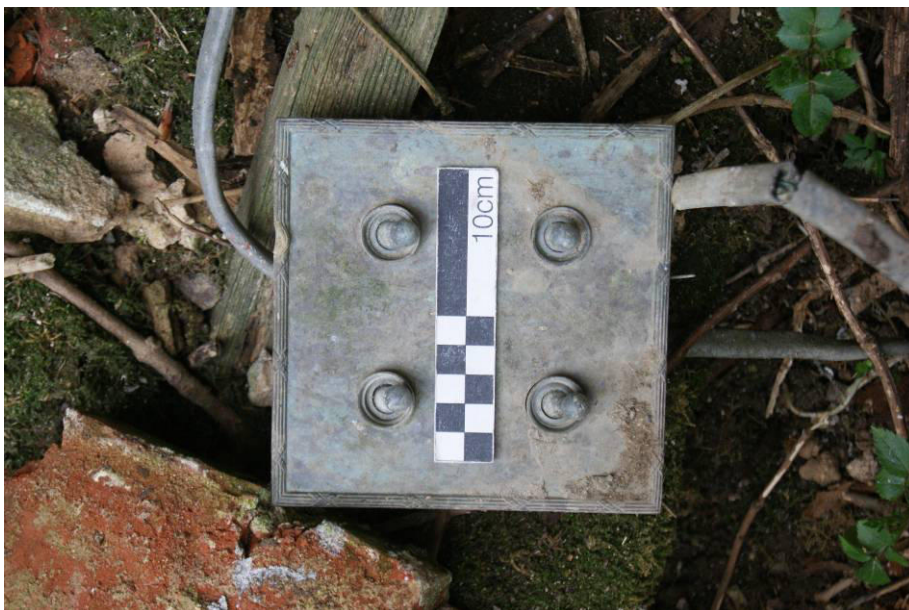
P90. North Range. R22. Detached 1923 light switch with 'Tucker Telac' insulators lying in the debris.

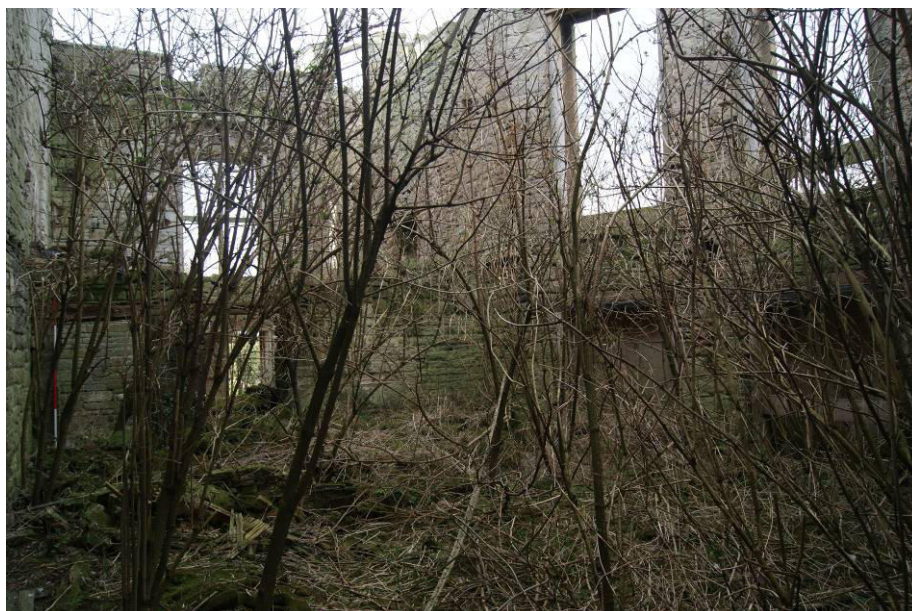
P91. North Range. R22 looking west. This area is proposed for a new 'freestanding' 'house', with a patio in the bay front (right). The lower part of a dividing wall demolished in 2013 is just visible. Since 2012 extensive undergrowth, principally elder, has rooted in the debris covering the floor.

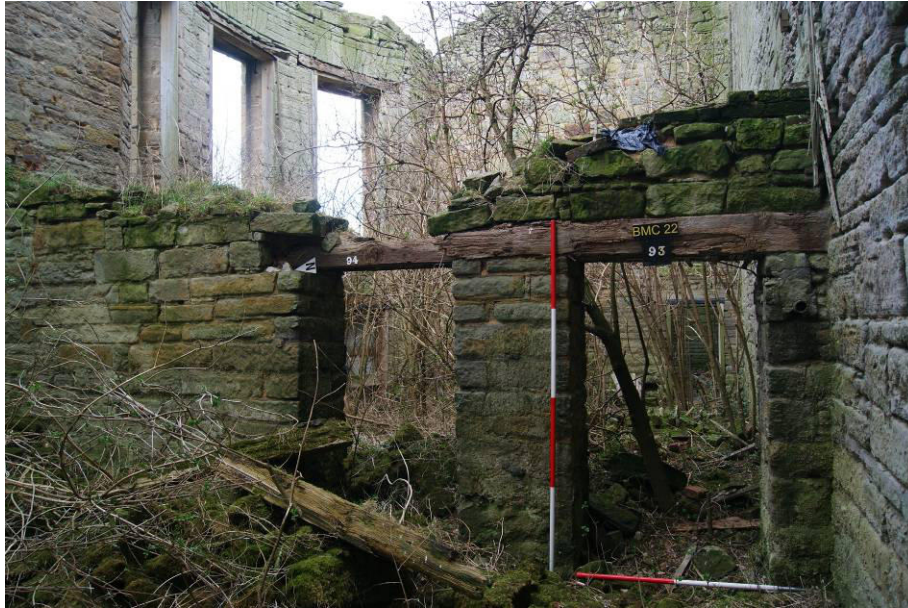
P92. R24. Looking east to the dividing wall with R22 and doors [93] and [94], which was reduced to first floor level in 2013.

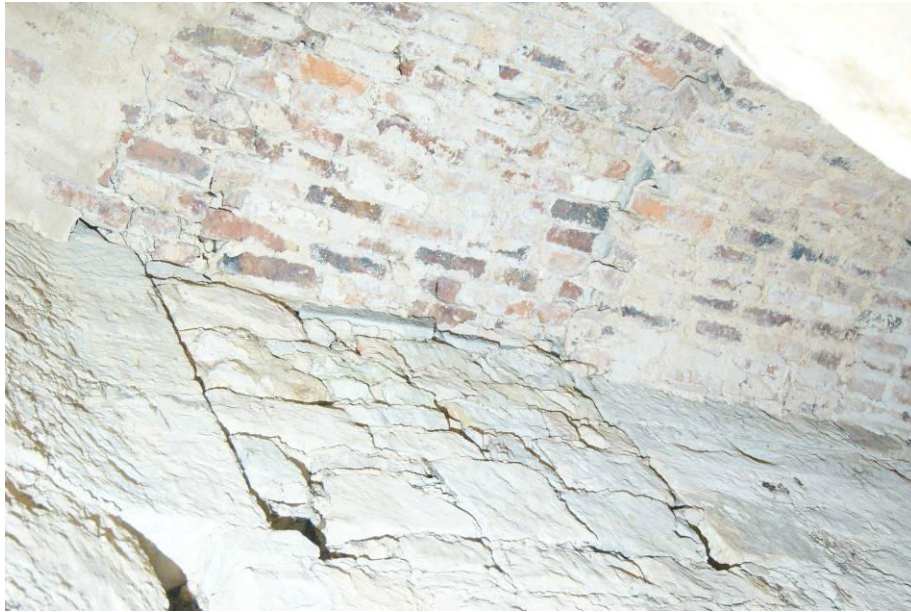
P95. R8.2 Blocked opening [185] at first floor level in the east side of the mural stair. A rough patch of brickwork in the vault appears to be associated. Possibly a pre-1801-4 feature.

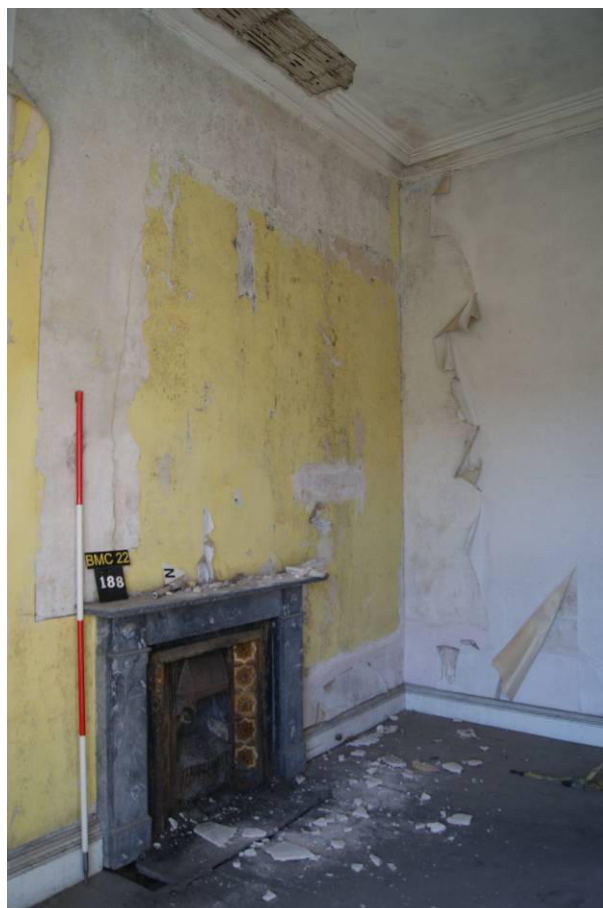
P99. R26, part of the c.1892 remodelling, looking north-west showing loss of ceiling above fire [188].

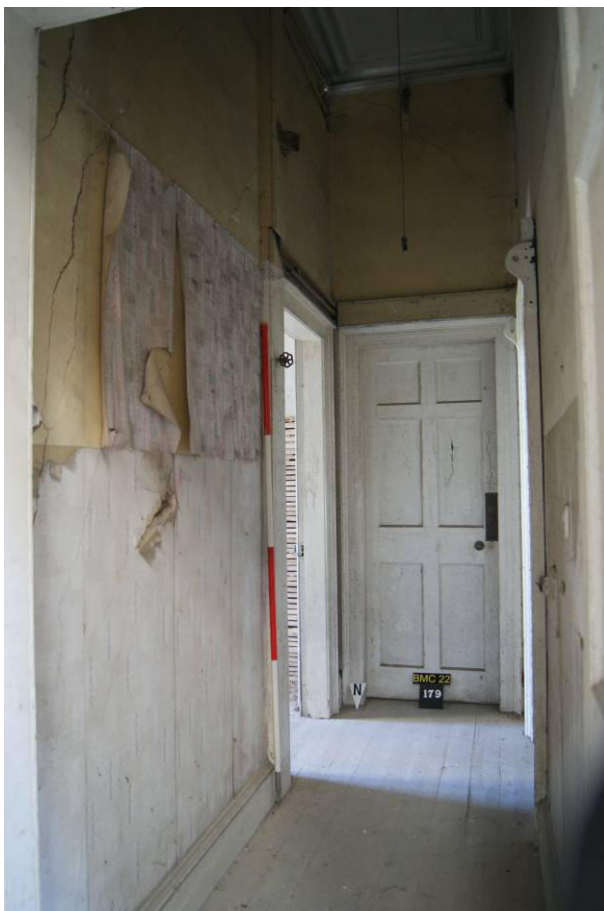
P101 R28 looking south to door [178] to R30 (left) and [179] to R29. The stud walls (c.1892), with 20th century wallpaper, are proposed to be removed and the spaces reconfigured.

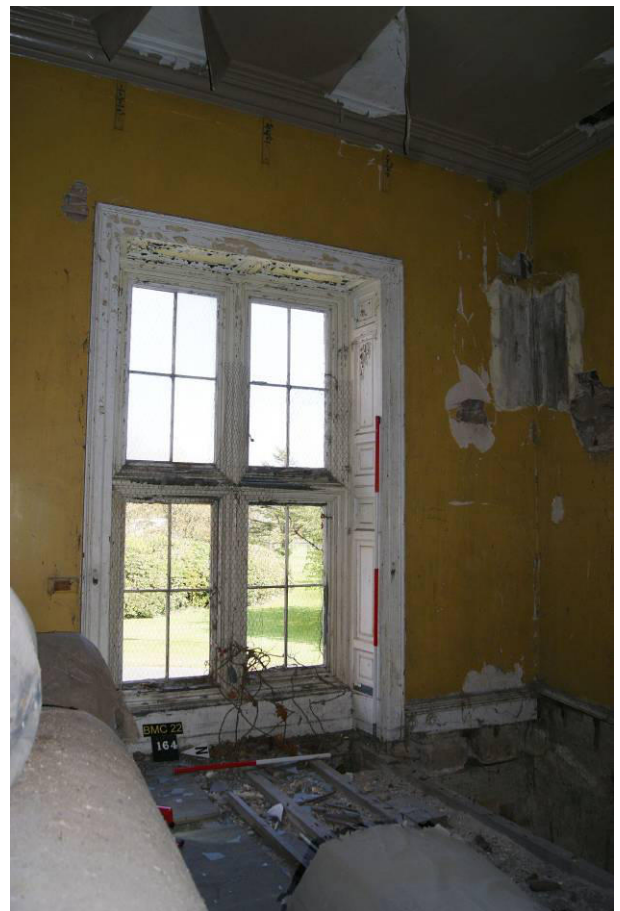
P104. R29 looking south-east with invasive creeper coming through window [164]. The southern part of the floor has been removed. This room is proposed to be reconfigured with a new partition.

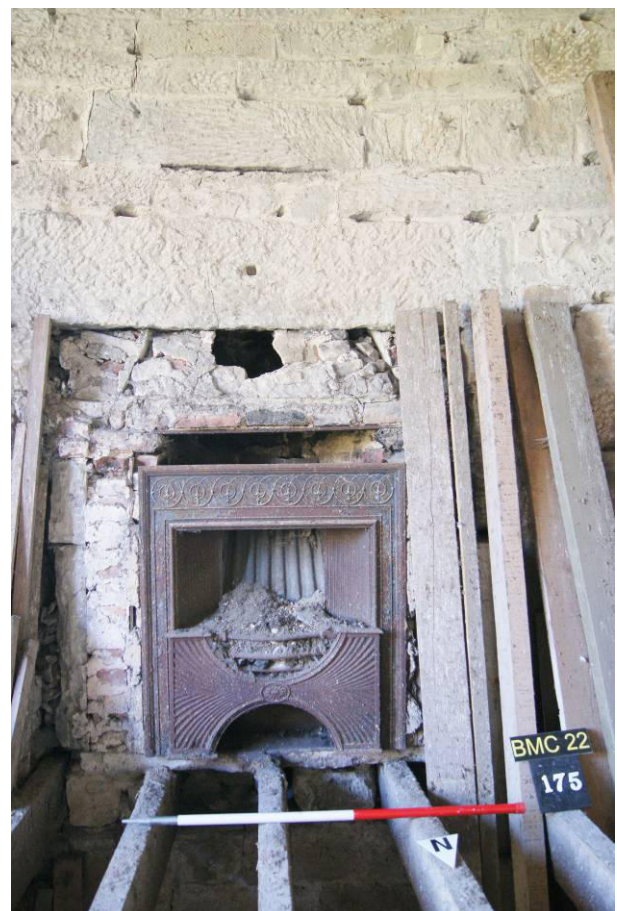
P111. R36. Early 19th century hob grate with surround removed (see P130) and replacement floor joists.

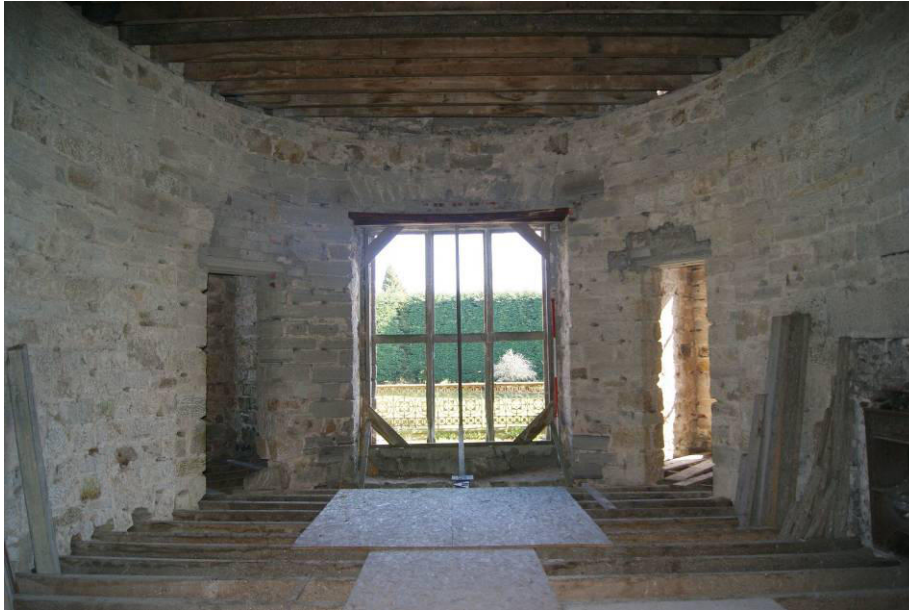
P112. R36, room view looking east. Window [169] (frame removed) and doors to turret rooms R37 and R38[173-4] have renewed cast concrete lintels. A new partition is proposed for the southern half of the room.

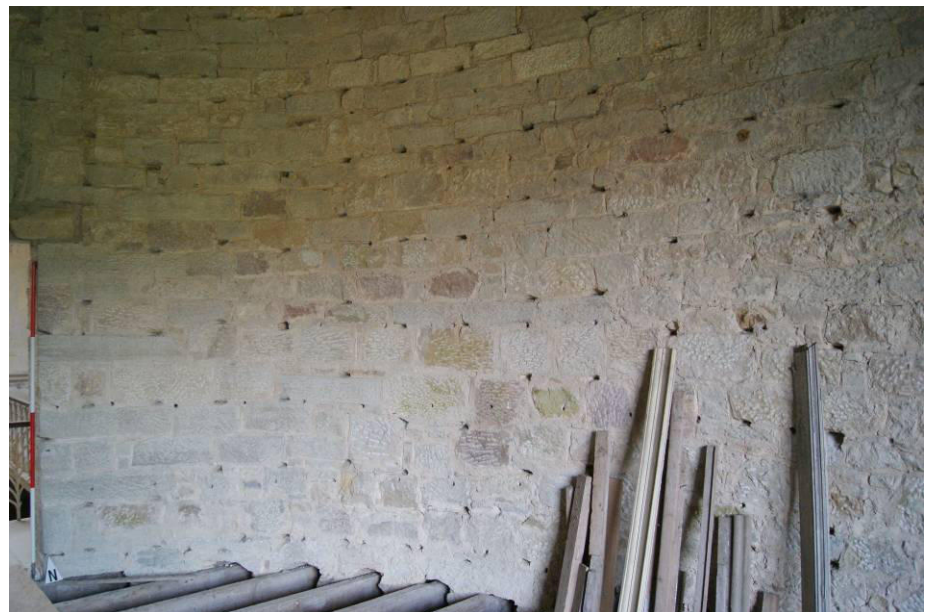
P113. R36 looking northwest to proposed site of a new doorway coming from R42. The wall is 1801-4 rubble masonry, stripped of lath and plaster. Replaced floor joists occupy the sockets

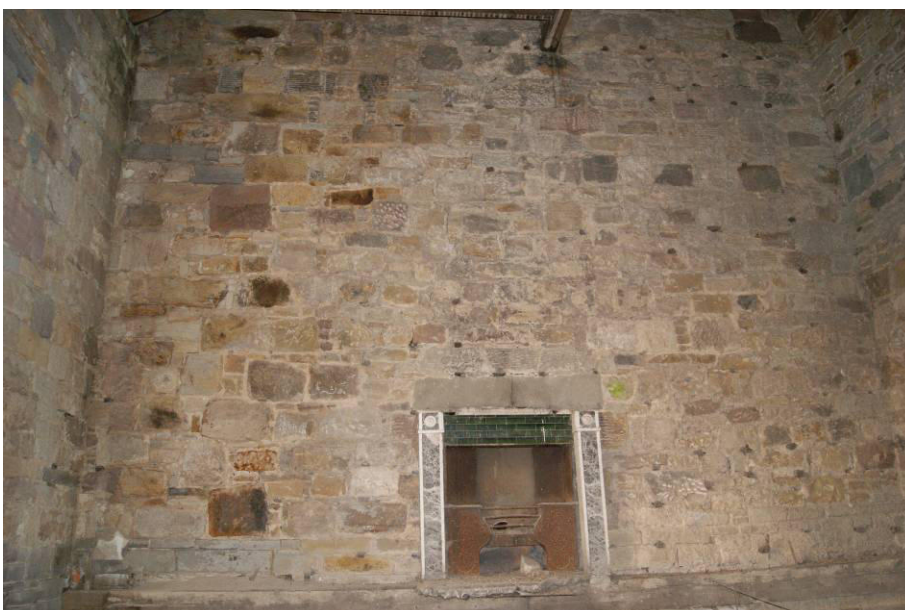
Fires – in the north wall is a fireplace [157] with remains of an Adam-style surround – jambs white marble edging and corner bull-eyes, with inset panels of grey and white marble. The mantel is missing. Contains a cast-iron Bath-type hob grate with classical figures and swags, probably of 1801-4, with later 19th-early 20th century hood inlaid with small green tiles. The hearthstone remains, suspended (P114).

P114. R39 looking north to fire [157]. The rubble masonry appears to be 1801-4, and shows differences in size of material used on the west and east sides. It is not clear if this reflects Sitwell economies, or has any dating significance. A new opening is proposed to be inserted left of the fire.

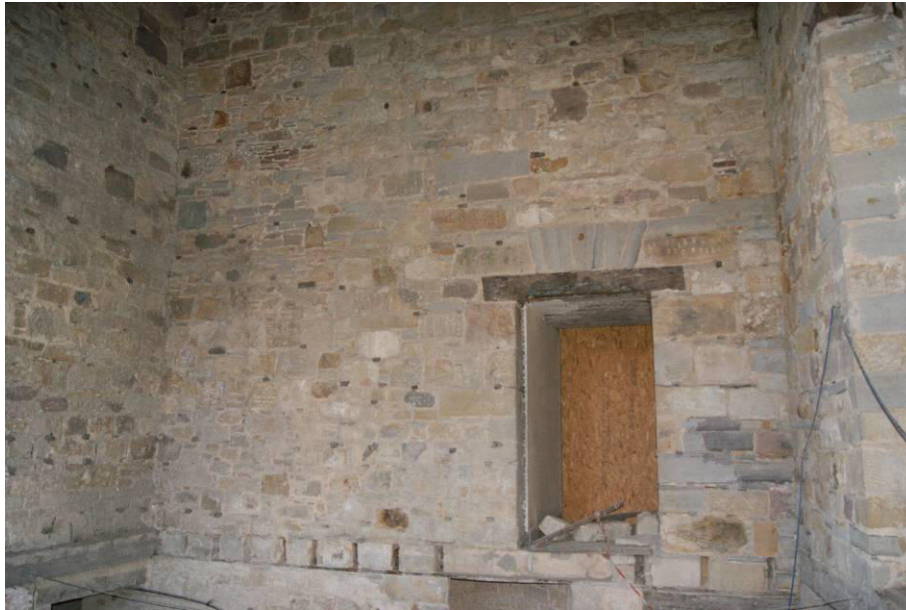
P115. R39 looking east to door [158] with sockets for removed floor joists below. The rubble masonry, stripped of lath and plaster, suggests either the survival of some earlier fabric, or reused material. New partitions are proposed along this wall-

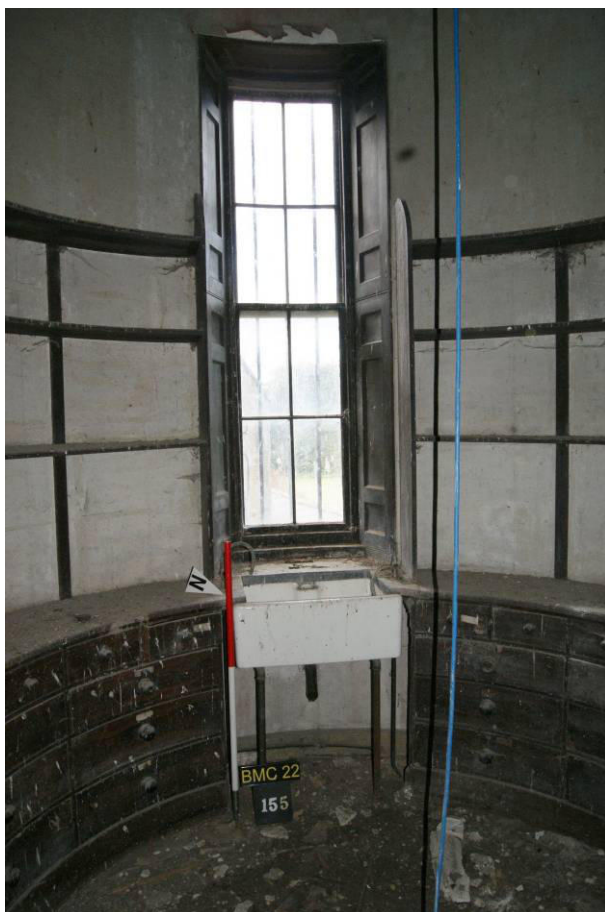
P116. R40. William Sitwell's 'lab', looking south-west to window [151]. This is the only room the castle retaining all its fittings, which are proposed to be removed and the room converted into a bathroom.

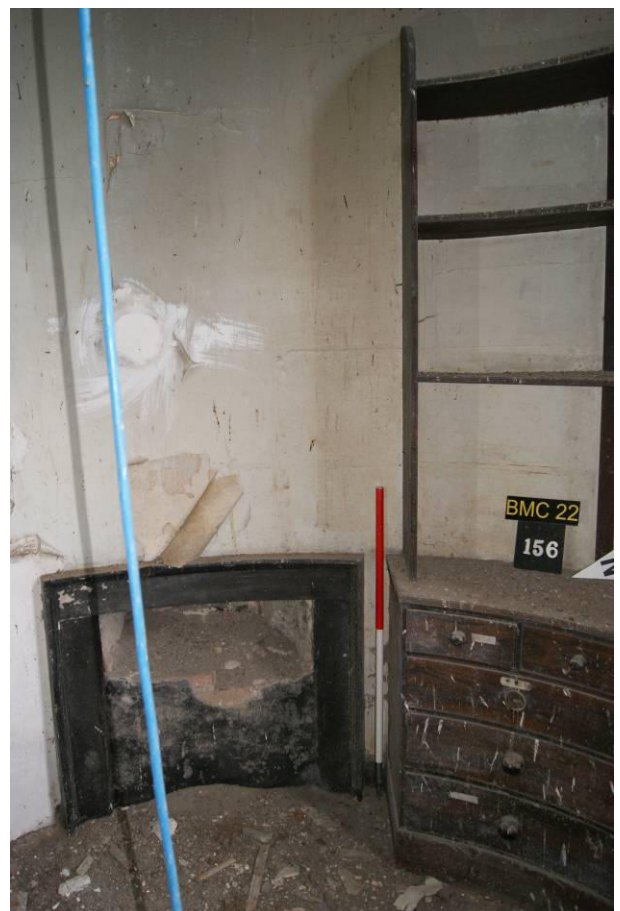
P117. R40 looking south-east to fire [259] which has been converted into a stove position (vent-pipe opening is infilled).

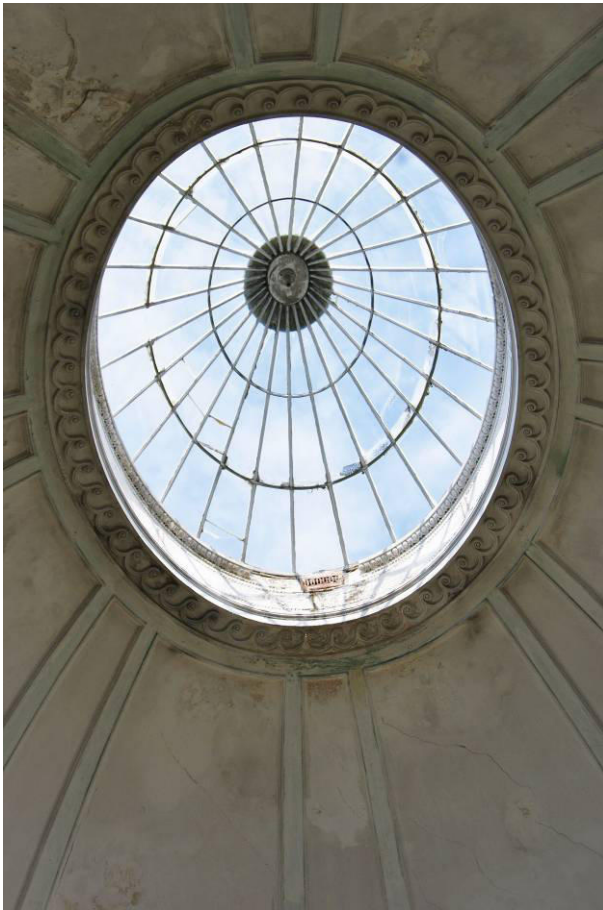
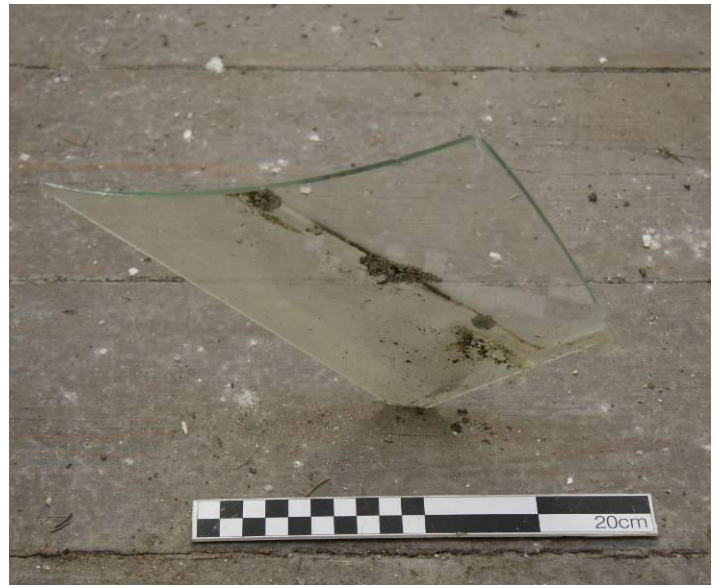
P124. R41, the glazed cupola over the Oval Saloon. Some minor delapidations since 2012 are apparent, largely a result of Storm Arwen which resulted in the shard of glass embedded in the floorboards

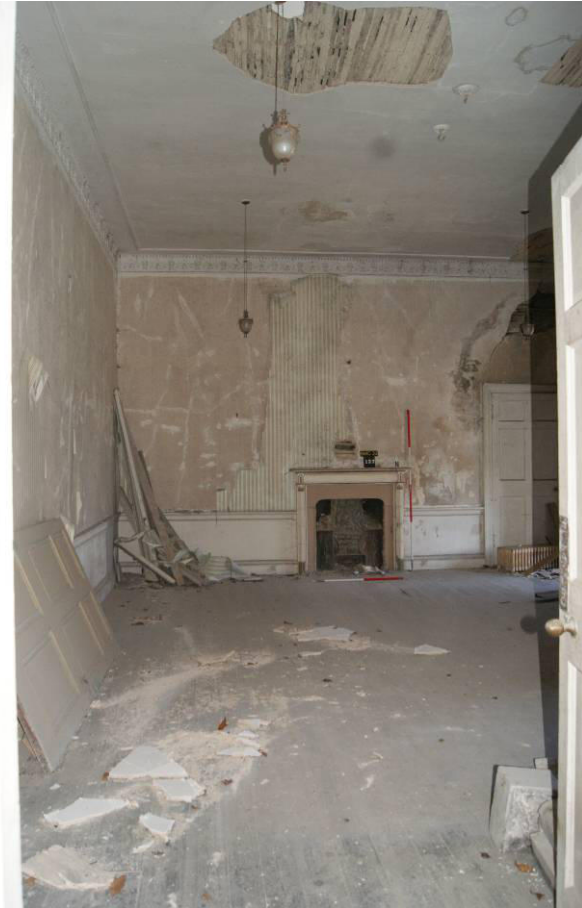
P126. R42 'Billiard Room' in 1801. Room view looking north to fire [127] showing ceiling plaster fallen since 2012. This is proposed to remain a

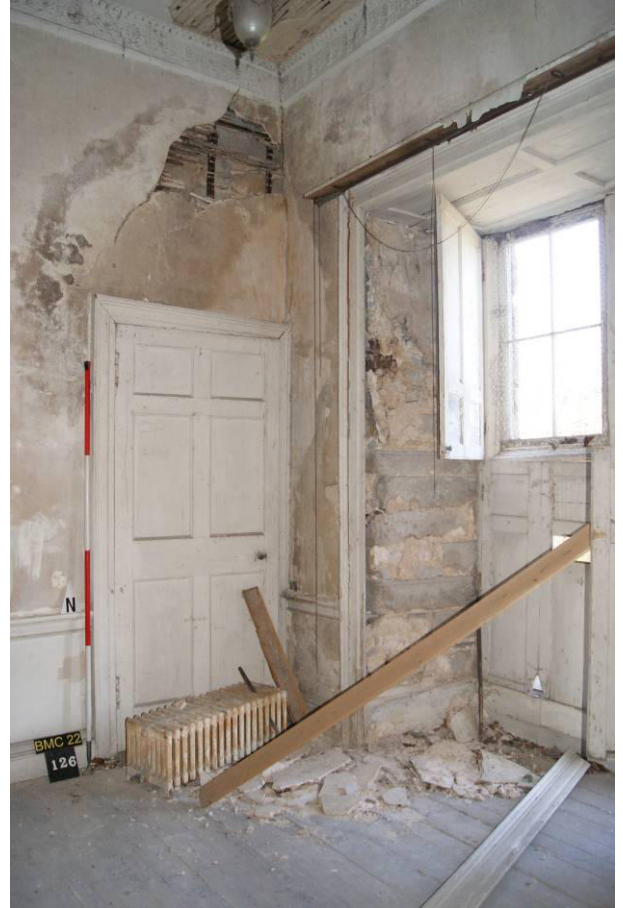
P127. R42. Door [126] of wall closet R42.2 made into a door to the North Range in 1801-4, blocked in the 1960s, and now proposed to be reopened (see also P129).

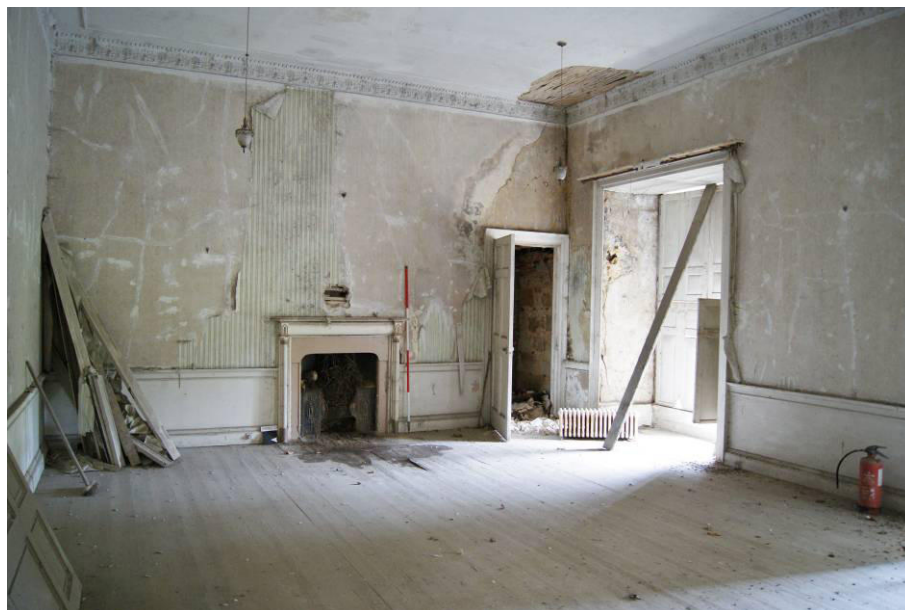
P128. R42. The same room view in 2012 for comparison. Closet door [126] is open and plaster in the reveal of window [125] is intact.

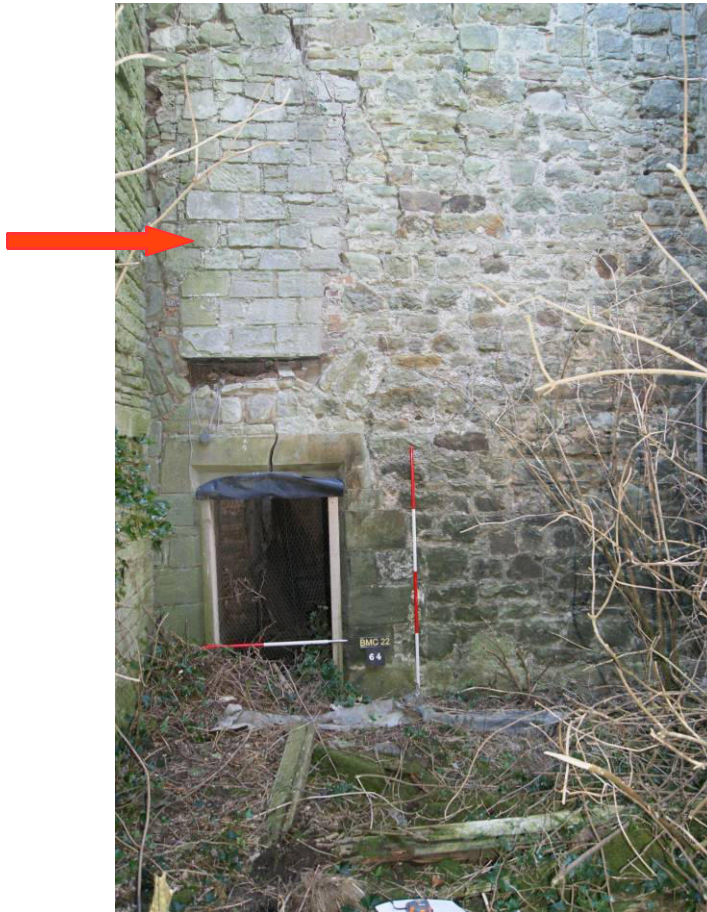
P129. North Range. R44. Doorway [128] (arrowed) from R42 inserted into the north wall of the late 16th/early 17th century range in 1801-4 and blocked in the 1950s. This doorway is proposed to be reopened to access a rooftop patio area above R20.

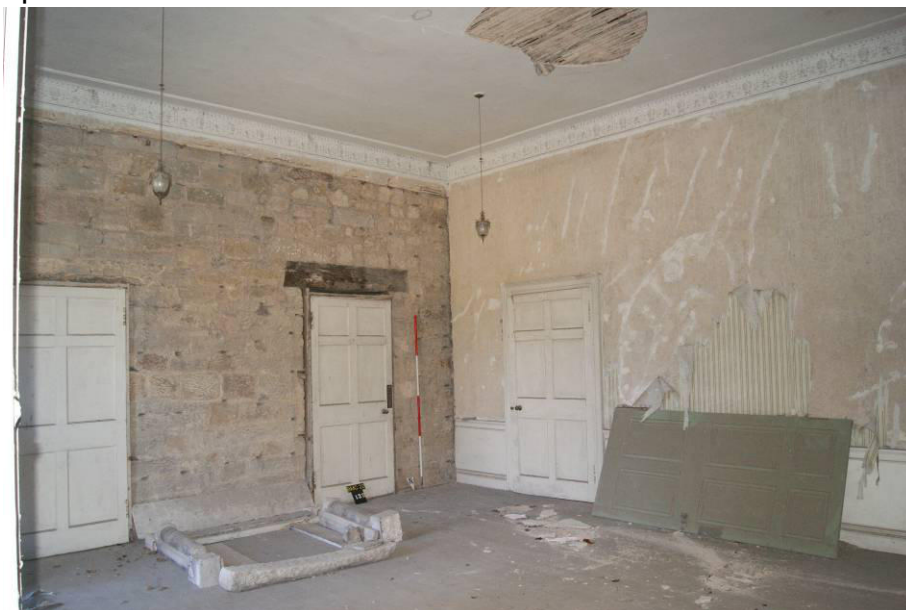
P130. R42 looking south-west showing area of fallen ceiling plaster. All three doors [121-3] are proposed to be retained. The fireplace surround lying on the floor belongs to fire [175]

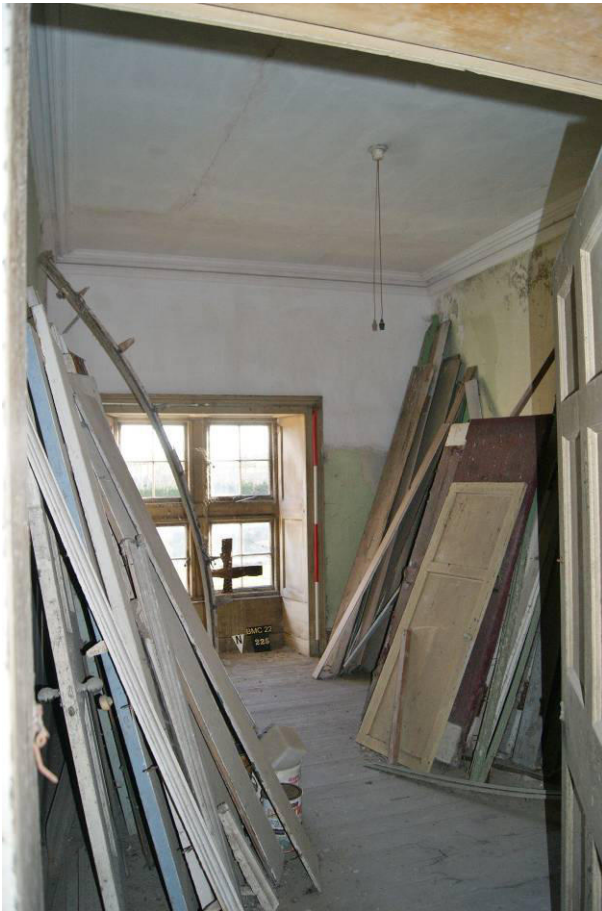
P137. R49 looking south. The position of a removed fire is shown by the grey plaster beside window [225].

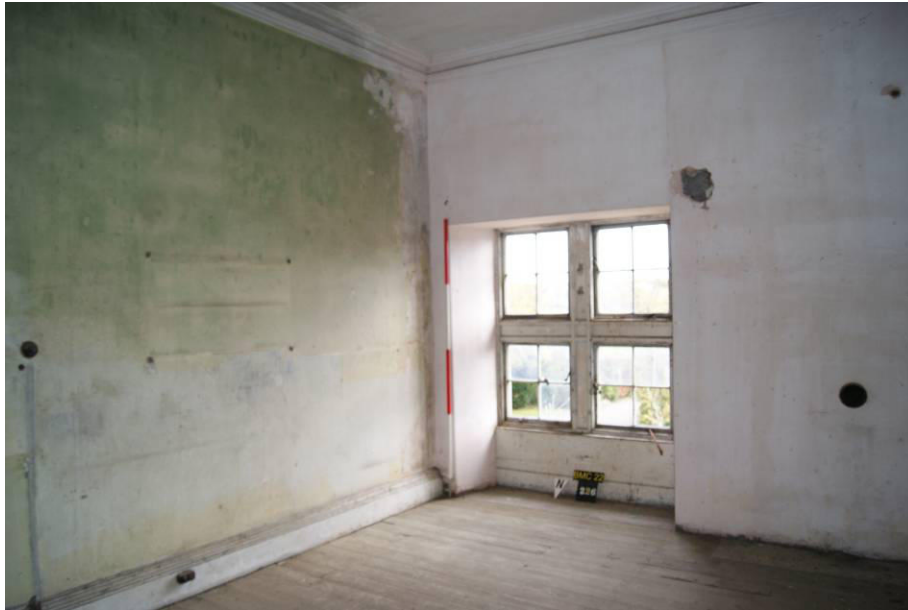
P140. R50 looking south-east. The east wall is proposed to be opened out into a wide opening linking to R51. The south wall and part of the ceiling above is late 20th century plasterboard. The original fire has been removed.
