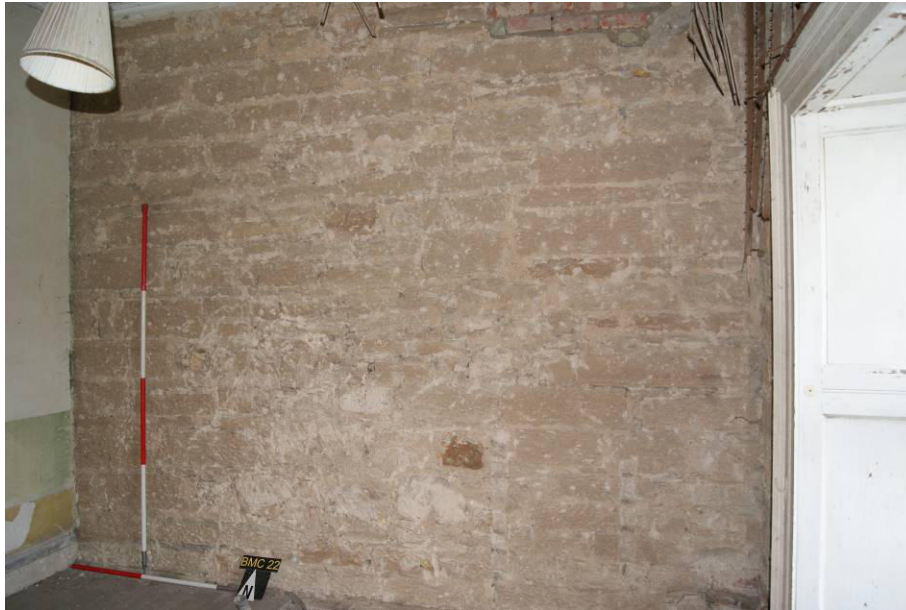
P145. R54. North wall stripped of lath and plaster. The western (left) side is the proposed site of a lift from ground floor level. There are traces of infilled holes forming a diagonal line, rising to the east, which may represent a former timber stair.

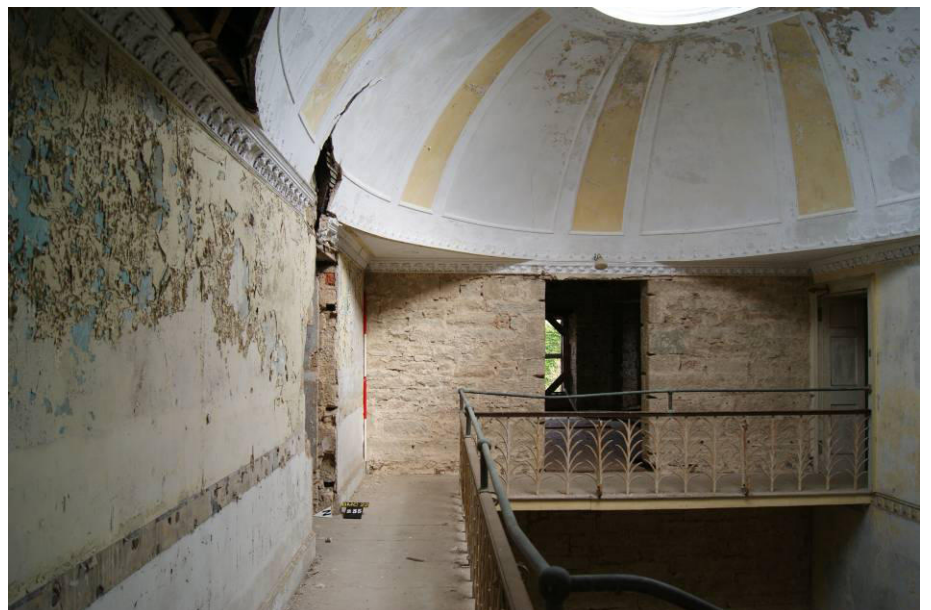
P151. R56 looking west, showing areas of lost decorative plasterwork on the spandrels of the cupola, and door [221].

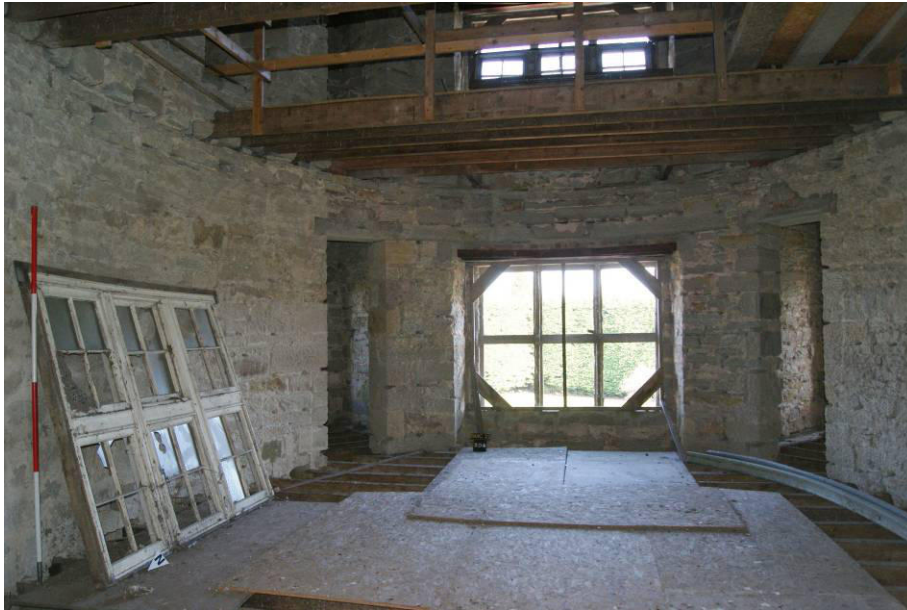
P154. R57. Room view looking east to window [205]. The modern replaced floor joists are partly decked with chipboard panels. Lintels above the doors have been replaced in cast concrete. The complete internal window frame with glazing rests against the north wall

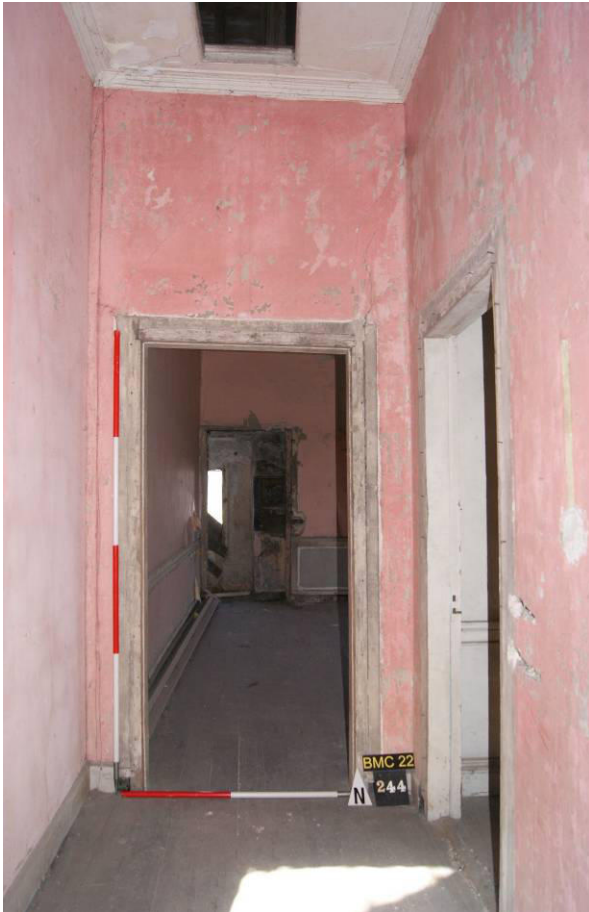
P156. R60 looking north. The door ahead [244] will be retained, but that on the right [237] will be blocked. Hatch [236] is visible in the ceiling.

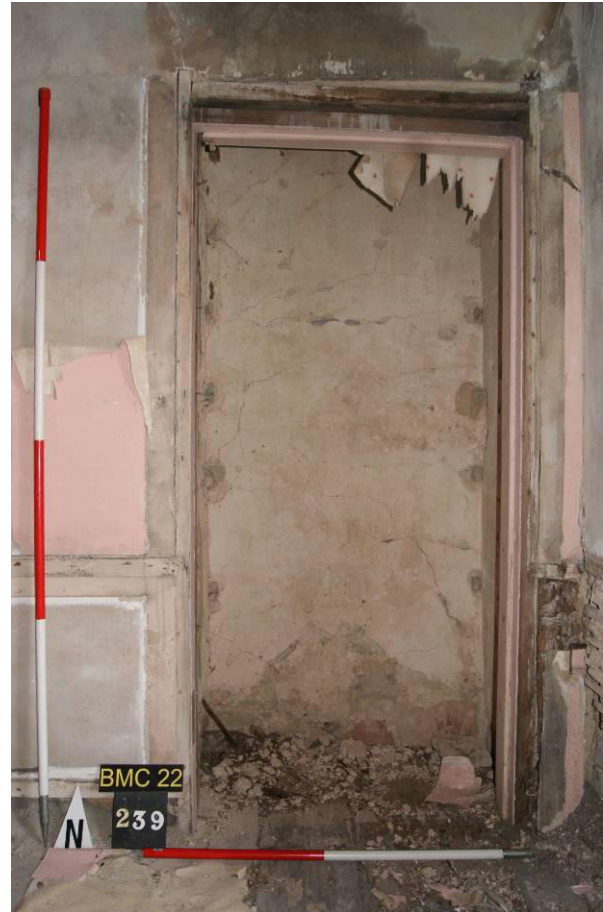
P157. R62.2. Wall closet shown on the 1778 floor plans. This is proposed to be broken through at the back to give access to a roof-top patio in the North Range.

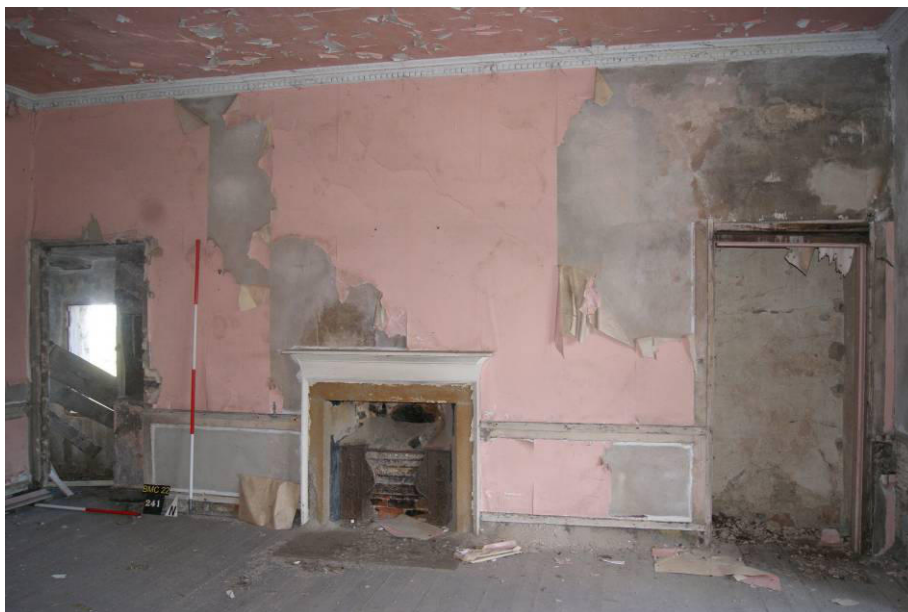
P158. R62 looking north showing wall closets [239] far right and [241] far left. Fire [24] has a stone surround, possibly 18th century, behind a later timber surround. This will be retained in the proposed conversion.

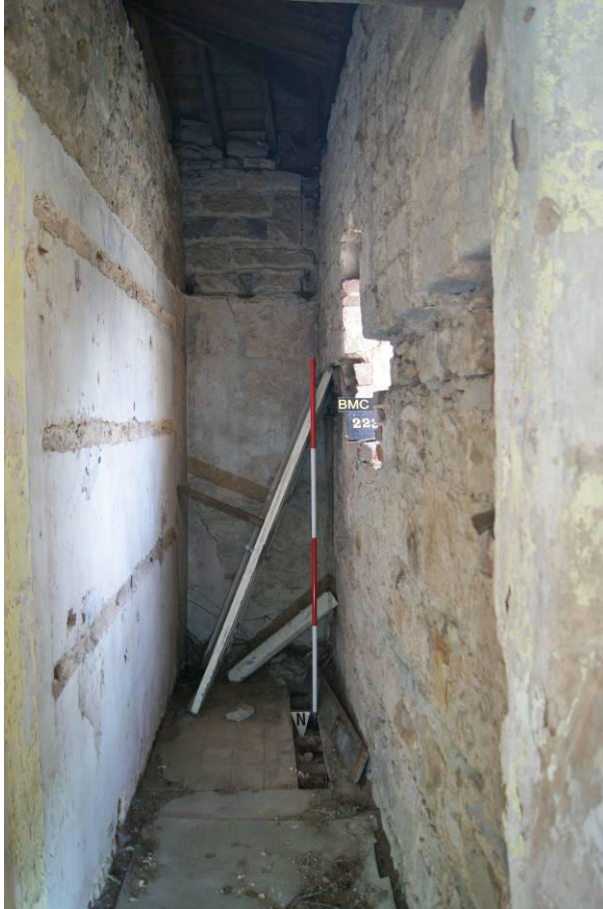
P159 R63. Looking south. Showing floorboarded end section and offset upper part of the west wall with window [223]. The offset wall may be as late as c.1892. The room may have been intended to carry another service stair but appears on the 1801 plan as a 'Water Closet'. In the current

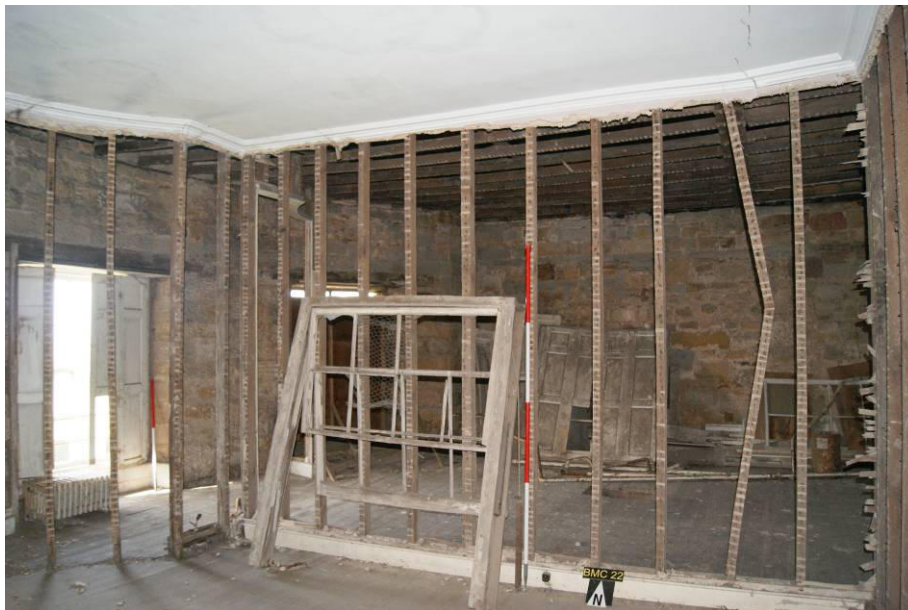
P160. R66 looking north-east to a stud partition stripped of lath and plaster. The framing looks recent but the partition corresponds broadly with that shown on the 1801 floor plan and the lath nails look hand-made. This suggests the partition belongs to the 1801-4 build. The frame of window [214] leans against it.

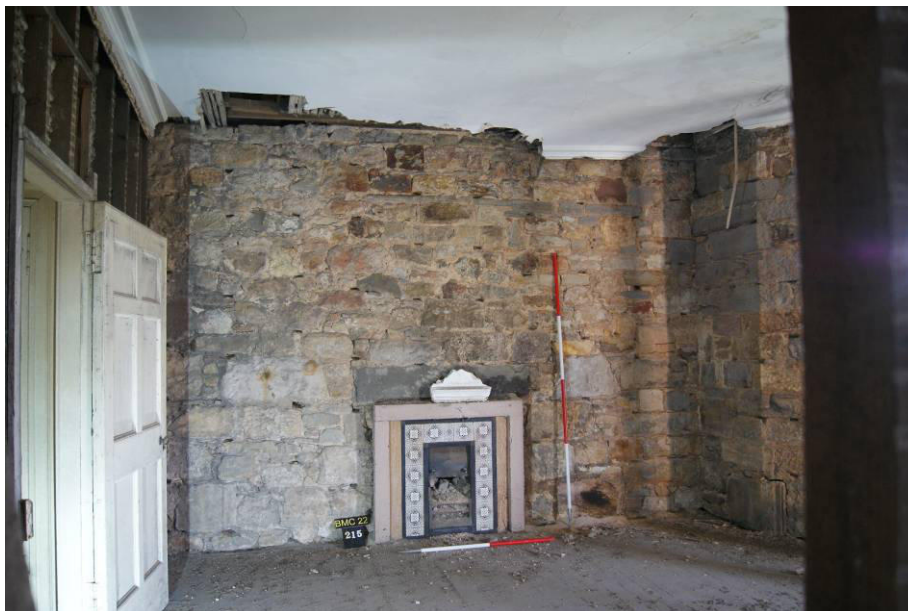
Fire – [215] in the south wall looks a late 19th or 20th century replacement, with a transfer-printed tile surround and hooded grate (**P162**).

P162 R66 looking south to fire [215] and the south wall stripped of plaster. Shows loss of some ceiling plaster and cornice (fallen fragment on the mantelpiece).

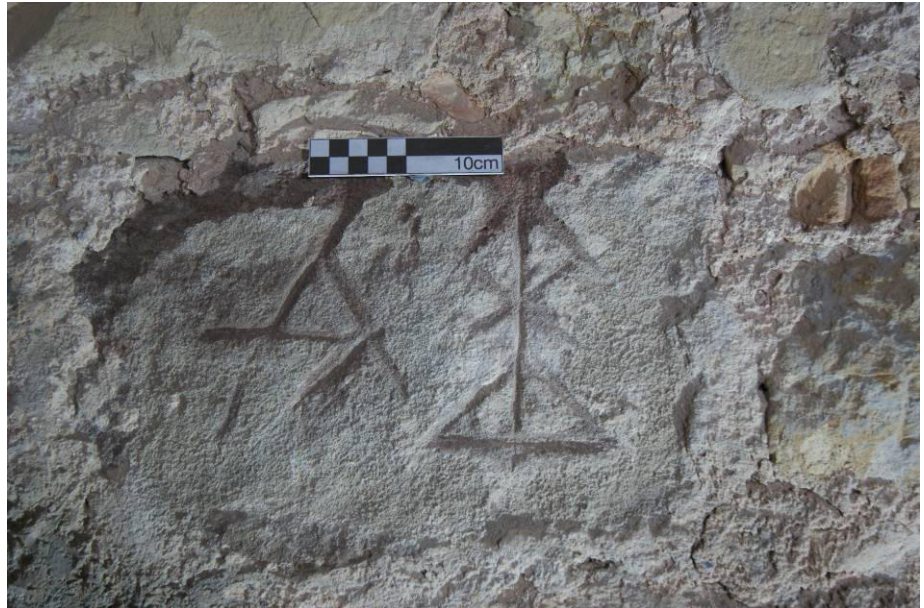
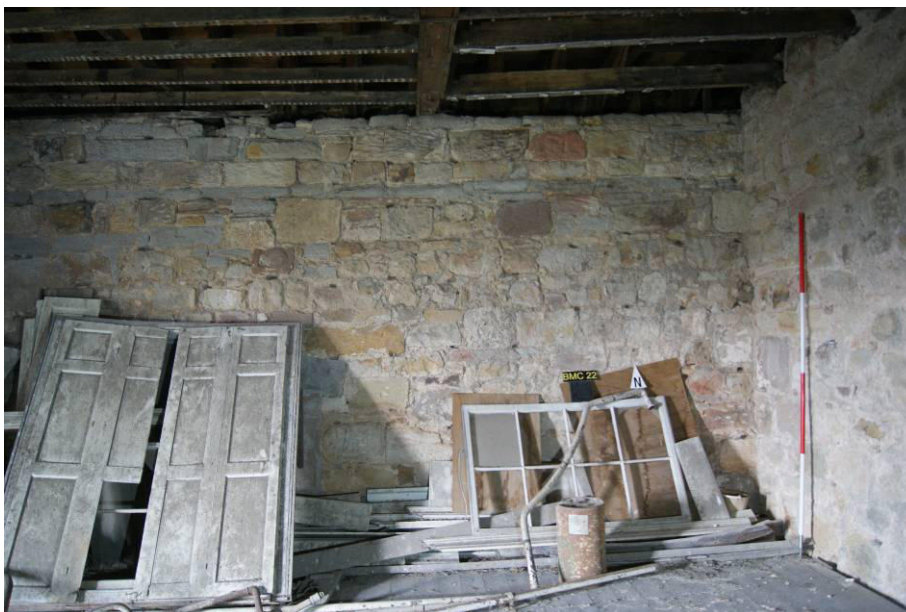
P165. R67, north wall.
The site of a proposed
new doorway leading
onto a patio above the
North Range is between
the shutters and the
window frames. The wall
shows a possible
levelling course of grey
ashlars.

P166. R67. The whole
north wall looking
obliquely north-east,
showing course of grey
ashlars and detached
windows and shutters.

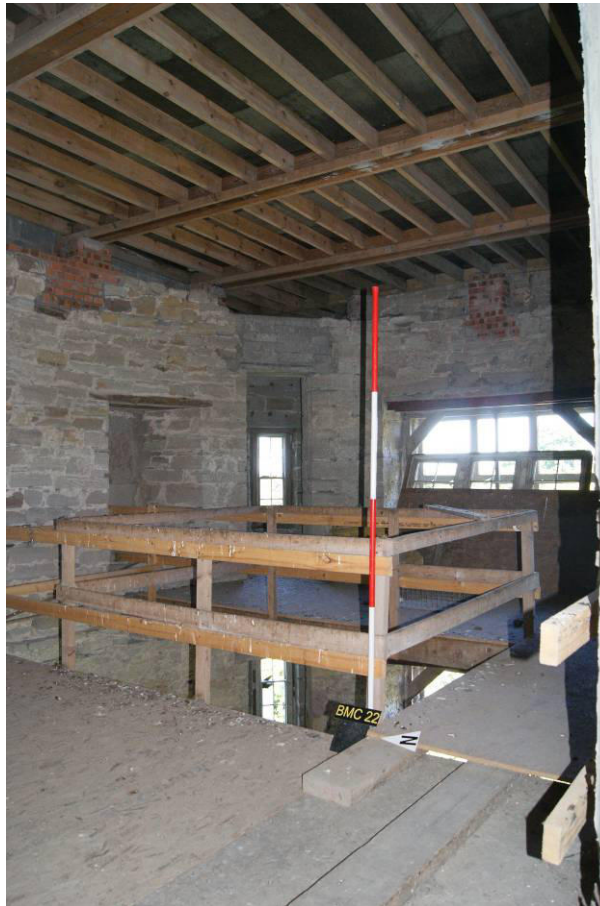
P167. Gatehouse, R69. General view looking north-east to window [305] and turret room R70. Little perceptible change has occurred since 2012. More chipboard decking panels have been laid and bird infestation continues.

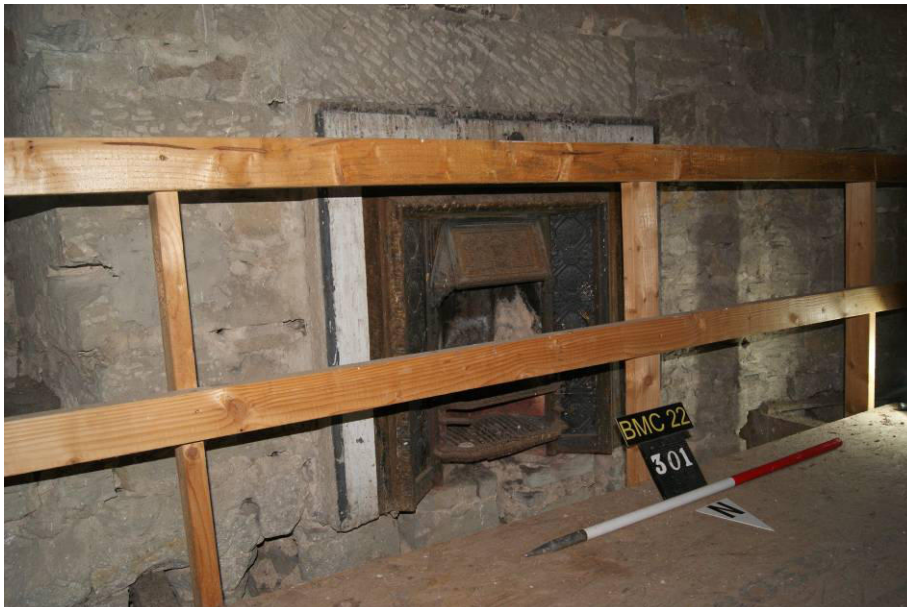
P168. Gatehouse, R69. Fire [310], with modern railing and chipboard decking. All walls have been stripped of lath and plaster. The fire has a late 19th century grate. This room is proposed to become a bedroom, with the fire retained as a

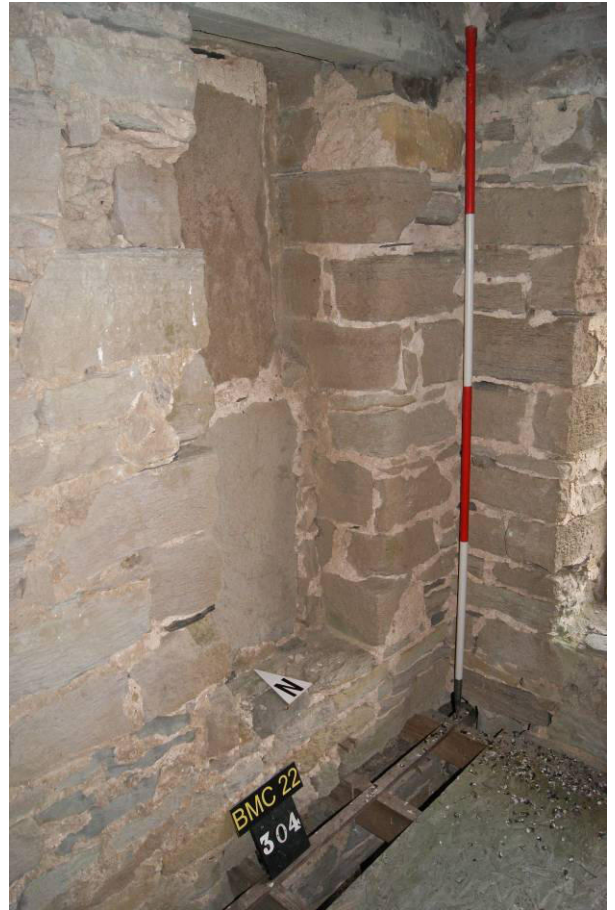
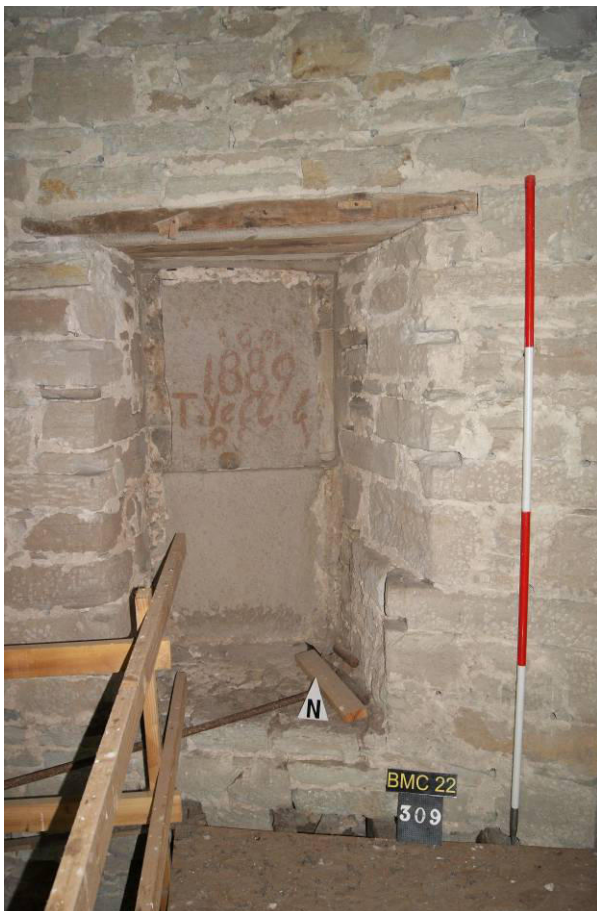
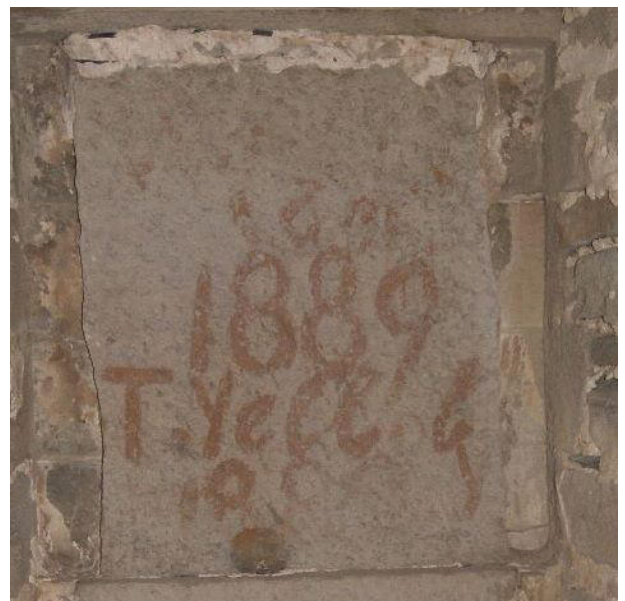
P169. Gatehouse, north-east turret R71. Showing slabs blocking 'blind' window [304]. This will be concealed in the proposed conversion to a bathroom. The former timber lintel has been replaced in cast concrete.

P170. Gatehouse, R69. North side of the room showing the inside of 'blind' window [309] with large blocking slabs. There is an inexplicable offset on the east reveal. (Right) Detail of painted graffiti on the upper blocking slab. The date '1889' and part of a name, perhaps 'T Yell(ow)ly', can be made out. This opening will be concealed by a proposed timber staircase.

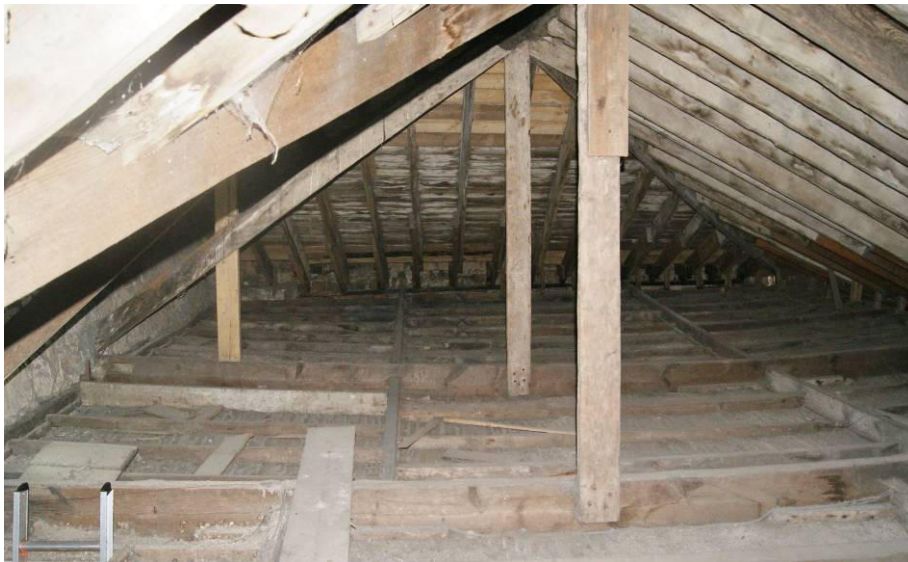
P172. Attic space R72 looking north showing trusses [313] and [314]. The joists to the ceiling of R62 below show evidence for deflection on the tie-beams. Loft hatch [236] is at bottom left.

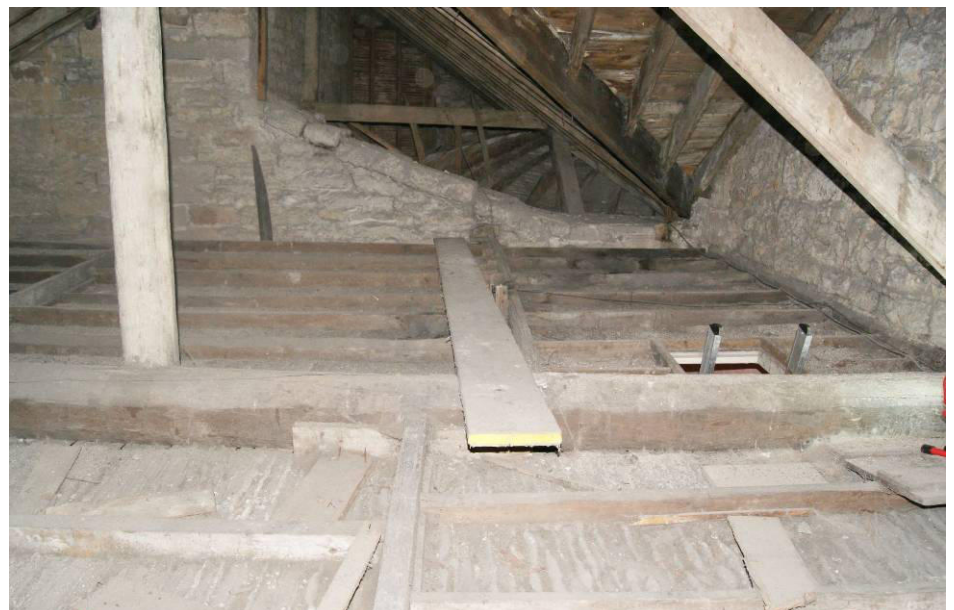
Ceiling – open to the underside of the sarked roofskin which shows evidence for considerable late 20th century repair and intervention. There are two kingpost trusses which incorporate old timbers: assembly marks IX and XIII are visible (**P174-5**). Otherwise all roof timbers appear to be late 19th/ 20th century.

P174. Attic space R72. Assembly or timber merchant's mark incised on the tie beam of truss [313].

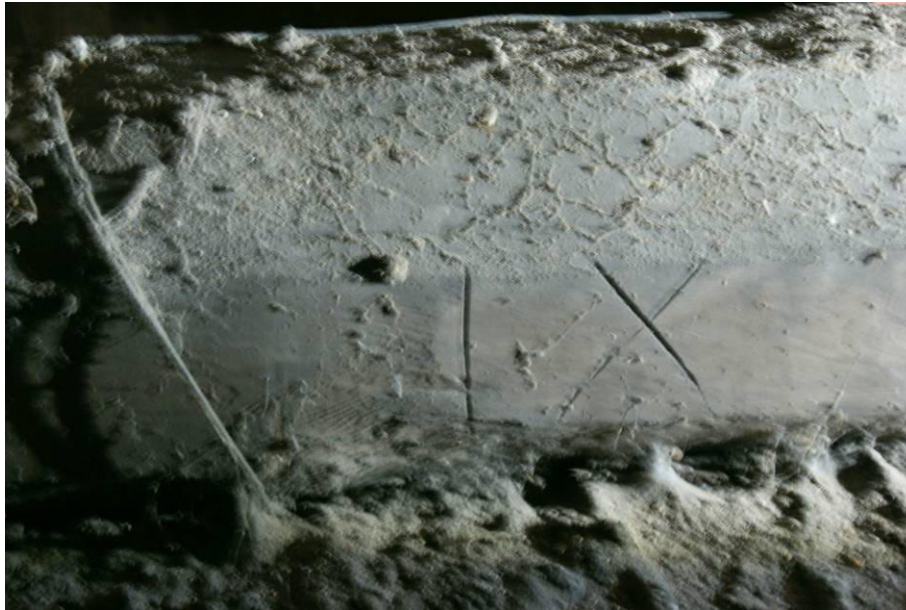
P175. Attic space R72. Assembly or timber-merchant's mark on the principal of truss [314].

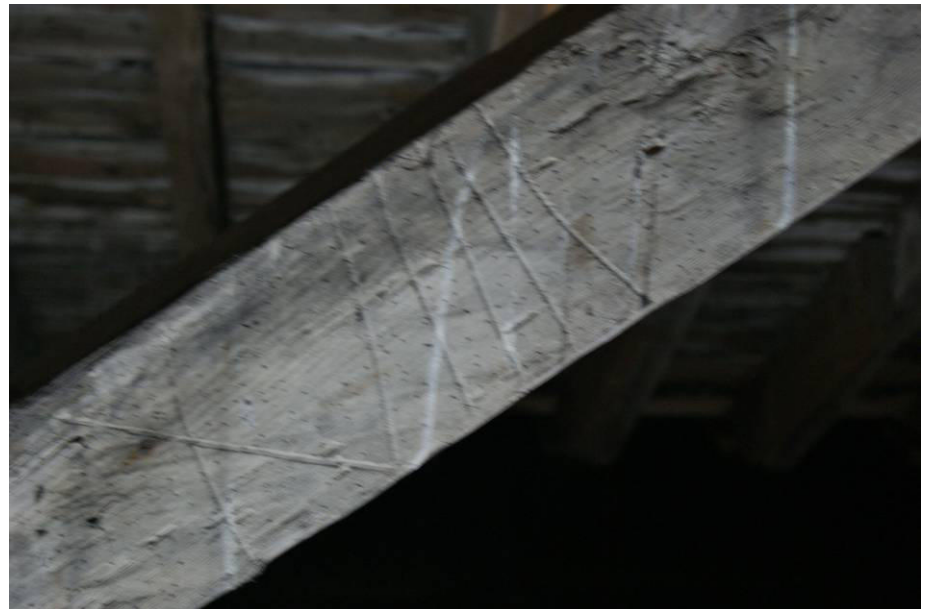
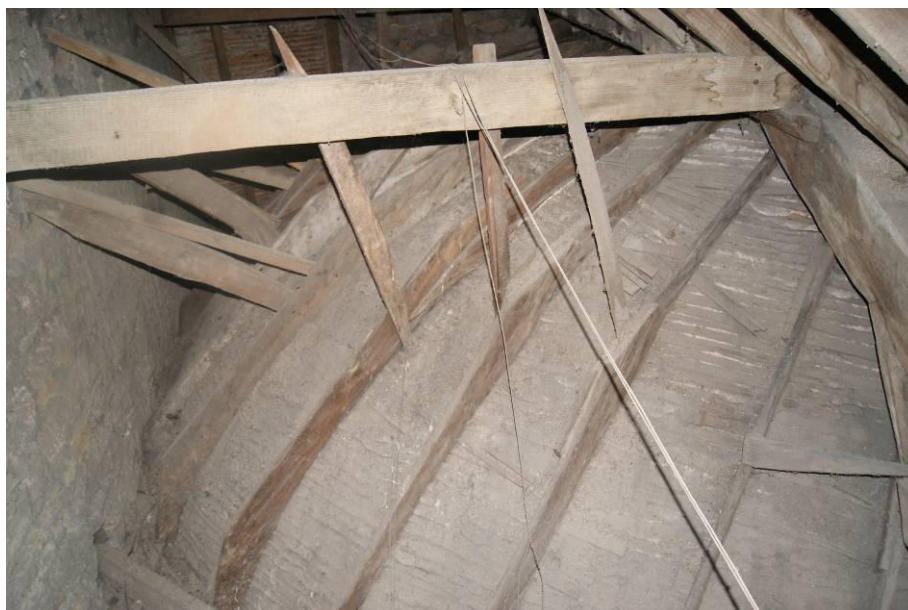
P176. Roof space R76, looking from R72 onto the inner surface of the cupola over the Great Stair, showing laths attached to shaped ribs, with some possible old patched repairs.

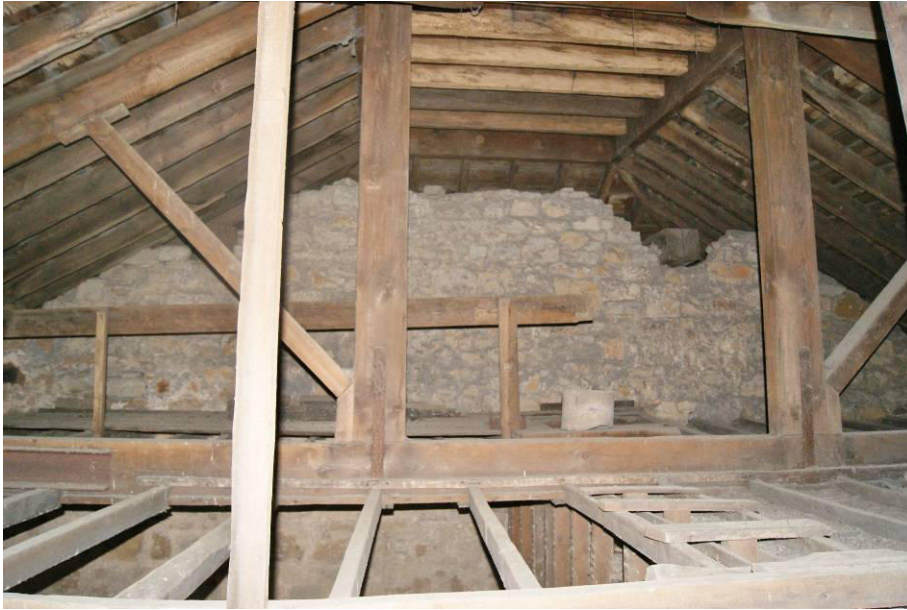
Walls - the east wall visible in R65/R66 rises into this space. It is of exposed coursed rubble and appears to predate the 1801-4 remodelling. The wall-head is ragged, with the suggestion of a gable end that that has been reduced, and it has been roughly broken into to carry two massive squared timbers forming part of the support for Oval Saloon cupola [317] (P177) (Fig.64).

Trusses – the east-west roof is carried on two Queen-post trusses with struts (added) and iron straps to the tie-beams (P177).

P177. Attic space R78 above the 1801-4 West Range. Looking east to a possibly fossilised gable from the pre-Paterson building forming the west wall of the Oval Saloon. The ends of two large squared timbers supporting the cupola over R41 have been roughly inserted through the masonry. Beyond the Queen post truss (with added modern raking struts) is the handrail of a planked walkway reached from hatch [218] in R65. This area is proposed to become

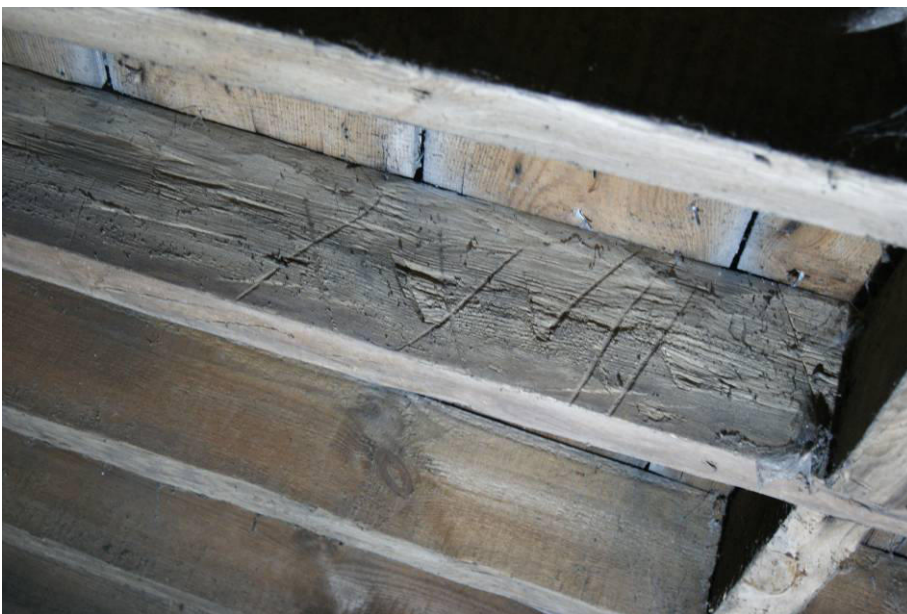
Ceiling – the rafters and the sarked underside of the roofskin are visible, showing evidence for late 20th century repairs including channel-profile RSJs. One rafter, probably reused, has an incised carpentry mark (P178).

P178. Attic space R78, carpenter's assembly mark (or timber-merchant's mark) on a rafter. Other roof timbers and sarking appear to belong to the 1801-4 build and later repairs.

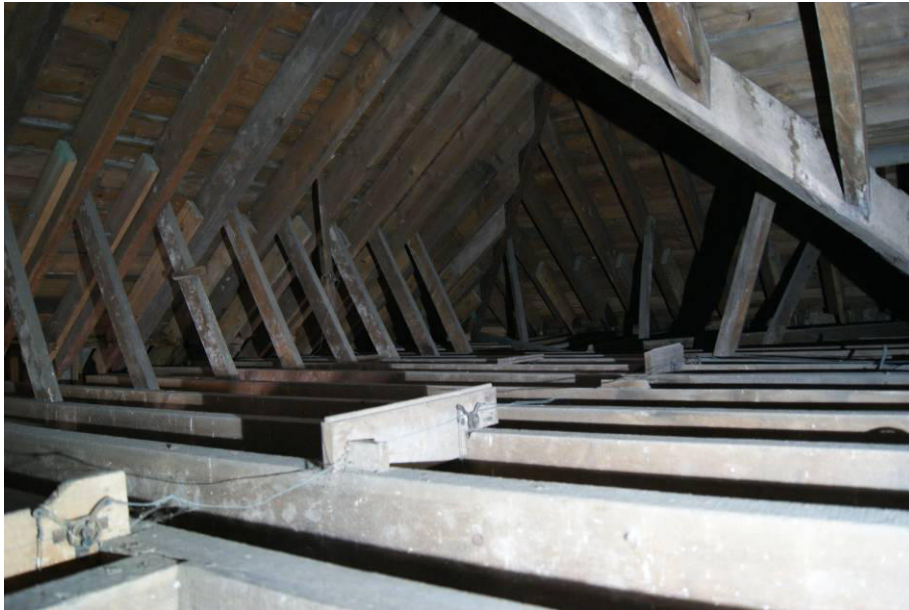
P179. Attic space R73 above R51 and R54. Looking south with a series of cast brass service bell-cranks mounted on sections of floorboard. This also shows roof repairs with bracing pieces to rafters, most of which have bolted-on replacement ends. This is all part of the c.1892 raising of the south wing.

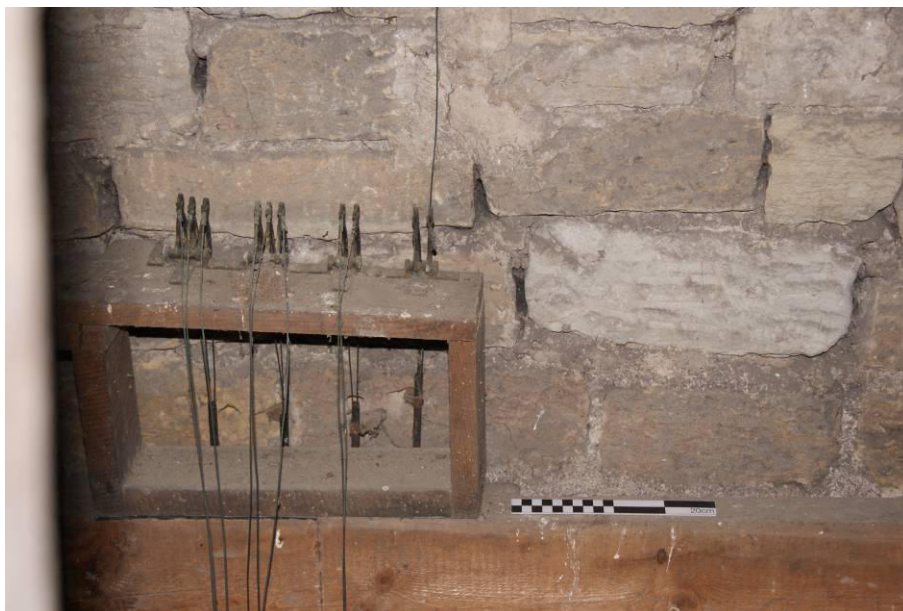
P180. Attic space R74 above R55. An array of cast brass bell-cranks with wires leading down to R2. Probably late 19th century. The wall behind is the south wall of R63. This space also contains the wooden case for a water cistern, stripped of its lead lining.
